## ENVIRONMENTAL MONITORING AND COMPLIANCE AUDIT REPORT

FOREST MANAGEMENT OF BENGKOKA AND TAMBALUGU  
FOREST RESERVES (6,467 HA), PITAS, SABAH

### 2<sup>nd</sup> REPORT OF YEAR 2021

AEC Ref. No. : JPAS/PP/15/600-1/01/3/60(36)  
Report Reference : CK/MO411/1197-2/21  
Date of Report : 15<sup>th</sup> September 2021  
Report No. : 8

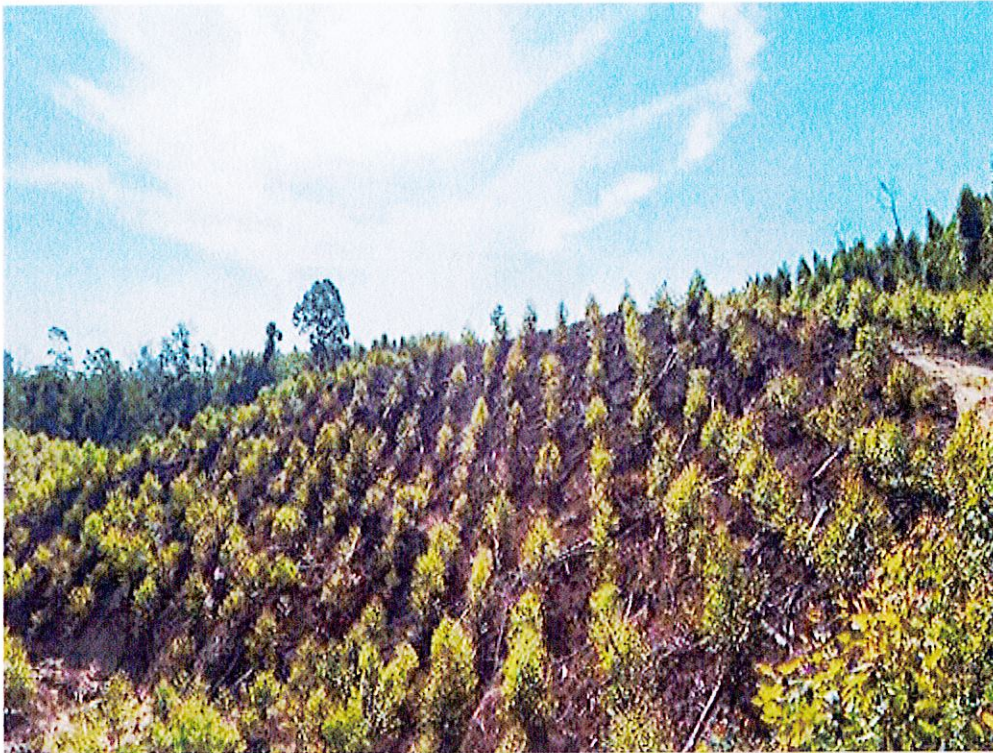
**Plate 1**

Chemical spray within planting area of Coupe 1 (Block 45).

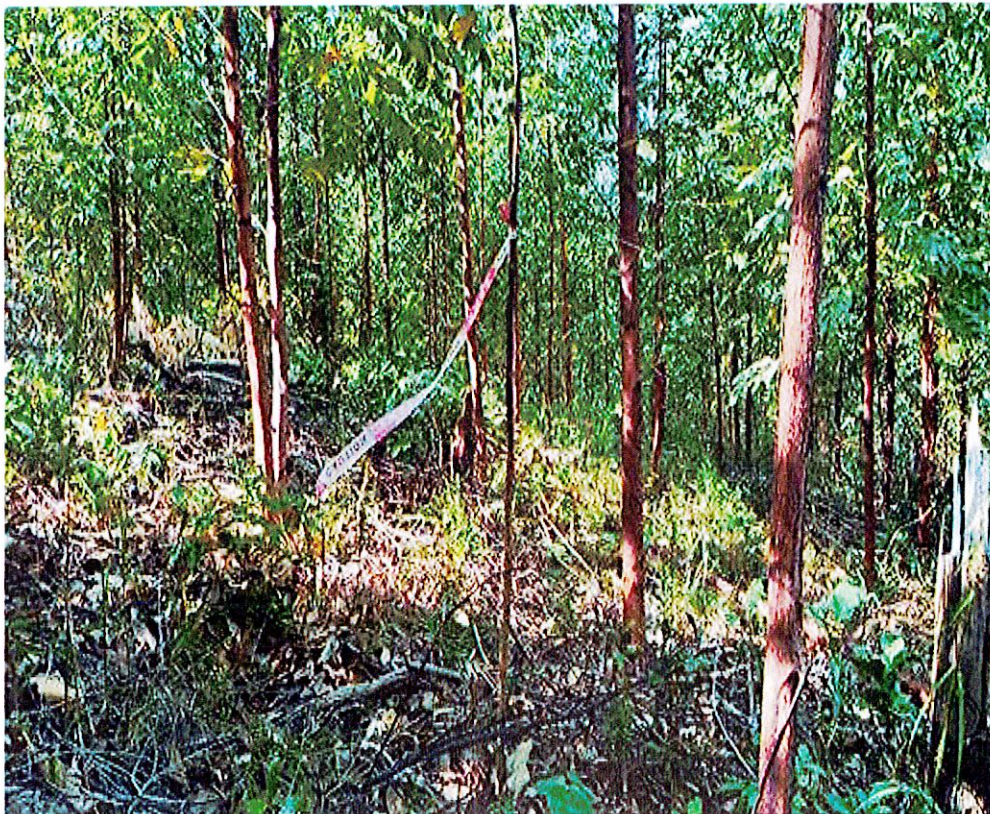
**Plate 2**

Slashing within planting area of Coupe 1 (Block 47).

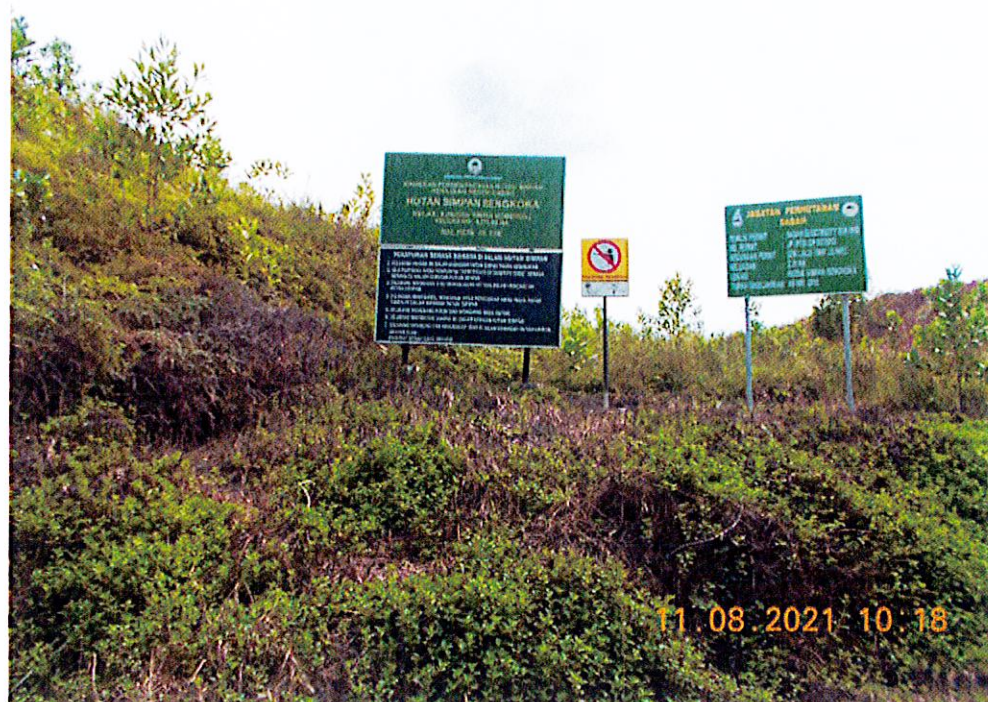
**Plate 3**

| AEC No. | Approved Environmental Conditions | Status | Observations / Comments | Photo No. | Corrective Action and Completion Date |
|---|---|---|---|---|---|
| iii | Semua tanda sempadan tapak projek hendaklah tidak ditimbus, dihalang, dirosakkan atau diganggu daripada kedudukan asal. | Comply | <ul style="list-style-type: none"> <li>Signboard and pegs are in good condition as sighted during the site visit.</li> </ul> | Plates 3 to 6 | - |

Signage in place demarcating boundary between the Project site and the adjacent forest reserves.

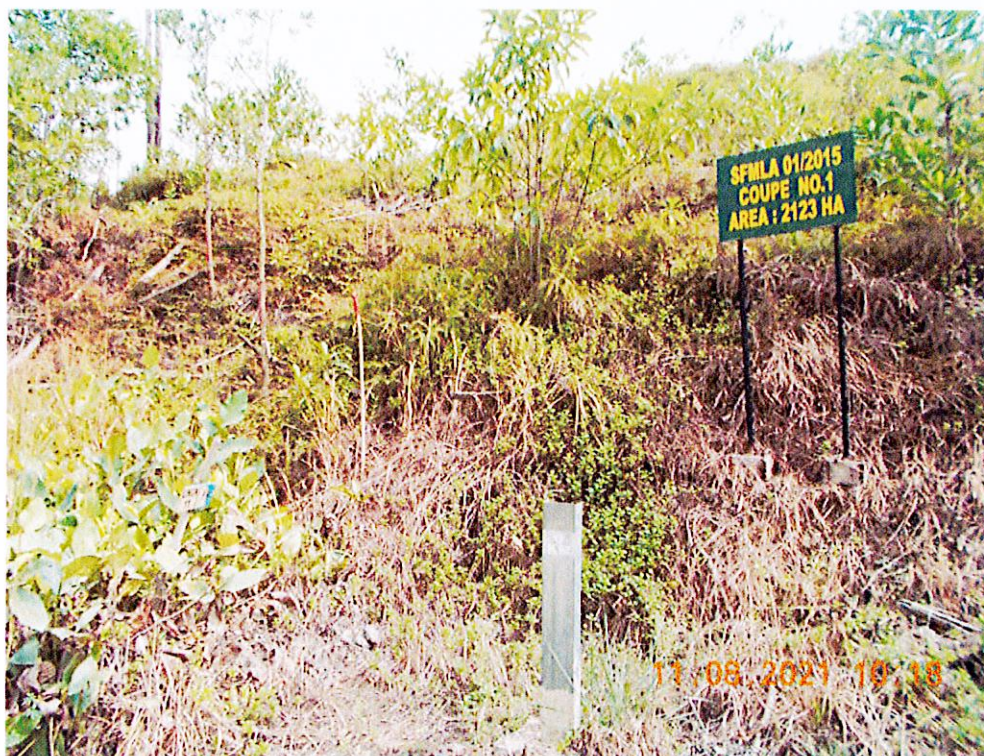
Signage in place demarcating boundary between coupe and block of the Project site.

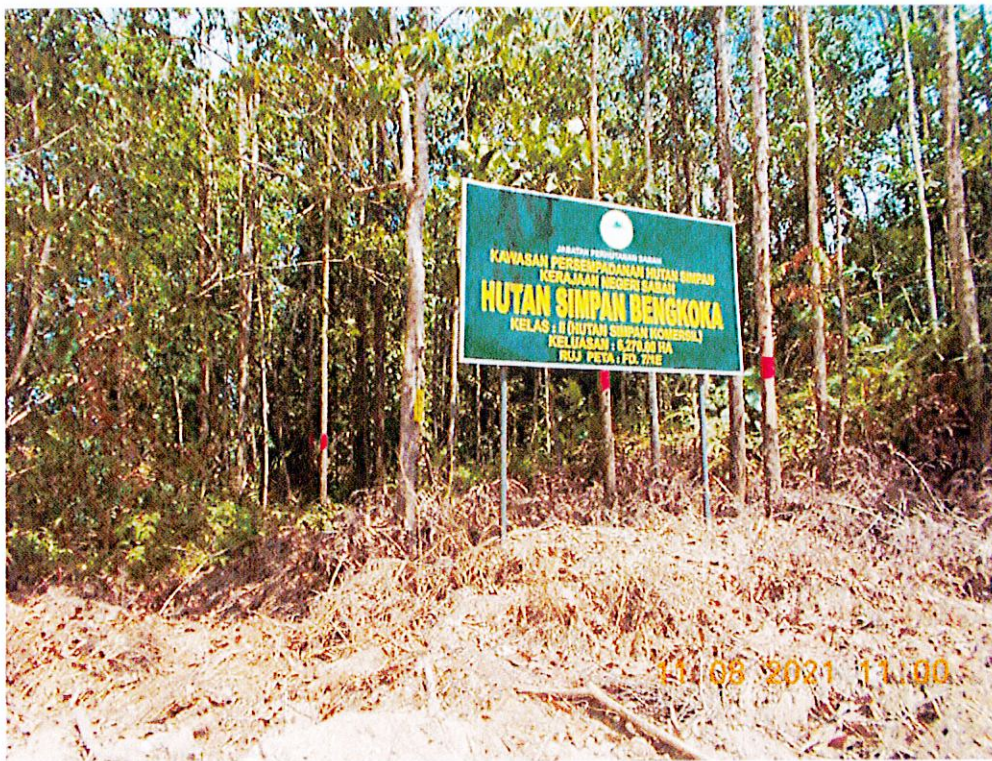
**Plate 5**

Signage in place demarcating boundary between the Project site and the adjacent local village.

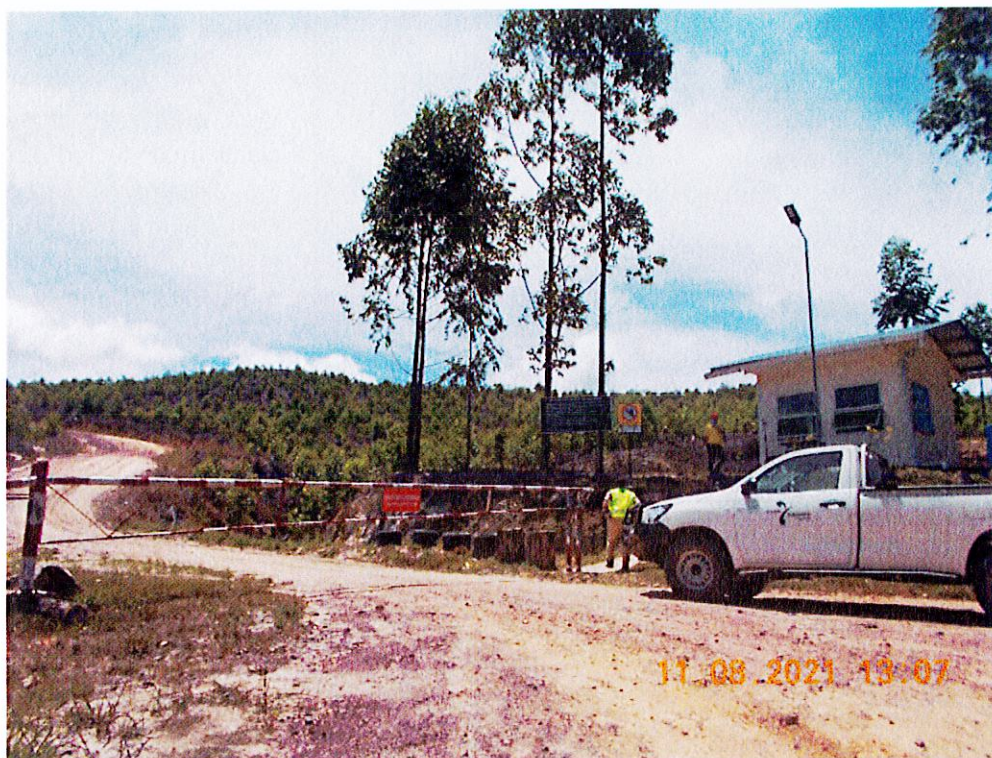
**Plate 6**

Entrance gate in place demarcating Project boundary.

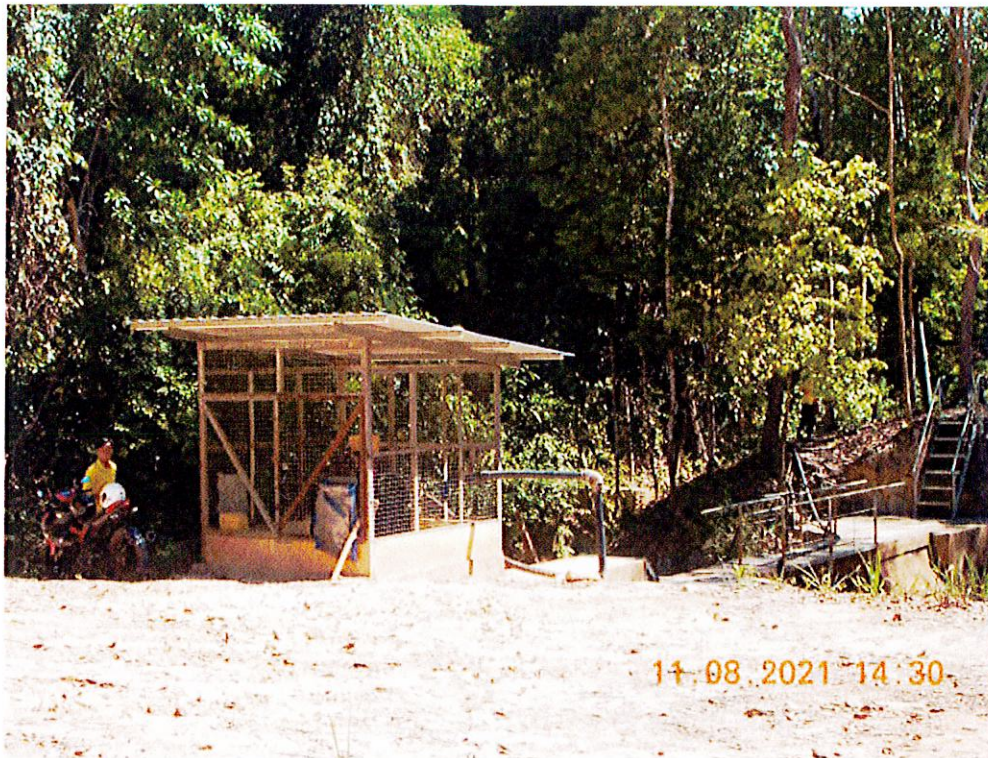
**Plate 7**

| AEC No. | Approved Environmental Conditions | Status | Observations / Comments | Photo No. | Corrective Action and Completion Date |
|---|---|---|---|---|---|
| iv | Aktiviti perladangan hutan adalah <b>tidak dibenarkan</b> di dalam kawasan tadahan air, takungan air dan "water intake point" sebagaimana dinyatakan dan masing-masing ditandakan sebagai "Water Catchment", "Water Reservoir" dan "Water Intake" dalam maklumat tambahan rujukan CK/EV403-4278/0199/17 bertarikh 13 April 2017 dan ditunjukkan pada "Figure 6.2.1" dalam Perjanjian Syarat-syarat Alam Sekitar ini. | Comply | <ul style="list-style-type: none"> <li>Development within the water catchments area, water reservoir and water intake was not sighted.</li> <li>In addition, the Project Proponent has conducted enrichment planting with local species trees along the Riparian Reserve of the water reservoir area.</li> </ul> | Plates 7 & 8 | - |

View of the water reservoir dam located within the Project site.

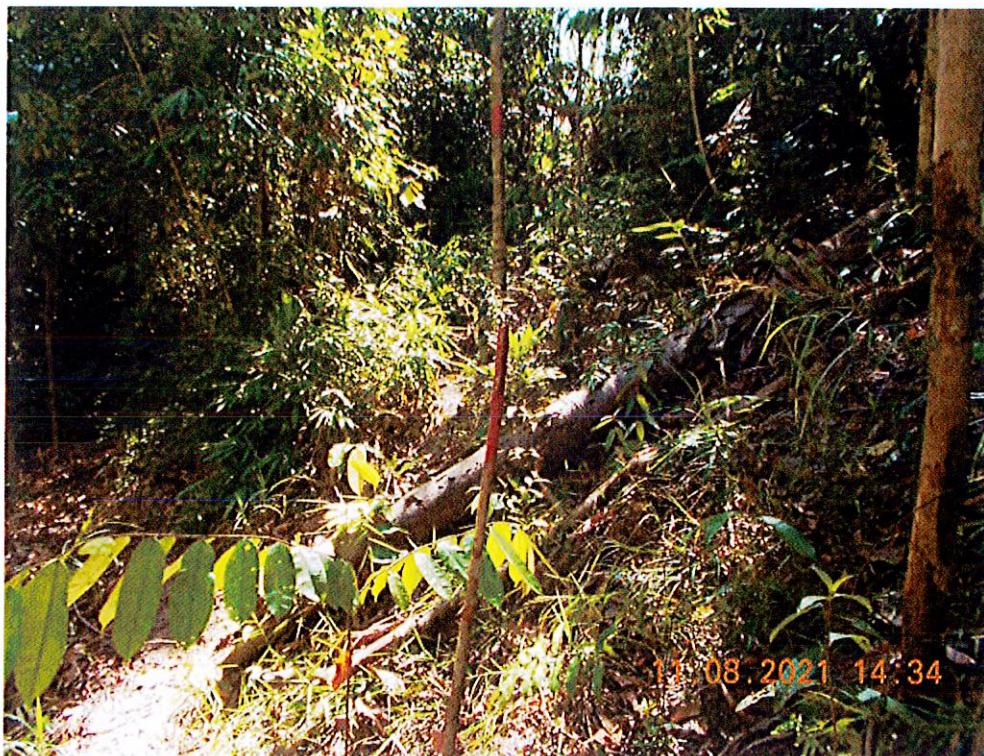
**Plate 8**

View of the enrichment planting conducted along the Riparian Reserve area near the water reservoir dam located within the Project site.

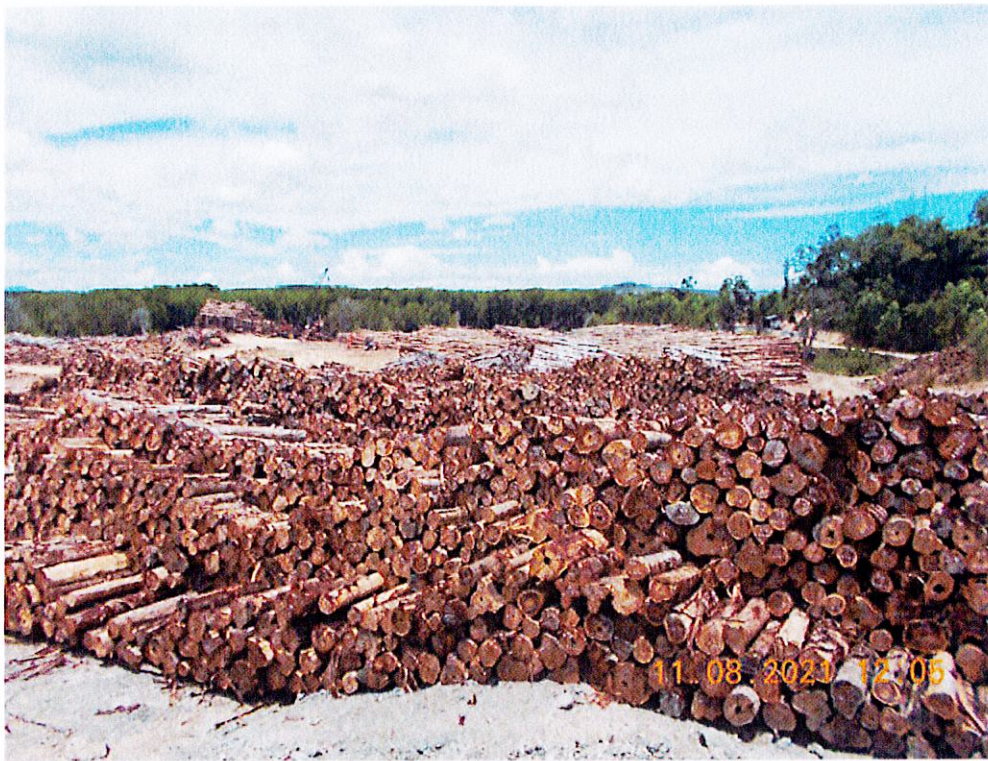
**Plate 9**

View showing the log pond on-site.

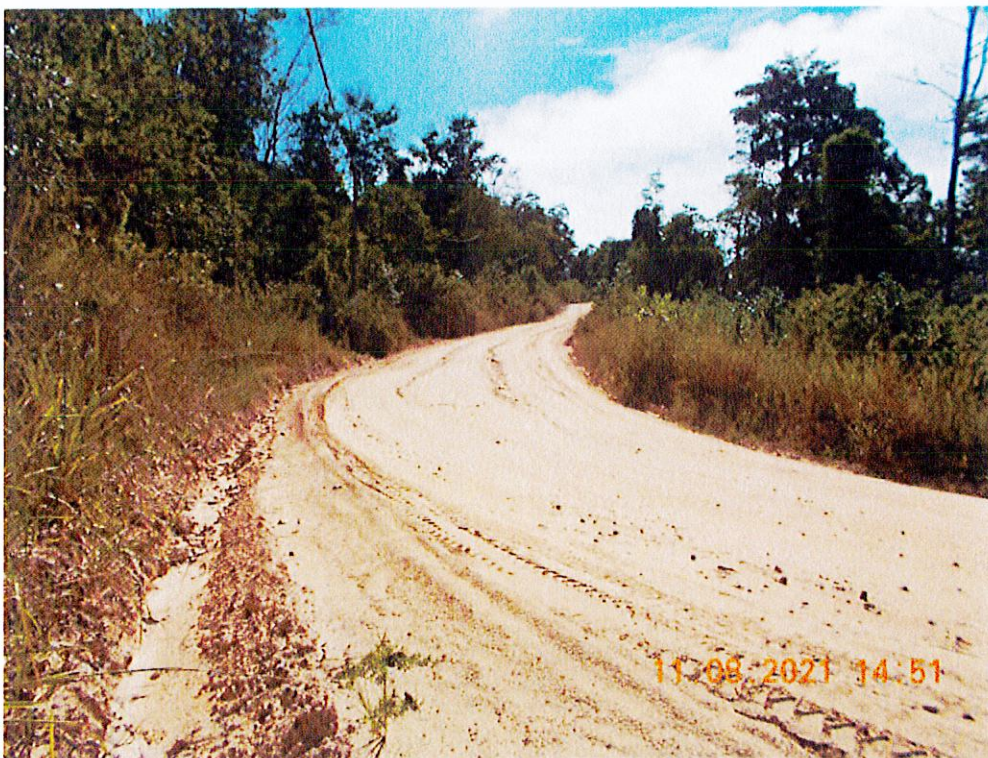
**Plate 10**

| AEC No. | Approved Environmental Conditions | Status | Observations / Comments | Photo No. | Corrective Action and Completion Date |
|---|---|---|---|---|---|
| i | Jalan sedia ada hendaklah digunakan bagi mengurangkan gangguan terhadap tanah. | Comply | <ul style="list-style-type: none"> <li>Existing access road was fully utilized as sighted during the site visit.</li> </ul> | Plate 10 | - |
| ii | Sistem perparitan hendaklah disediakan bagi mengalirkan air keluar dari struktur jalan dan dilencongkan ke kawasan yang mempunyai tumbuhan. | Comply | <ul style="list-style-type: none"> <li>Existing access road are equipped with earth drainage, channelling surface runoff towards the nearest vegetated area.</li> </ul> | Plate 10 | - |

View showing the existing access road on-site.

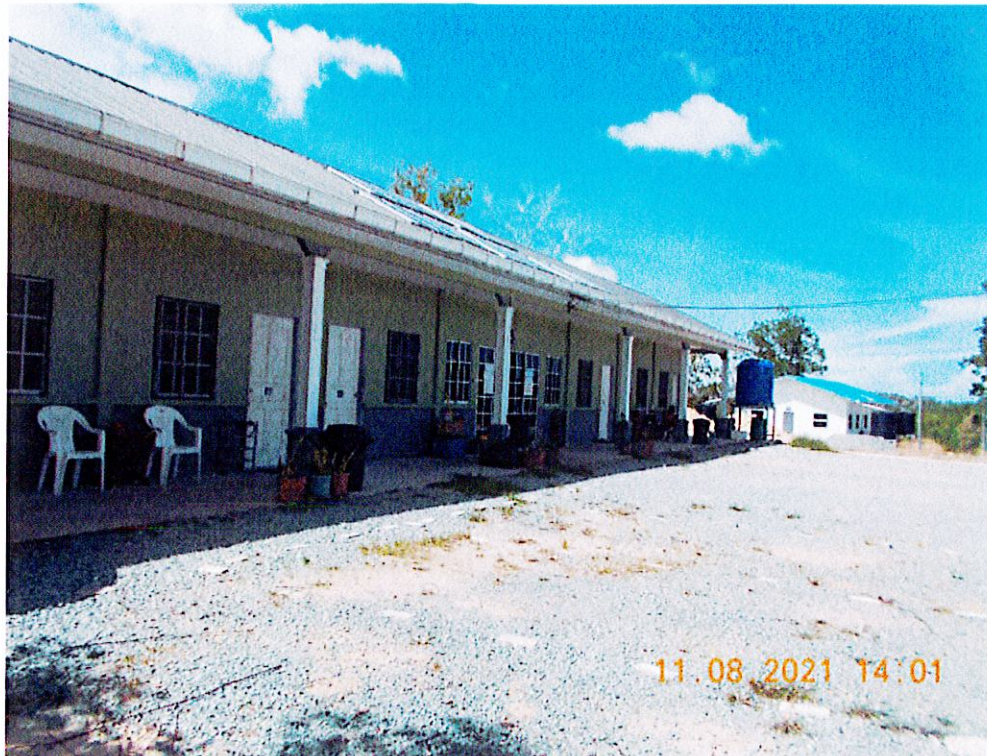
**Plate 11**

| AEC No. | Approved Environmental Conditions | Status | Observations / Comments | Photo No. | Corrective Action and Completion Date |
|---|---|---|---|---|---|
| iii | Kedudukan rumah pekerja atau kem pekerja hendaklah terletak pada jarak mendatar tidak kurang <b>30 meter</b> dari tebing sungai atau alur air. | Comply | <ul style="list-style-type: none"> <li>Staff's quarters and workers' quarters are located at more than 30 m away from the nearest natural waterways.</li> </ul> | Plates 11 & 13 | - |

View of the staff' quarters at the base camp.

The facility is located at more than 30 meters away from any nearest natural waterways.

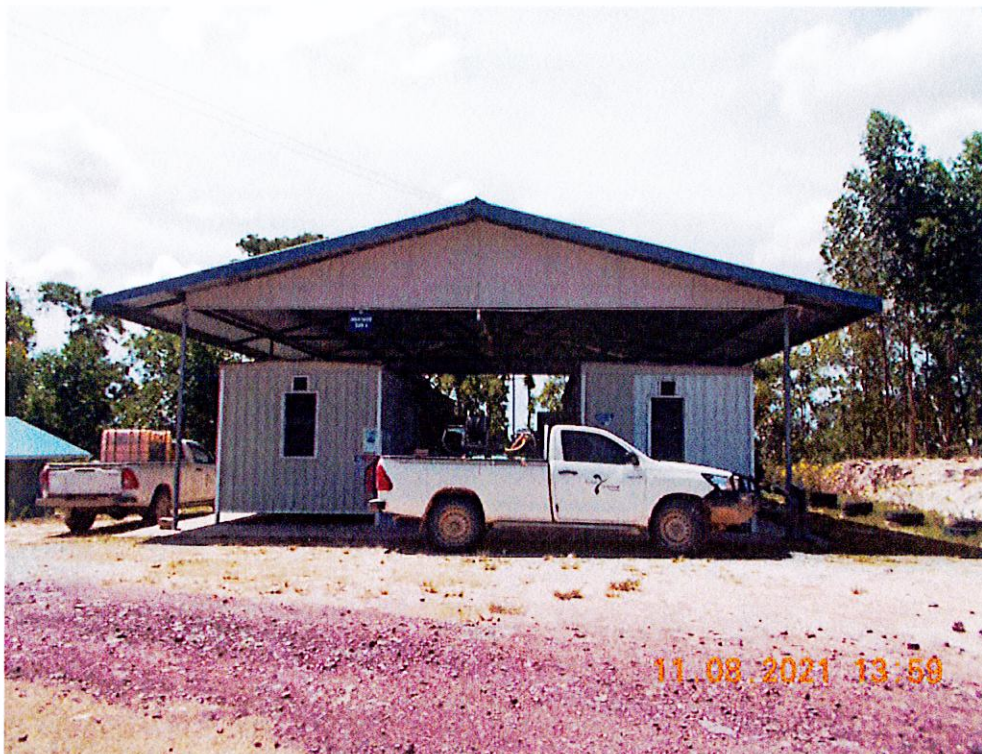
**Plate 12**

View showing the workers' quarters near base camp.

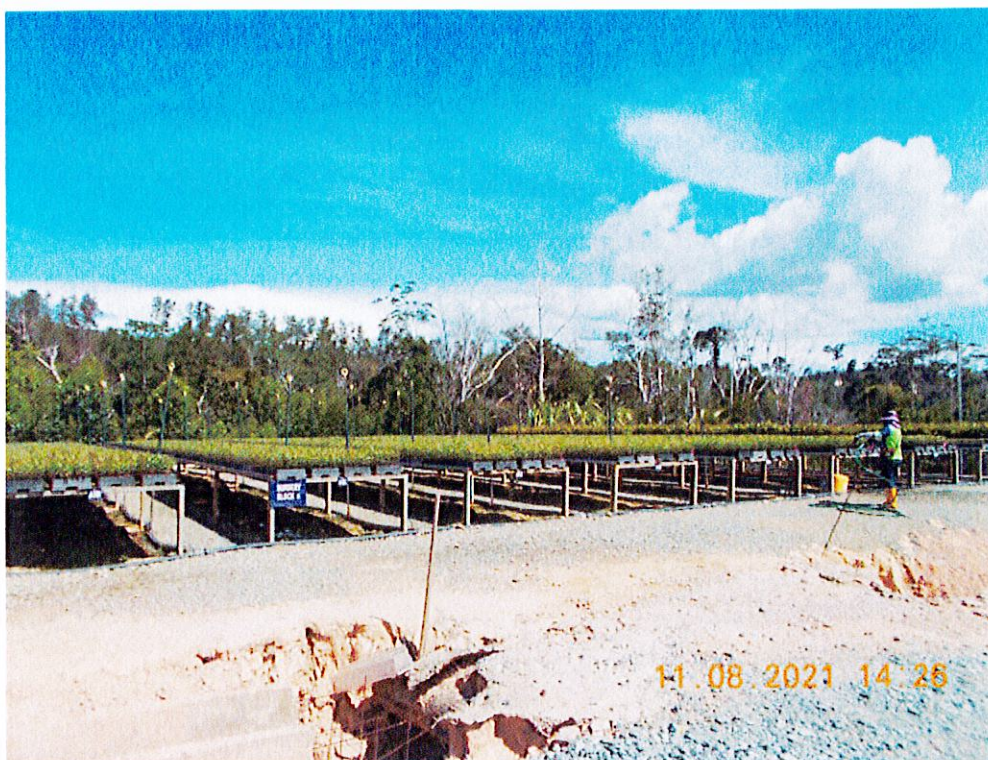
**Plate 13**

View showing the nursery on-site.

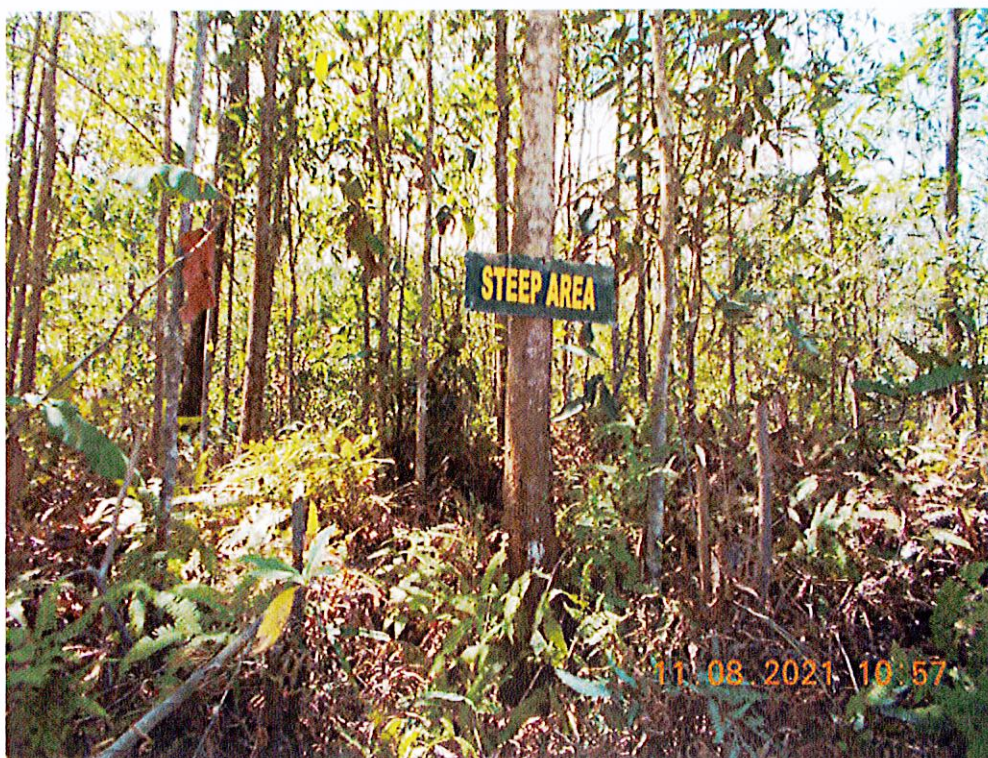
**Plate 14**

Steep area within Coupe 2 (Block 39) is clearly demarcated on-site.

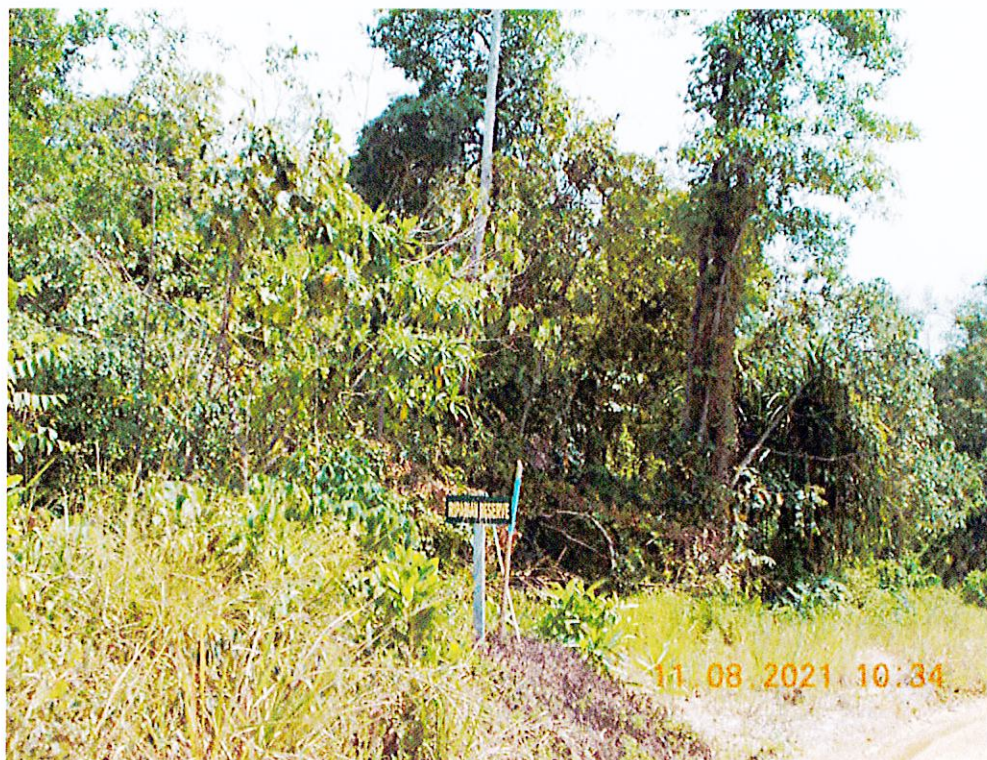
**Plate 15**

Signboard in place demarcating the riparian reserves on-site.

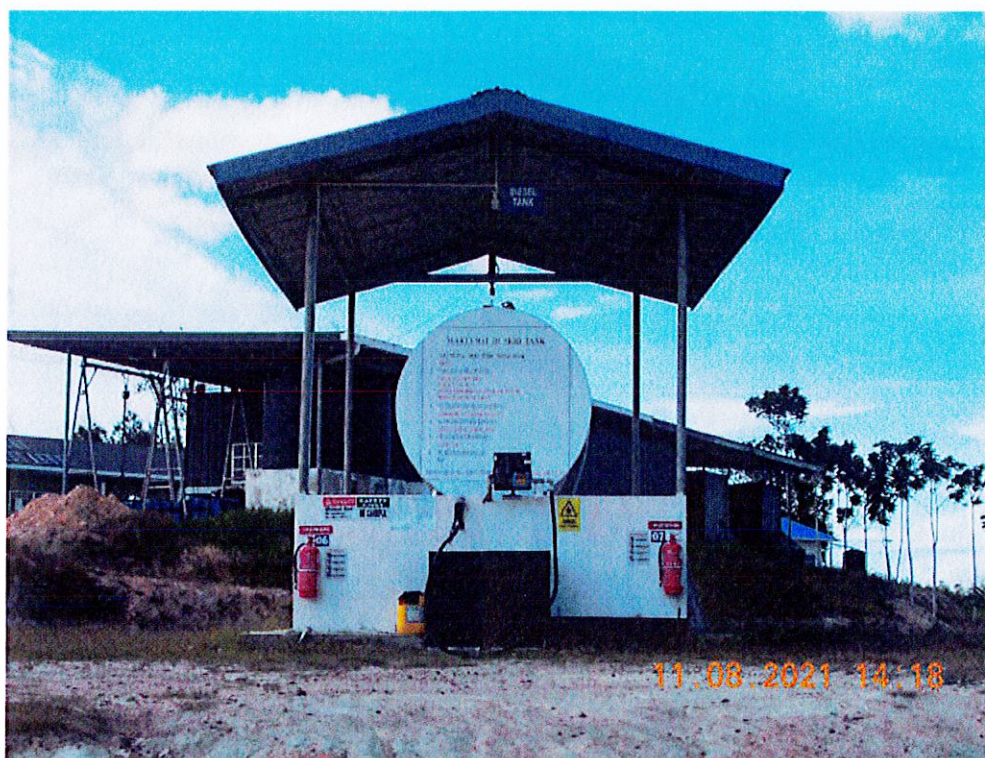
**Plate 16**

The facility was located at 50 meters away from any nearest natural waterways.

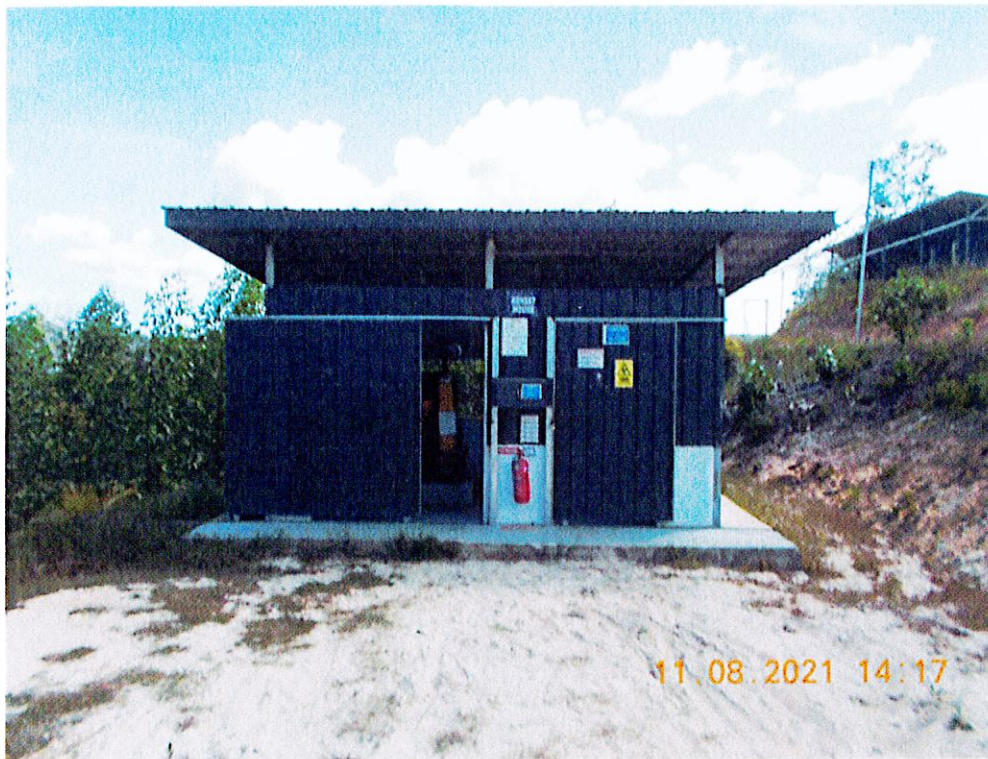
**Plate 17**

View showing the lubricant and oil storage, and Genset building situated near the staff quarters area.

The facility was located at 50 meters away from any nearest natural waterways.

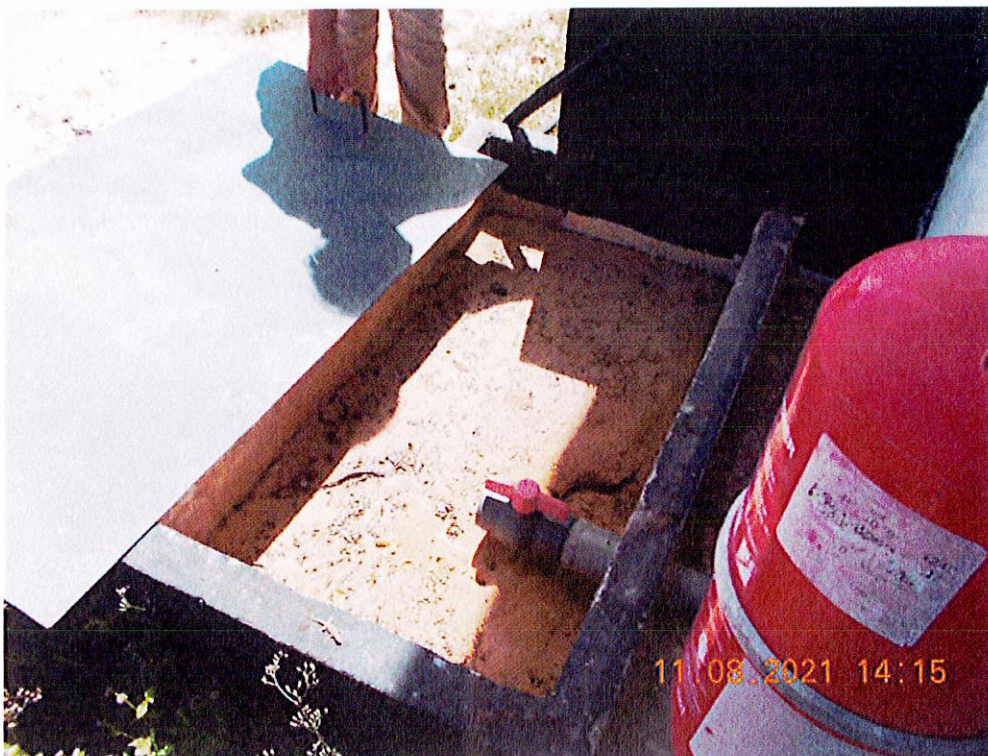
**Plate 18**

Diesel skid tank storage building was equipped with an oil trap.

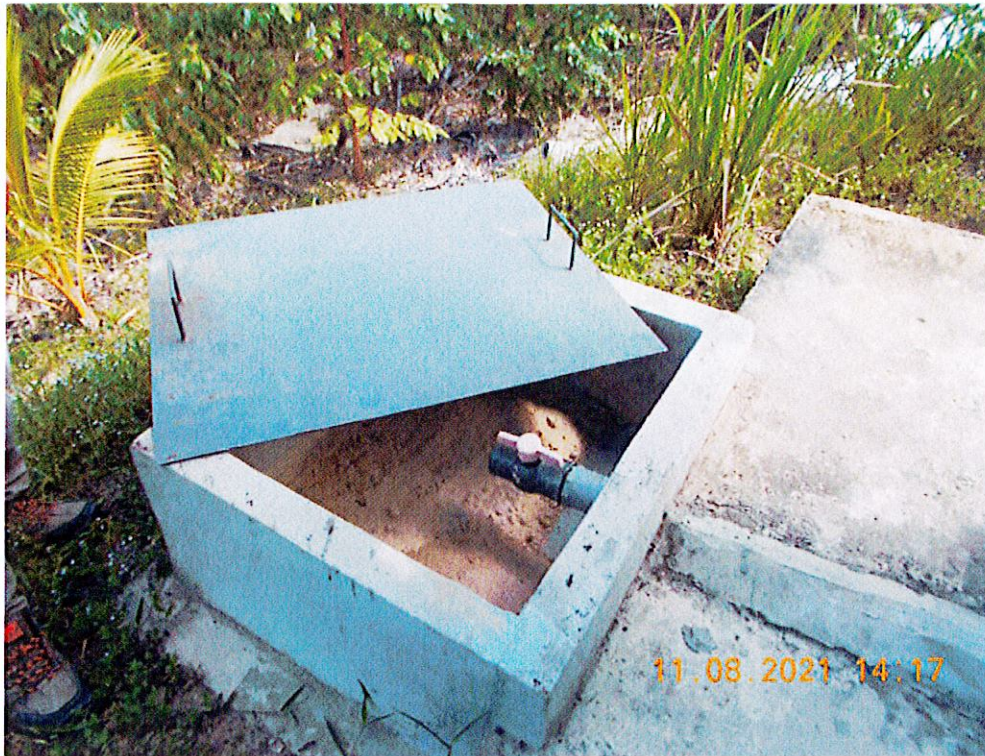
**Plate 19**

Lubricant and oil storage building was equipped with an oil trap.

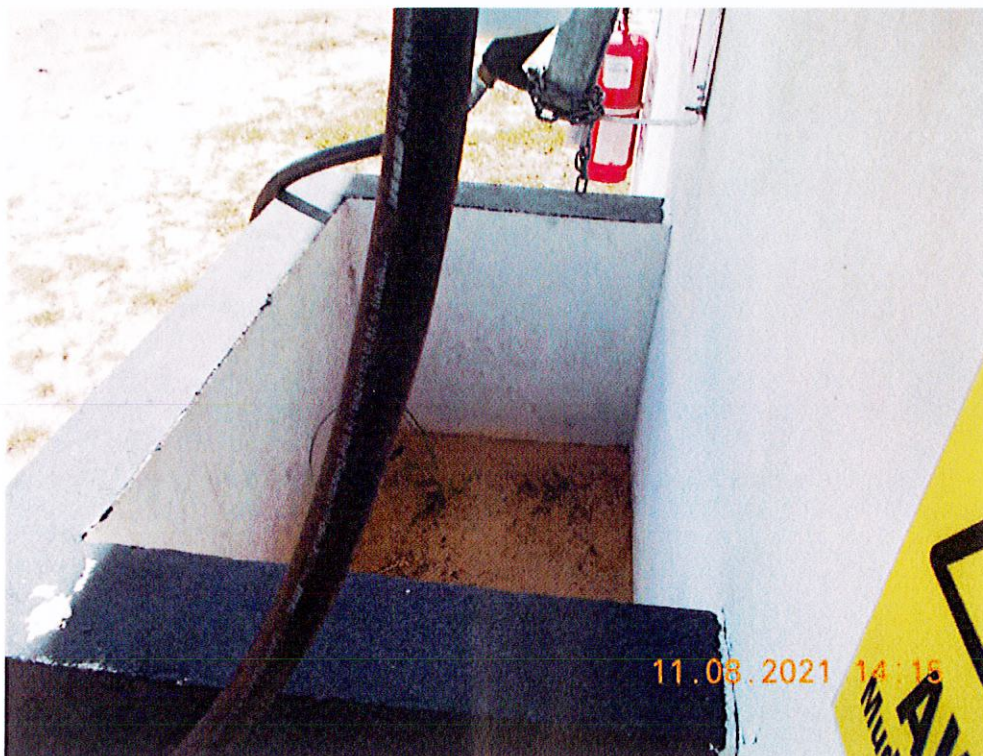
**Plate 20**

Nozzle storage area of the skid tank was equipped with concrete containment bund filled with sand to prevent oil from directly seep into the ground.

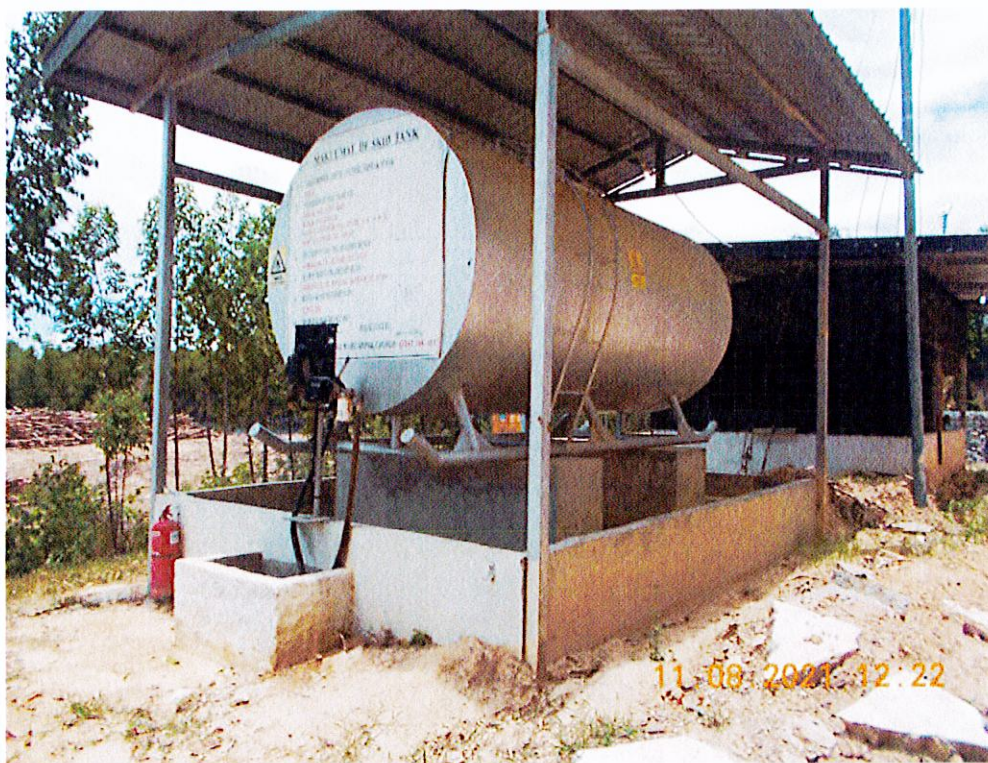
**Plate 21**

View showing the diesel skid tank situated within the log pond area.

It is situated at more than 50 m away from the nearest natural waterways and sheltered from weather exposure.

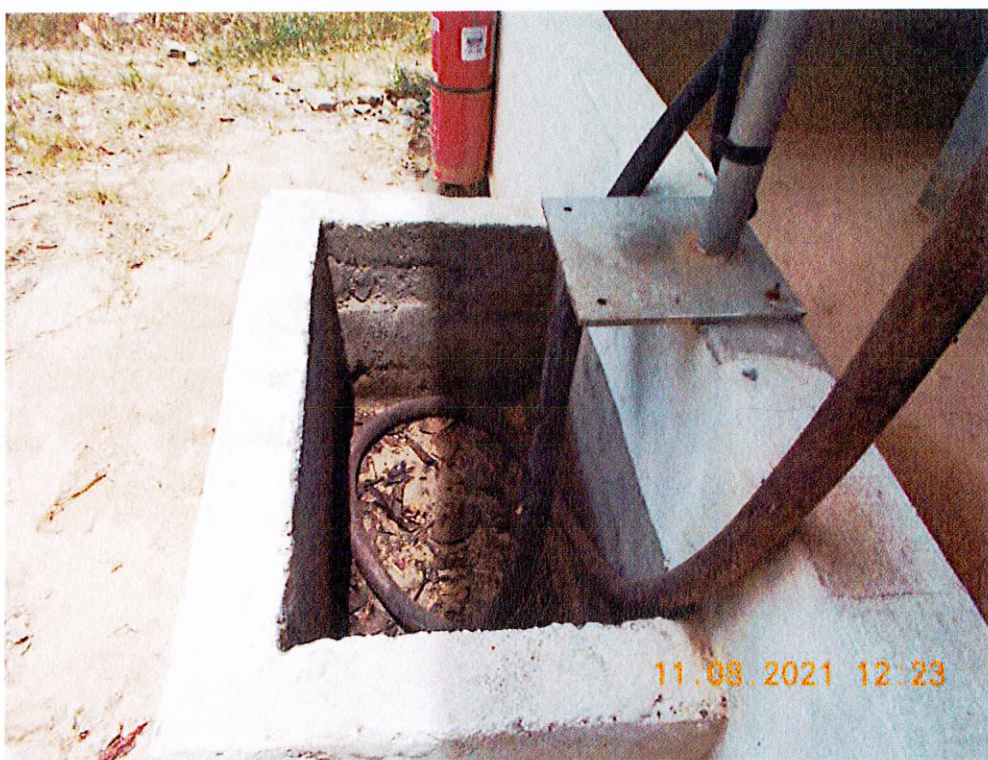
**Plate 22**

Nozzle storage area of the skid tank within the log pond area was equipped with concrete containment bund filled with sand to prevent oil from directly seep into the ground.

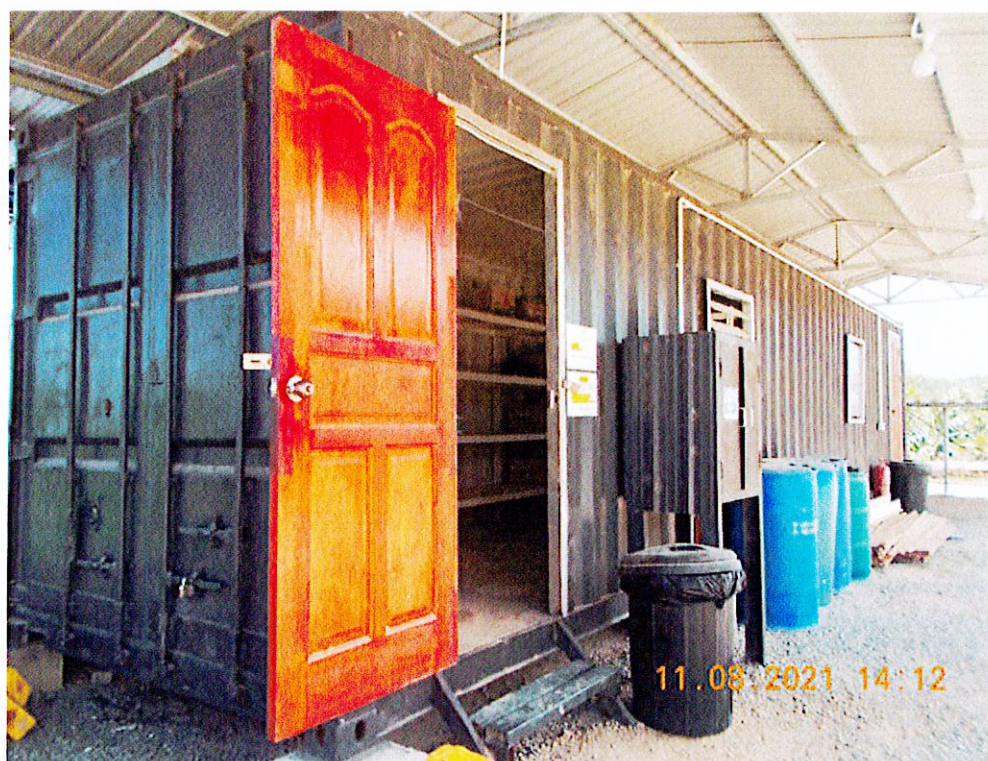
**Plate 23**

View showing the agrochemical storage area on-site.

The facility is located at more than 50 m away from any nearest natural waterways.

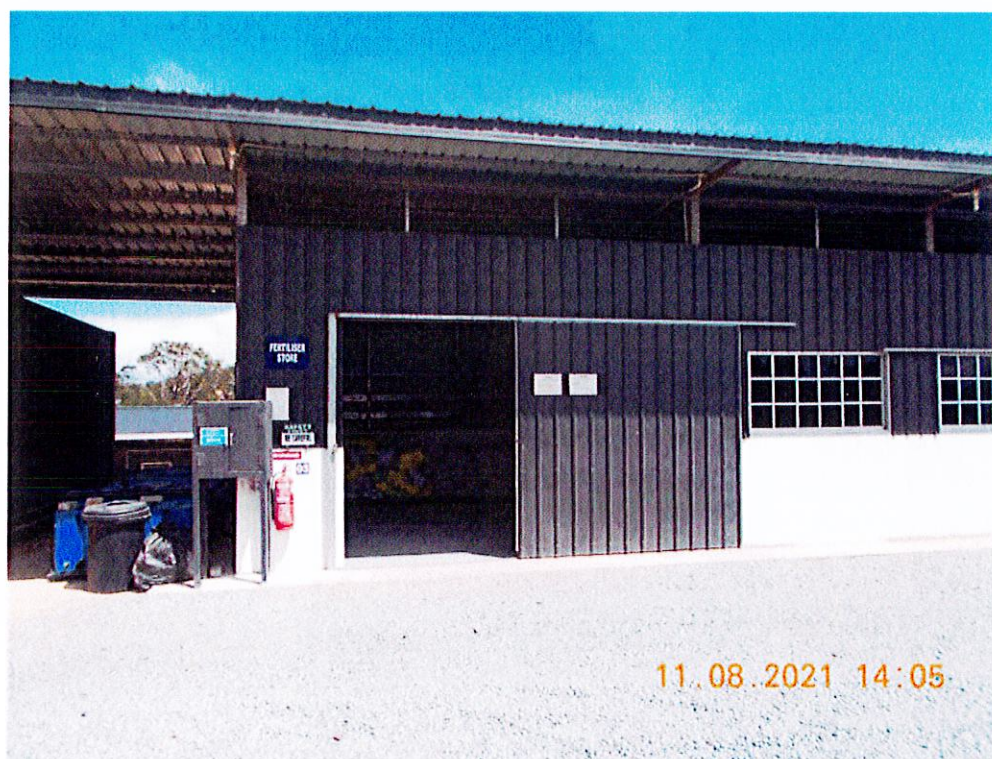
**Plate 24**

View showing the fertiliser storage area on-site.

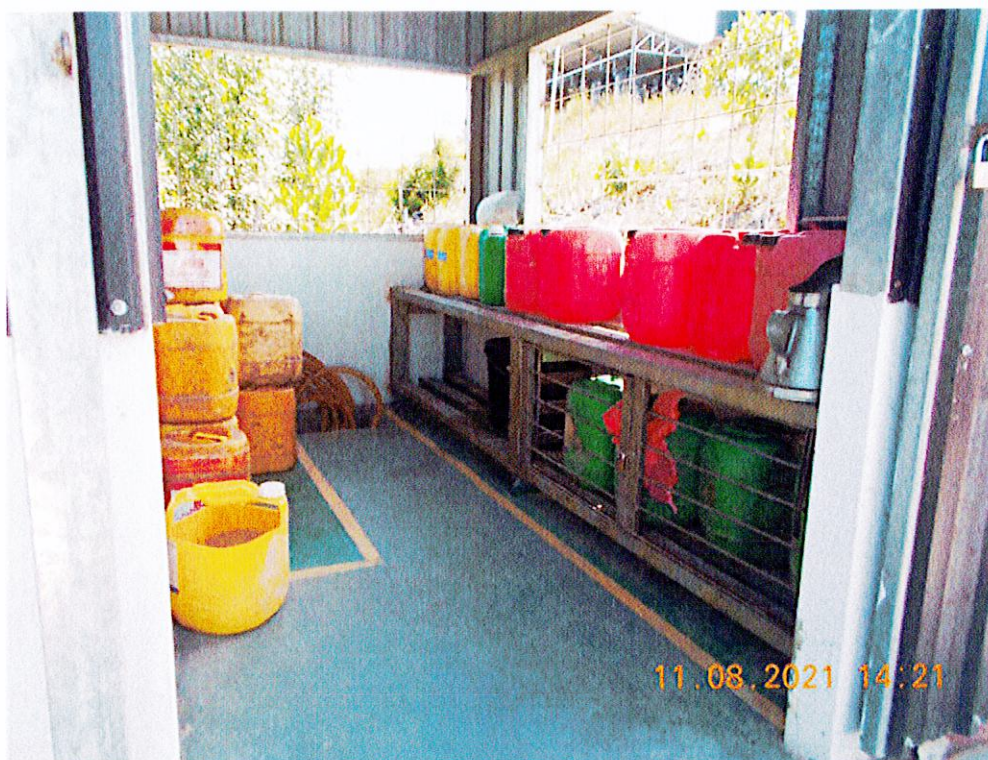
**Plate 25**

Close up view of the lubricant and oil storage area situated at the site office.

The facility is located at more than 50 m away from any nearest natural waterways.

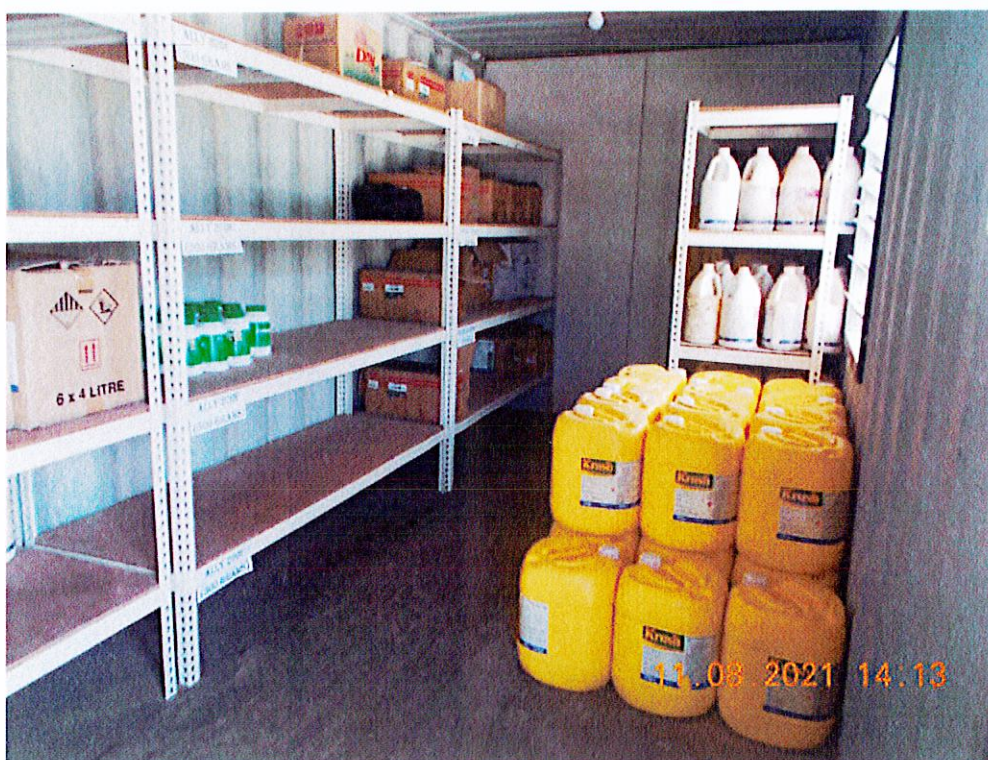
**Plate 26**

Agrochemical containers on-site was labelled and stacked properly.

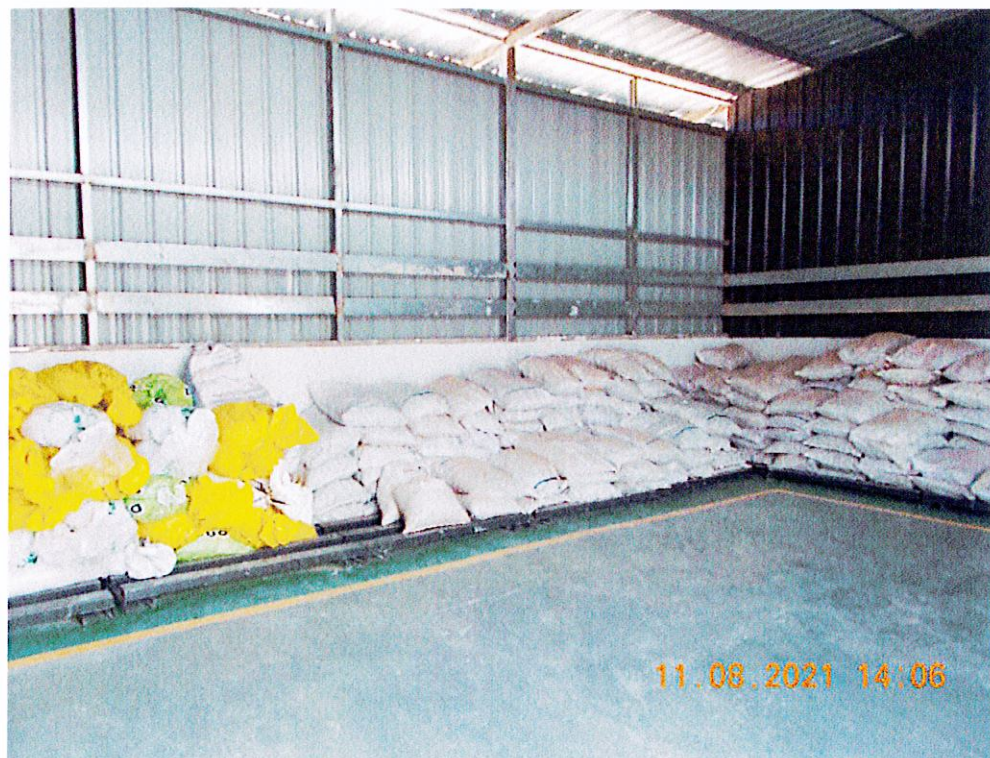
**Plate 27**

Fertiliser on-site was labelled and stacked properly.

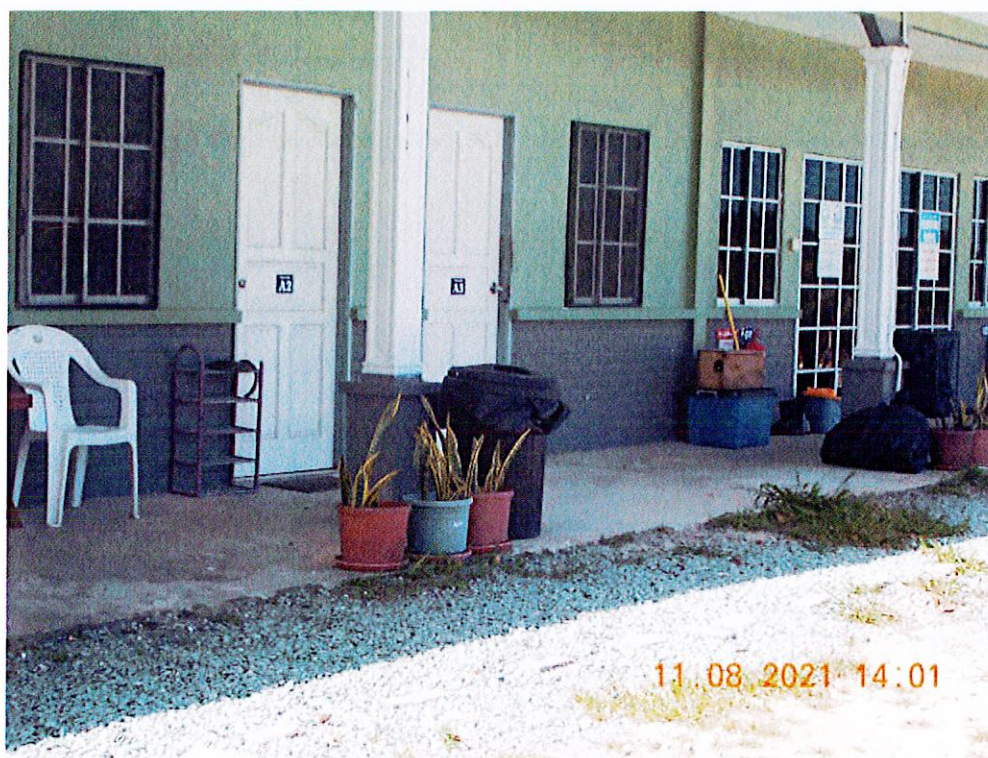
**Plate 28**

Garbage bin was provided to facilitate solid wastes collection.
