## ENVIRONMENTAL MONITORING AND COMPLIANCE AUDIT REPORT

FOREST MANAGEMENT OF BENGKOKA AND TAMBALUGU  
FOREST RESERVES (6,467 HA), PITAS, SABAH

### 2<sup>nd</sup> REPORT OF YEAR 2021

AEC Ref. No. : JPAS/PP/15/600-1/01/3/60(36)  
Report Reference : CK/MO411/1197-2/21  
Date of Report : 15<sup>th</sup> September 2021  
Report No. : 8

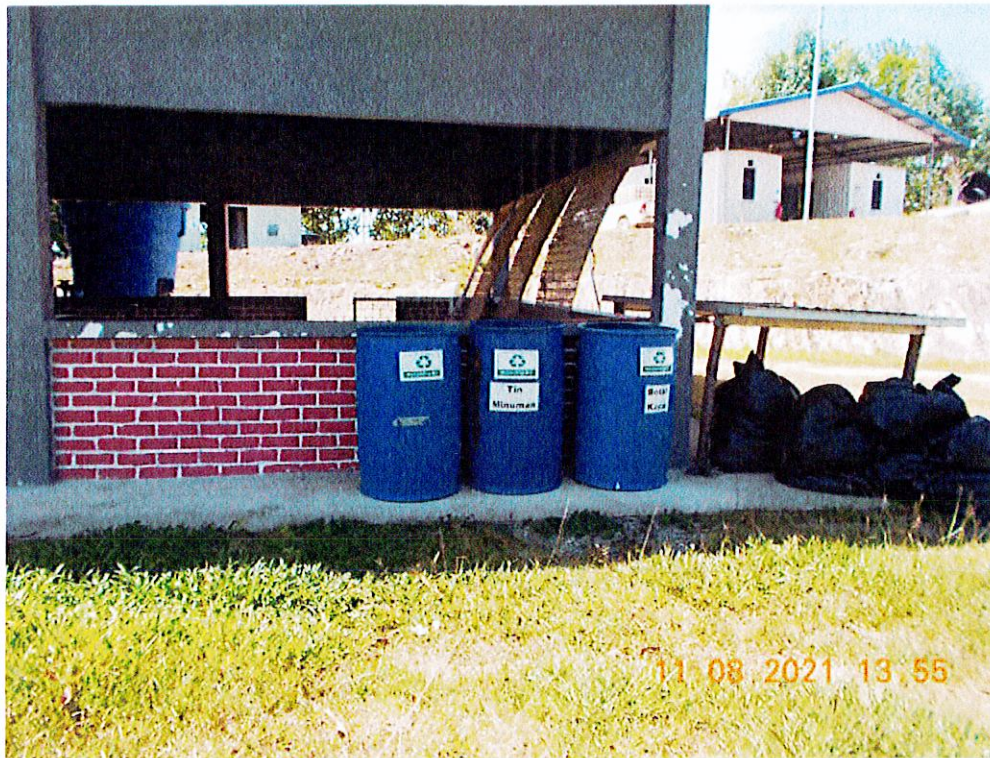
**Plate 29**

Recycle bins in place to facilitate solid waste segregation.

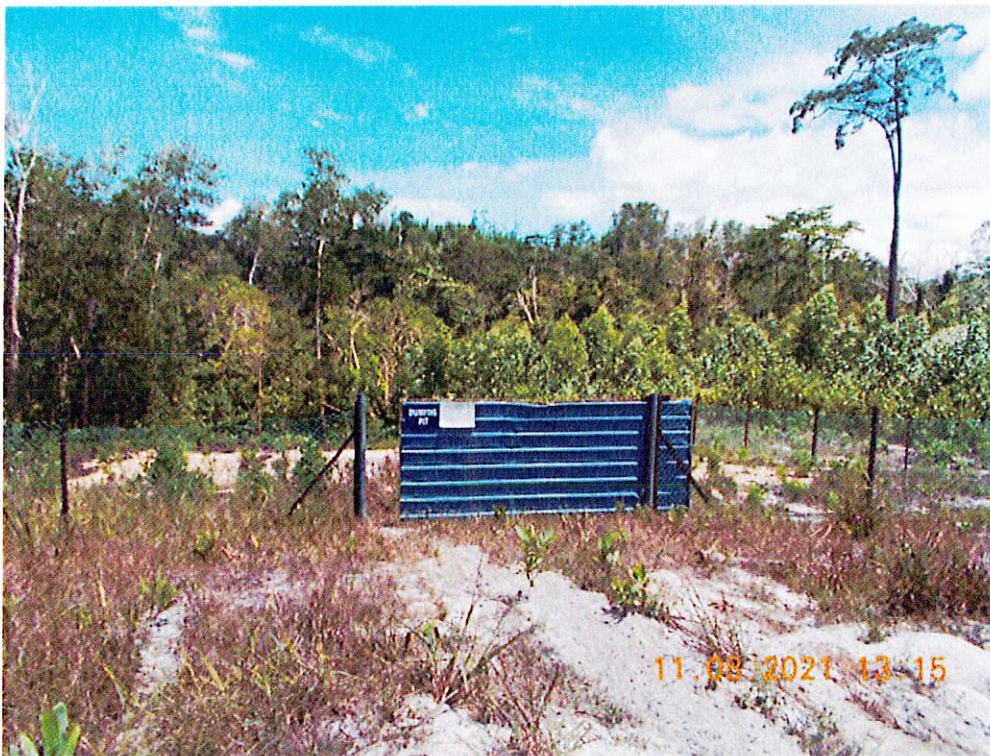
**Plate 30**

Dumping pit is available on-site.

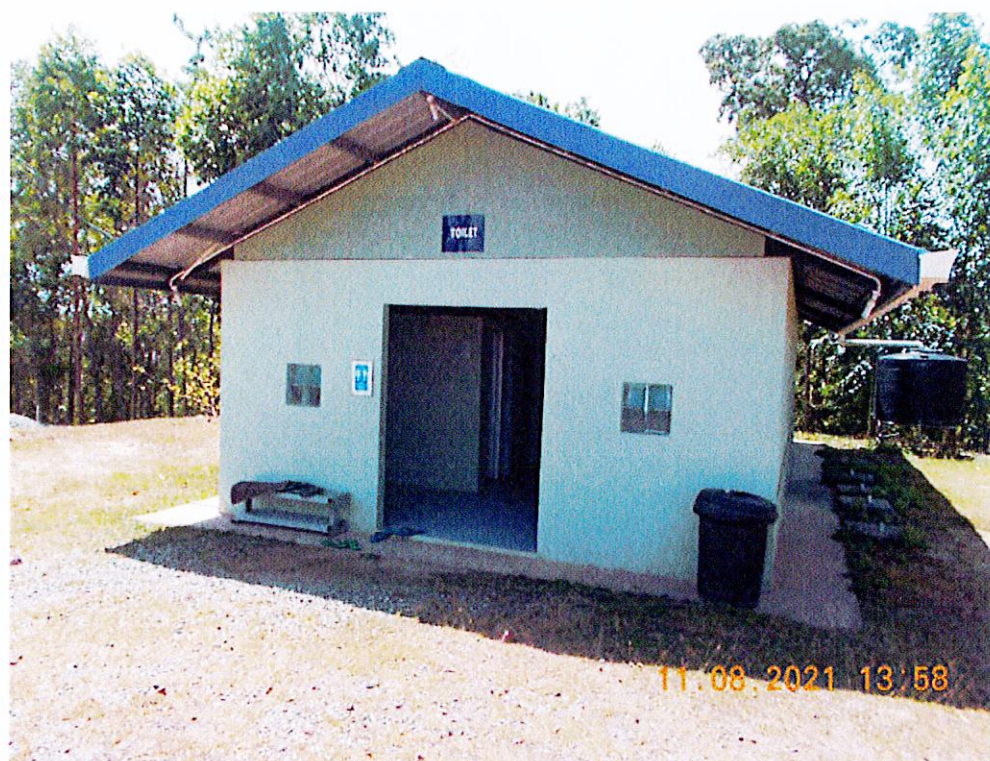
**Plate 31**

Toilet with septic tank was available at the project site to cater sewage waste.

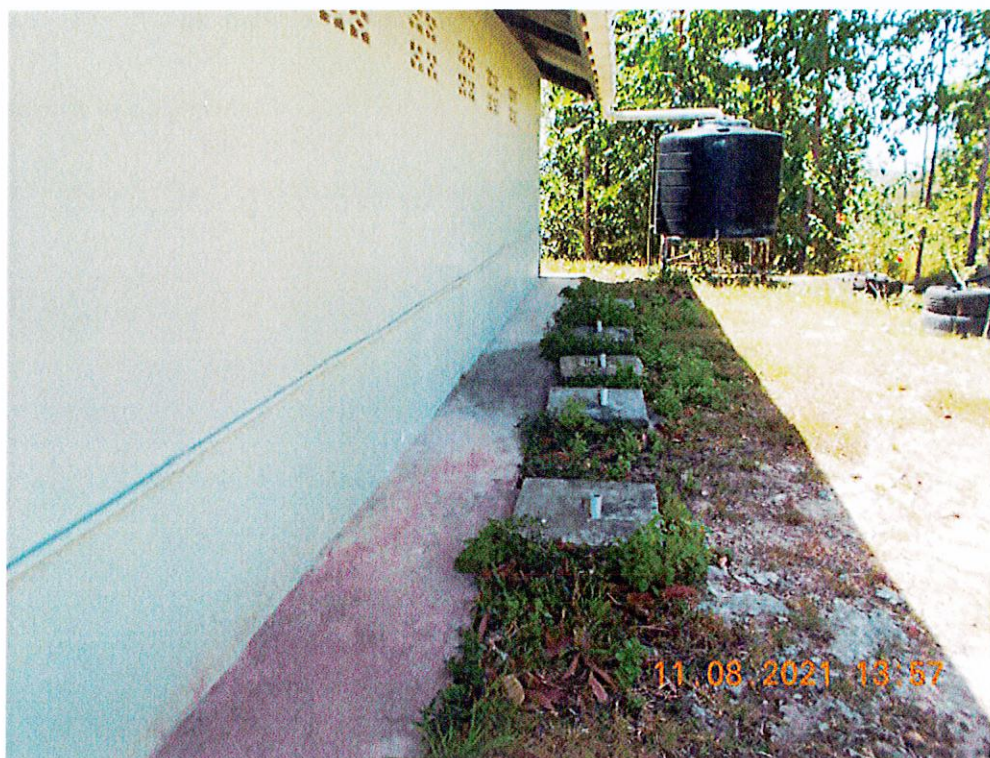
**Plate 32**

Toilet of the workers' quarters at the base camp is equipped with septic tank.

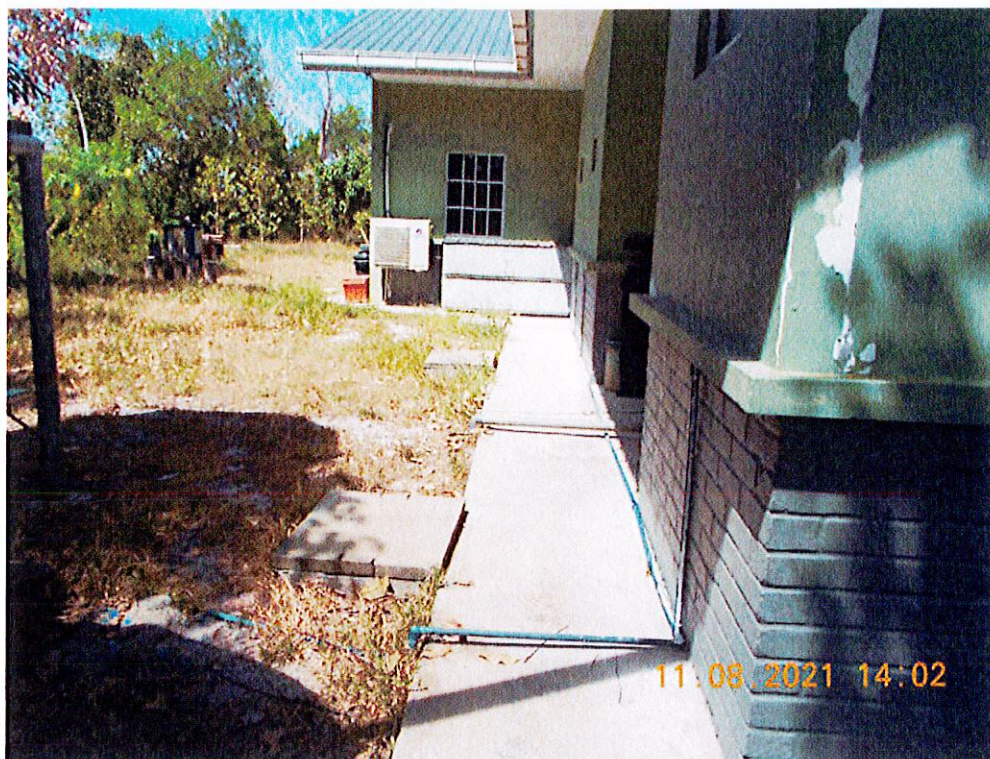
**Plate 33**

Toilet of the staff quarters within the base camp area is equipped with septic tank.

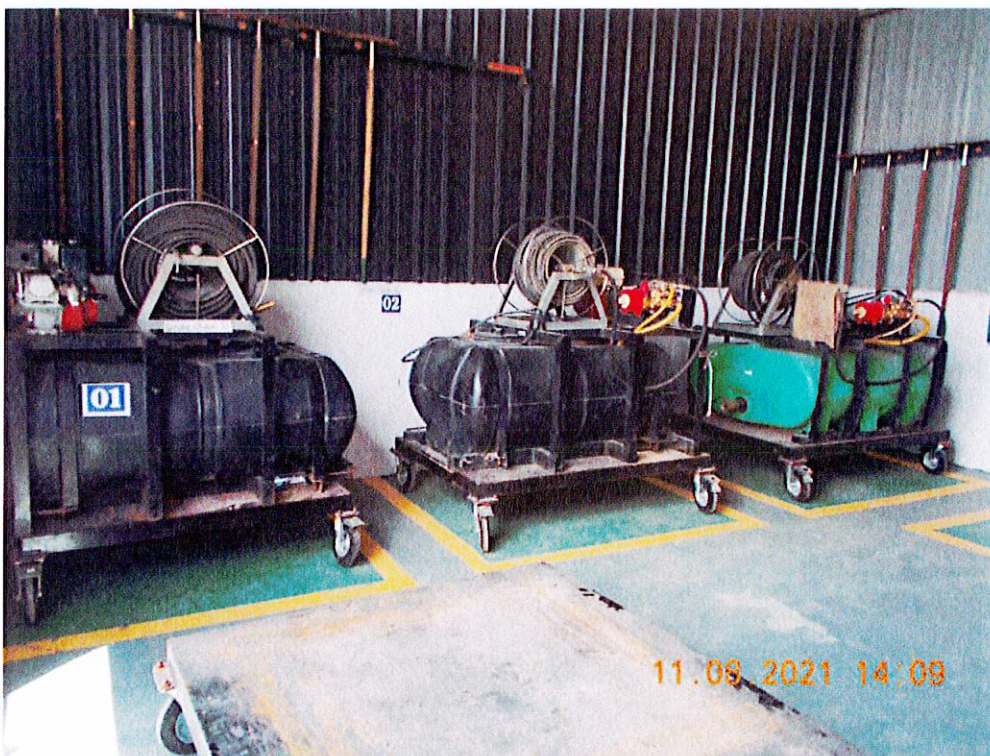
**Plate 34**

| AEC No. | Approved Environmental Conditions | Status | Observations / Comments | Photo No. | Corrective Action and Completion Date |
|---|---|---|---|---|---|
| <i>i</i> | <i>Pembakaran terbuka adalah <b><u>tidak dibenarkan</u></b>.</i> | Comply | <ul style="list-style-type: none"> <li>The Project Proponent had given assurance that there will be no open burning conducted during the Project development activities.</li> <li>Signboard pertaining to the prohibition of open burning in place, for notification purpose.</li> <li>Firefighting equipment provided on-site</li> </ul> | <i>Plate 34</i> | - |

Portable fire prevention equipment provided to control fire outbreak (if any).
