## ENVIRONMENTAL MONITORING AND COMPLIANCE AUDIT REPORT

### FOREST MANAGEMENT OF BENGKOKA AND TAMBALUGU FOREST RESERVES (6,467 HA), PITAS, SABAH

1<sup>st</sup> REPORT OF YEAR 2021

AEC Ref. No. : JPAS/PP/15/600-1/01/3/60(36)  
Report Reference : CK/MO411/1197-1/21  
Date of Report : 30<sup>th</sup> April 2021  
Report No. : 7

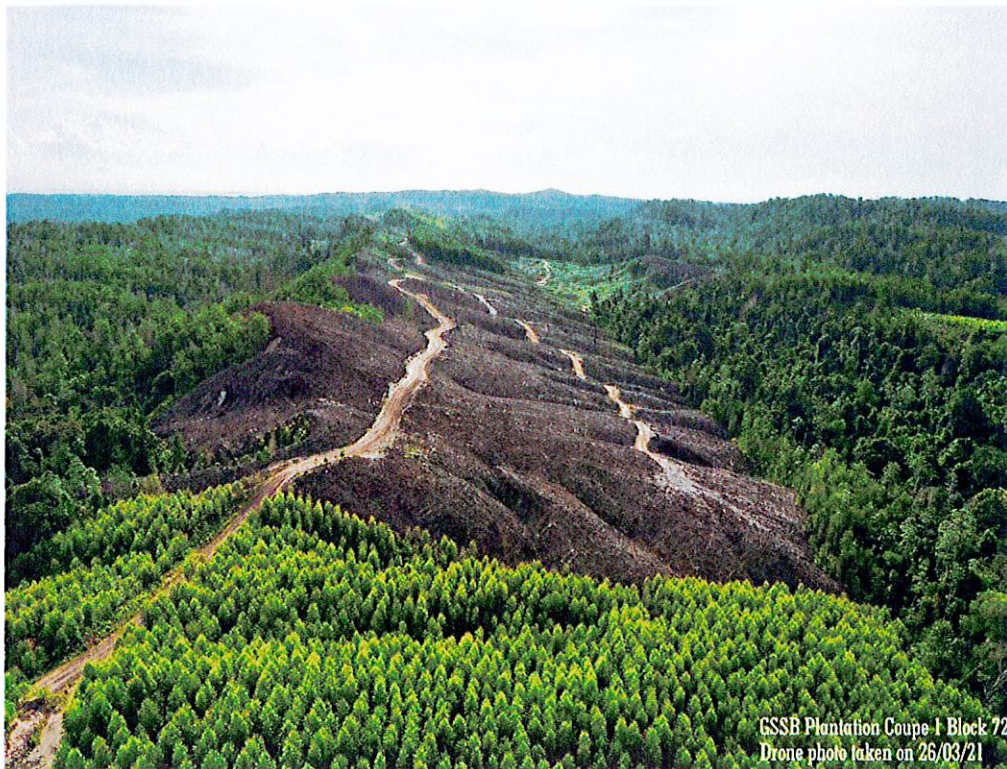
**Plate 1**

Aerial view of planting area Coupe 1 (Block 72).

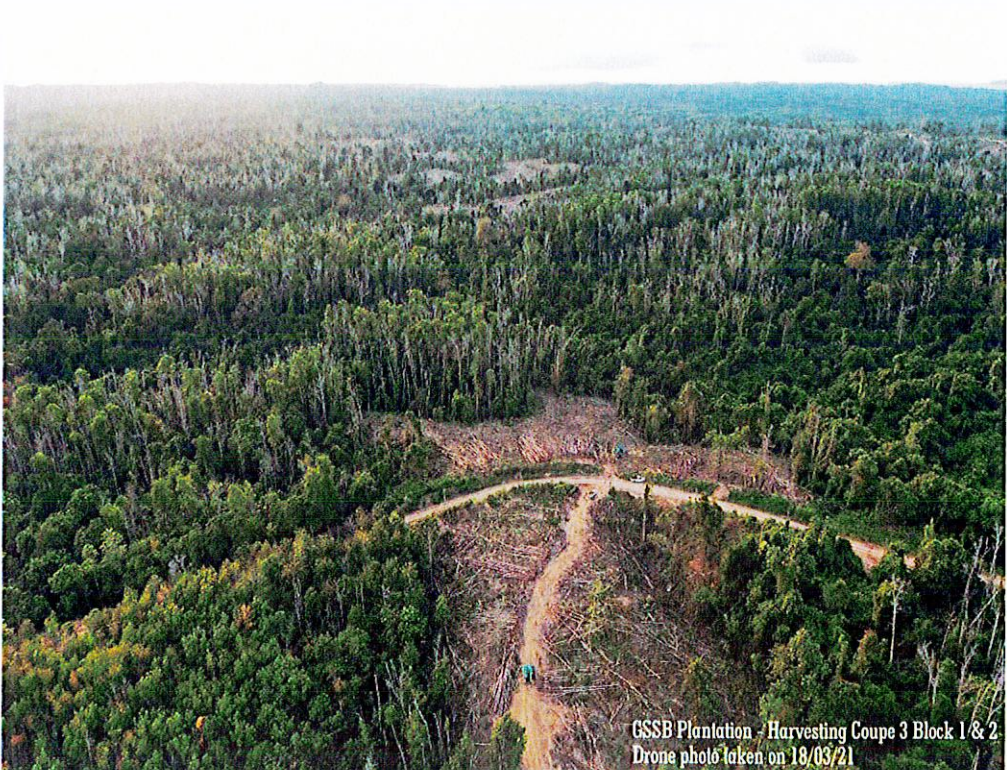
**Plate 2**

Aerial view of planting area Coupe 1 (Block 1 & 2).

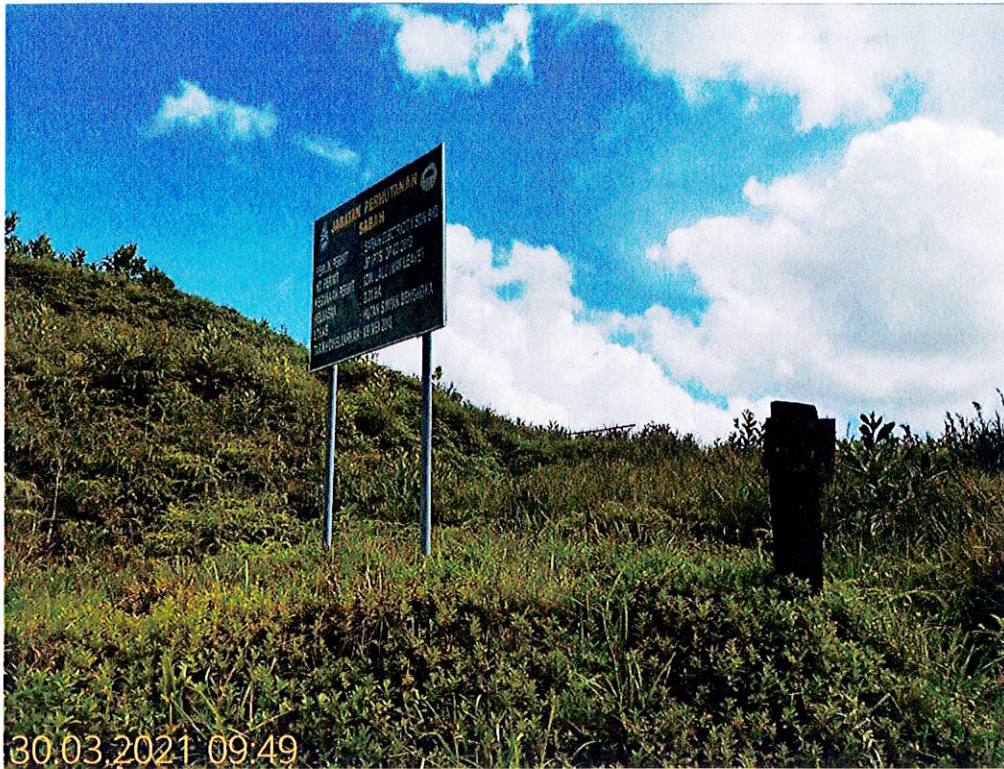
**Plate 3**

Signage in place demarcating boundary between the Project site and the adjacent forest reserves.

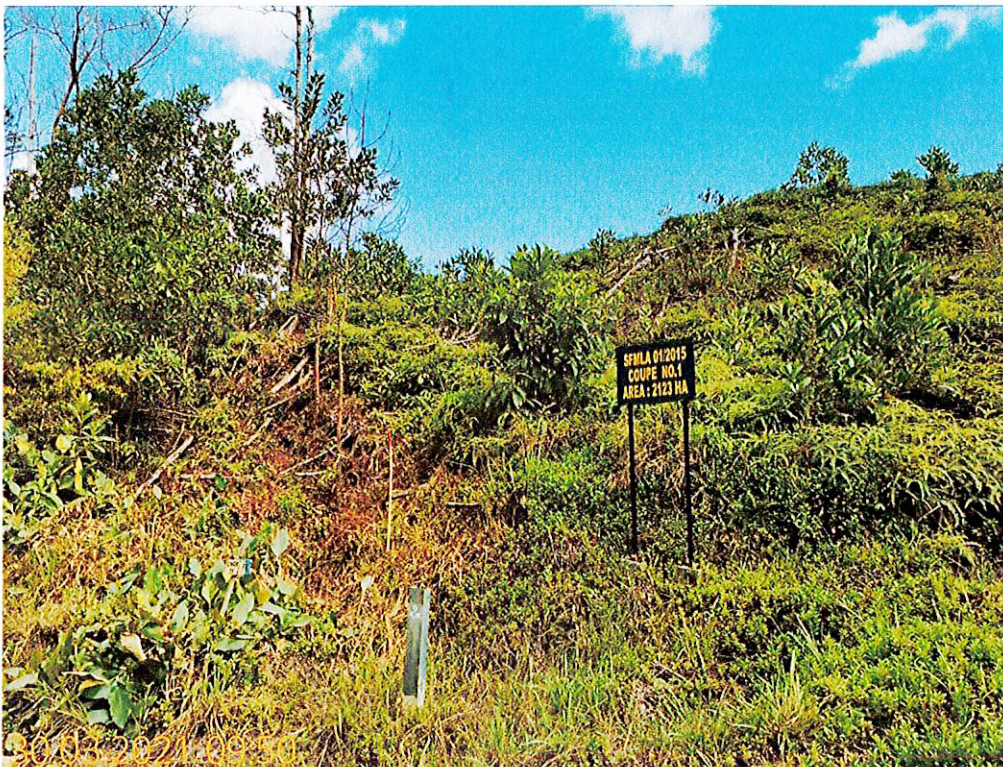
**Plate 4**

| AEC No. | Approved Environmental Conditions | Status | Observations / Comments | Photo No. | Corrective Action and Completion Date |
|---|---|---|---|---|---|
| iii | <i>Semua tanda sempadan tapak projek hendaklah tidak ditimbus, dihalang, dirosakkan atau diganggu daripada kedudukan asal.</i> | Comply | <ul style="list-style-type: none"> <li>Signboard and pegs are in good condition as sighted during the site visit.</li> </ul> | <i>Plates 4 to 6</i> | - |

Signage in place demarcating boundary between coupe and block of the Project site.

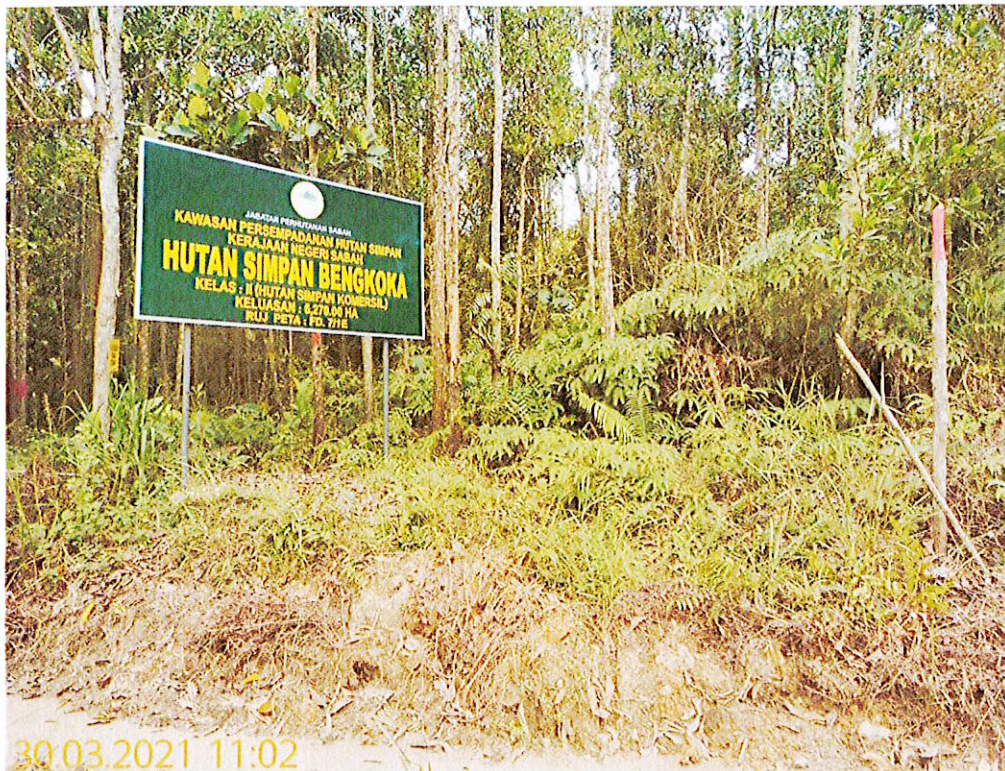
**Plate 5**

Signage in place demarcating boundary between the Project site and the adjacent local village.

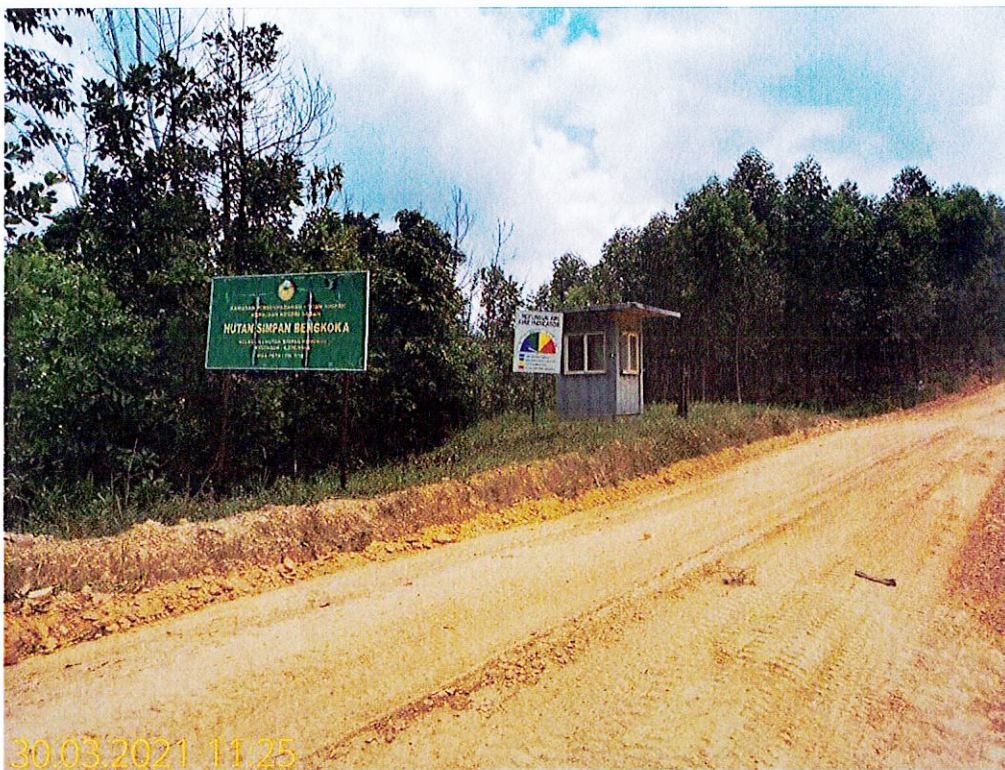
**Plate 6**

Entrance gate in place demarcating Project boundary.

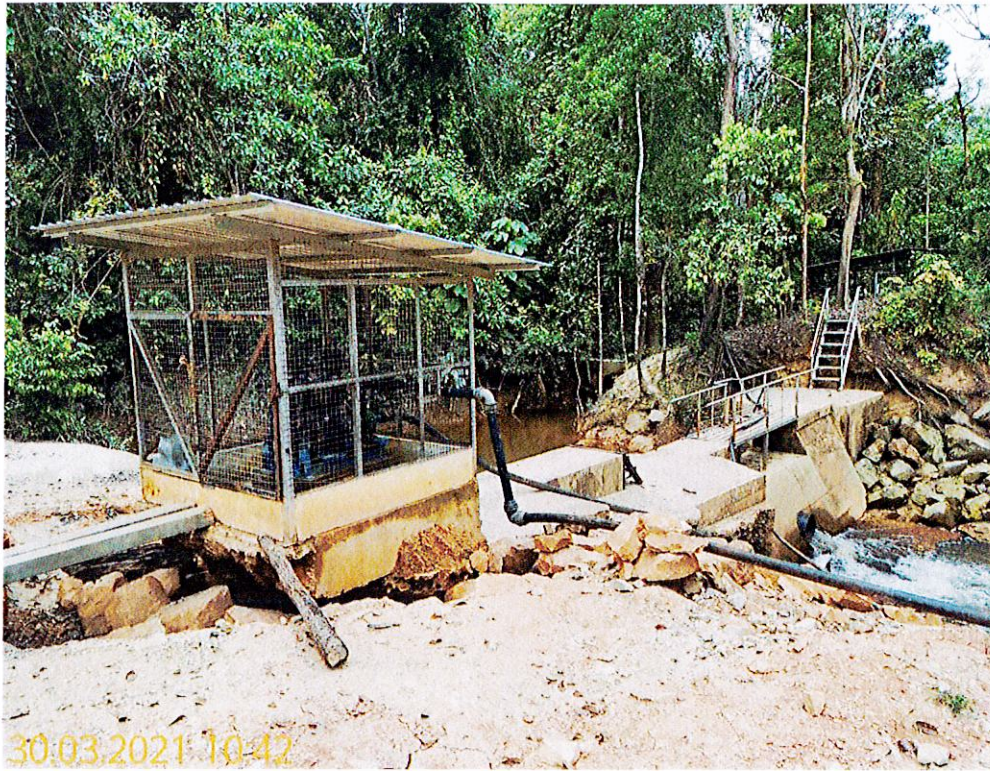
**Plate 7**

| AEC No. | Approved Environmental Conditions | Status | Observations / Comments | Photo No. | Corrective Action and Completion Date |
|---|---|---|---|---|---|
| iv | <i>Aktiviti perladangan hutan adalah <b>tidak dibenarkan</b> di dalam kawasan tadahan air, takungan air dan "water intake point" sebagaimana dinyatakan dan masing-masing ditandakan sebagai "Water Catchment", "Water Reservoir" dan "Water Intake" dalam maklumat tambahan rujukan CK/EV403-4278/0199/17 bertarikh 13 April 2017 dan ditunjukkan pada "Figure 6.2.1" dalam Perjanjian Syarat-syarat Alam Sekitar ini.</i> | Comply | <ul style="list-style-type: none"> <li>Development within the water catchments area, water reservoir and water intake was not sighted.</li> </ul> | <i>Plate 7</i> | - |

View of the water reservoir dam located within the Project site.

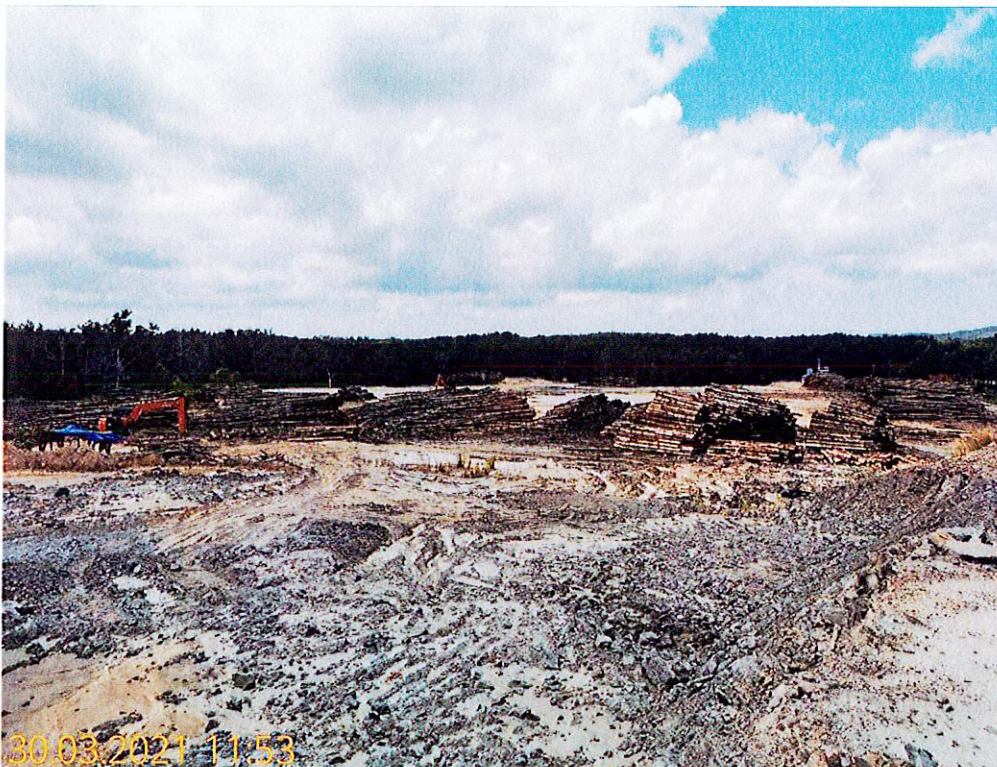
**Plate 8**

View showing the log pond on-site.

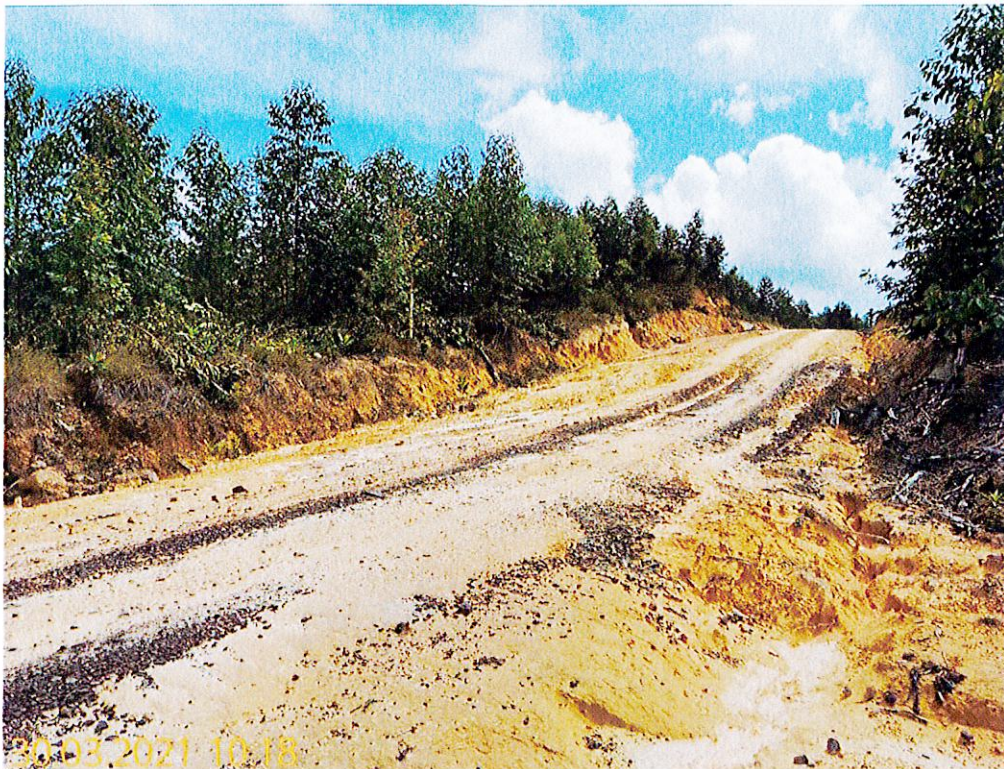
**Plate 9**

| AEC No. | Approved Environmental Conditions | Status | Observations / Comments | Photo No. | Corrective Action and Completion Date |
|---|---|---|---|---|---|
| i | Jalan sedia ada hendaklah digunakan bagi mengurangkan gangguan terhadap tanah. | Comply | <ul style="list-style-type: none"> <li>Existing access road was fully utilized as sighted during the site visit.</li> </ul> | Plate 9 | - |
| ii | Sistem perparitan hendaklah disediakan bagi mengalirkan air keluar dari struktur jalan dan dilencongkan ke kawasan yang mempunyai tumbuhan. | Comply | <ul style="list-style-type: none"> <li>Existing access road are equipped with earth drainage, channelling surface runoff towards the nearest vegetated area.</li> </ul> | Plate 9 | - |

View showing the existing access road on-site.

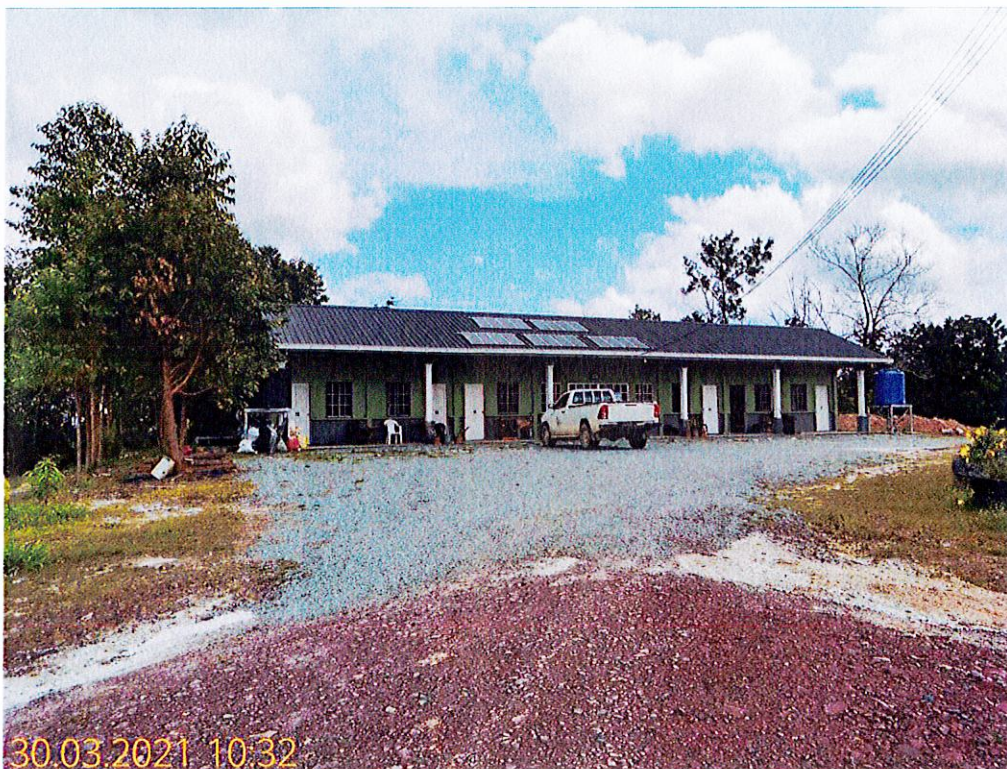
**Plate 10**

View of the staff quarters at the base camp.

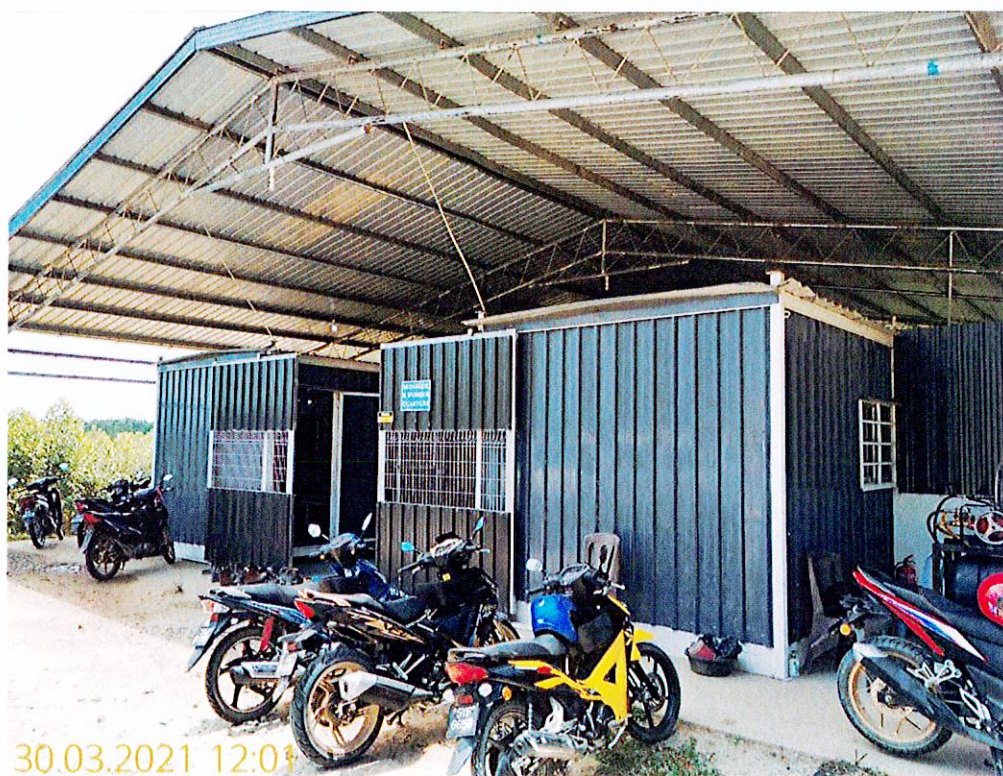
**Plate 11**

View showing the staff quarters near camp of the log pond

The facility is located at more than 30 meters away from any nearest natural waterways.

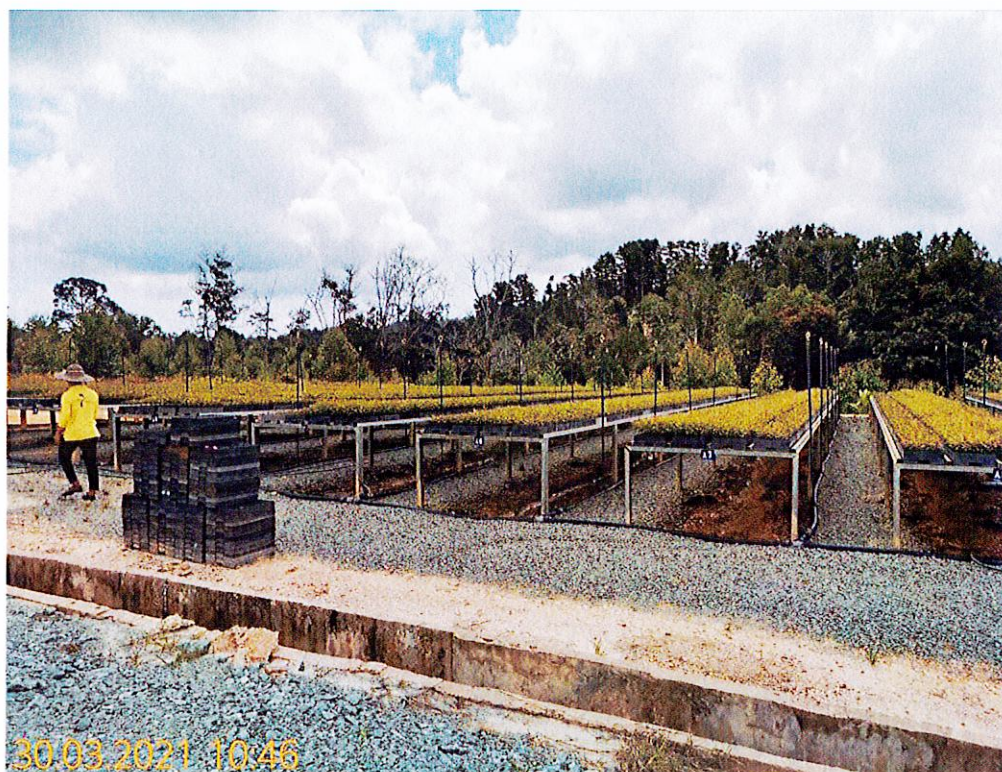
**Plate 12**

View showing the nursery on-site.

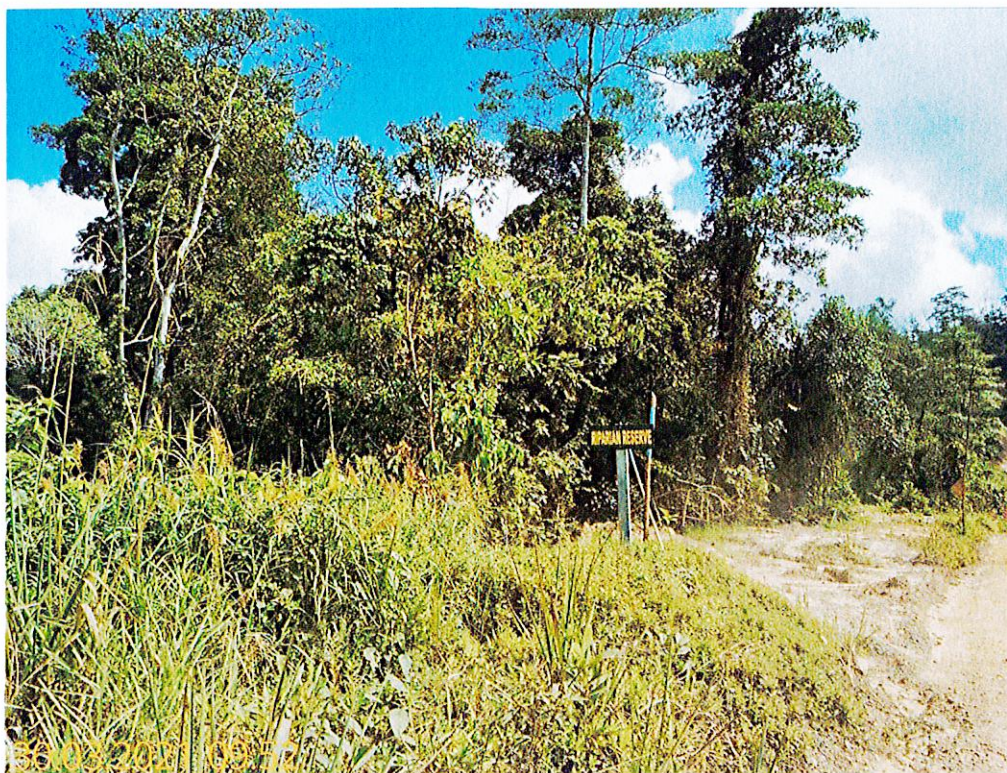
**Plate 13**

| AEC No. | Approved Environmental Conditions | Status | Observations / Comments | Photo No. | Corrective Action and Completion Date |
|---|---|---|---|---|---|
| <i>i</i> | Sebarang aktiviti pembersihan dan perladangan hutan adalah <b><u>tidak dibenarkan</u></b> dalam simpanan sungai sebagaimana ditunjukkan pada "Figure 6.2.1" dalam Perjanjian Syarat-syarat Alam Sekitar ini. | Comply | <ul style="list-style-type: none"> <li>Development within the riparian reserves area was not sighted.</li> </ul> | Plate 13 | - |
| <i>ii</i> | Sempadan simpanan sungai hendaklah ditanda di lapangan dengan cat merah serta dipasang dengan papan tanda di lokasi-lokasi yang mudah dilihat sebelum aktiviti pembersihan dan perladangan hutan dimulakan. | Comply | <ul style="list-style-type: none"> <li>Tree trunks along belt of the riparian reserves were painted in blue colour for demarcation purposes.</li> <li>Signboard in place demarcating the riparian reserves on-site.</li> </ul> | Plate 13 | - |

Signboard in place demarcating the riparian reserves on-site.

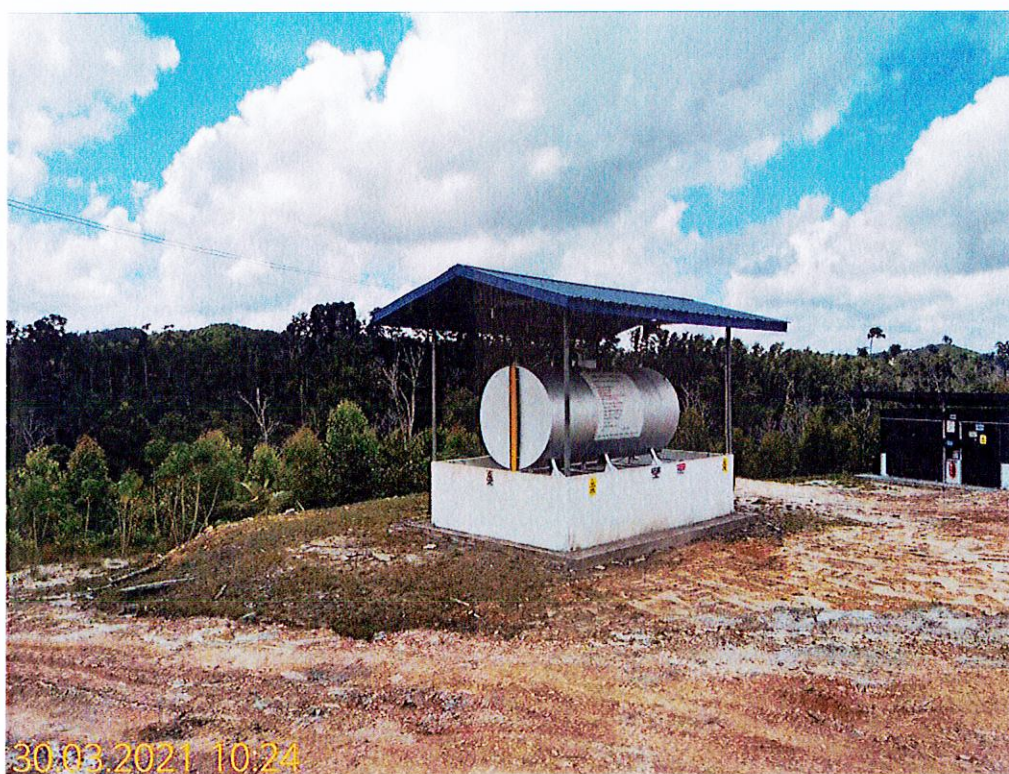
**Plate 14**

View showing the skid tank storage building situated near the staff quarters area.

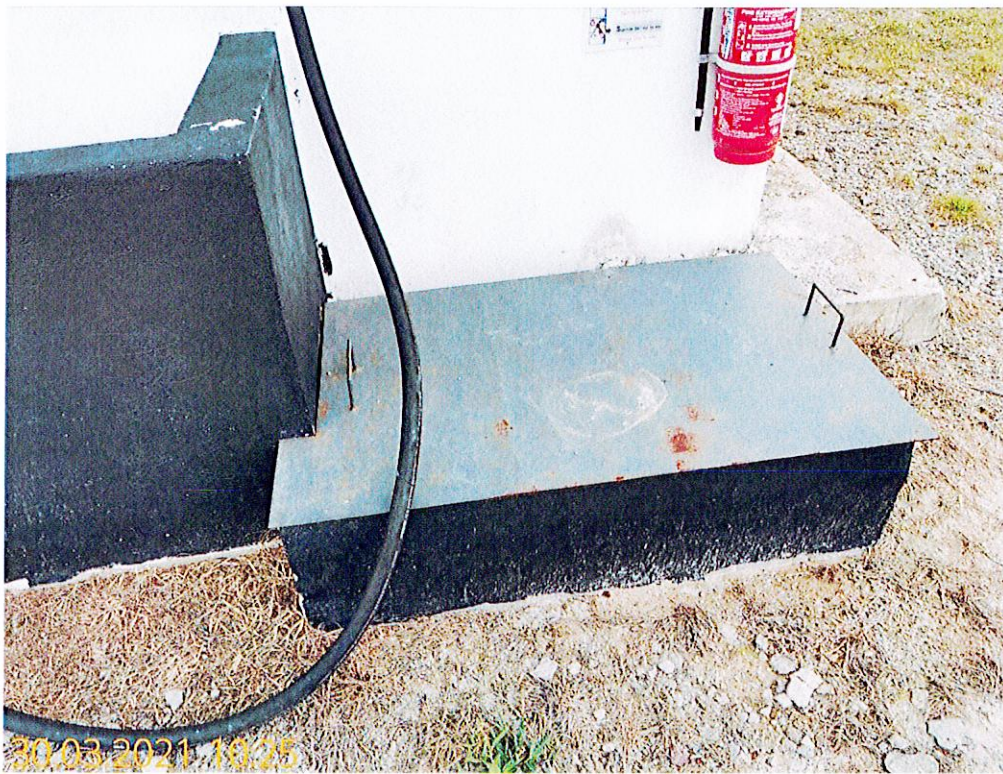
**Plate 15**

Diesel skid tank storage building was equipped with an oil trap.

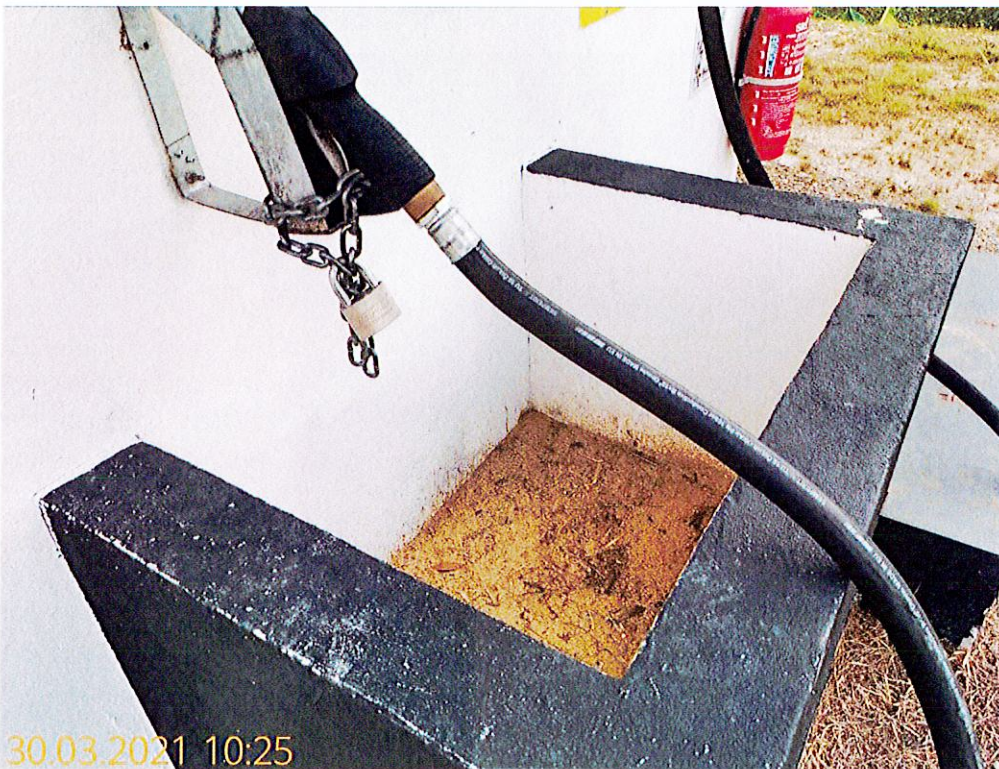
**Plate 16**

Nozzle storage area of the skid tank was equipped with concrete containment bund filled with sand to prevent oil from directly seep into the ground.

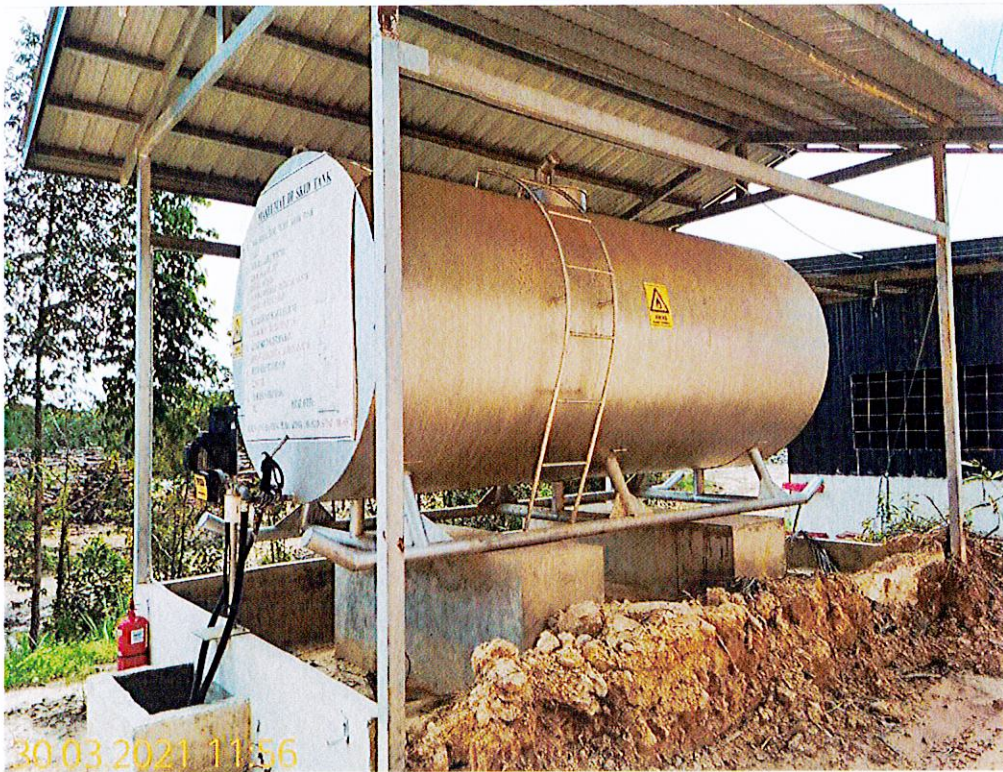
**Plate 17**

View showing the diesel skid tank situated within the log pond area.

It is situated at more than 50 m away from the nearest natural waterways and sheltered from weather exposure.

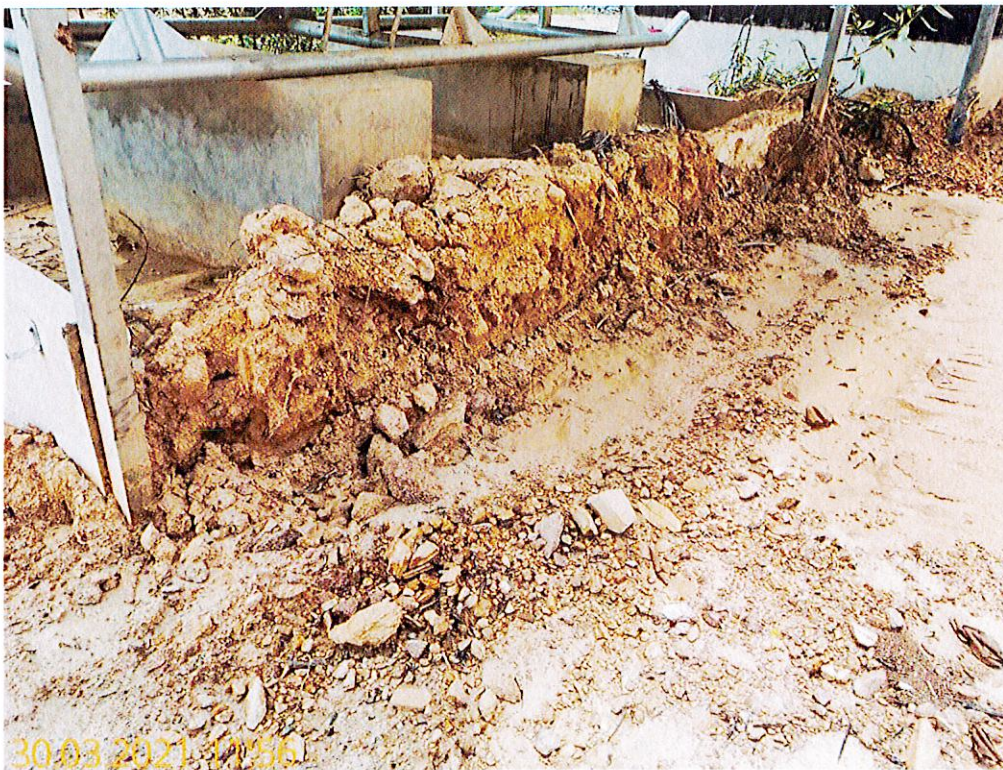
**Plate 18**

View showing the crushed concrete bund of the diesel skid tank situated within the log pond area.

| AEC No. | Recommendations | Dateline |
|---|---|---|
| <u>Kawalan Bahan</u><br><u>Minyak Dan Sisa</u><br><u>Toksik</u><br>5.3 (iii) | <ul style="list-style-type: none"> <li>The Project Proponent is advised to repair the concrete bund of the diesel skid tank as soon as possible.</li> </ul> | 31 <sup>st</sup> August 21 |

The Project Proponent is advised to repair the concrete bund as soon as possible.

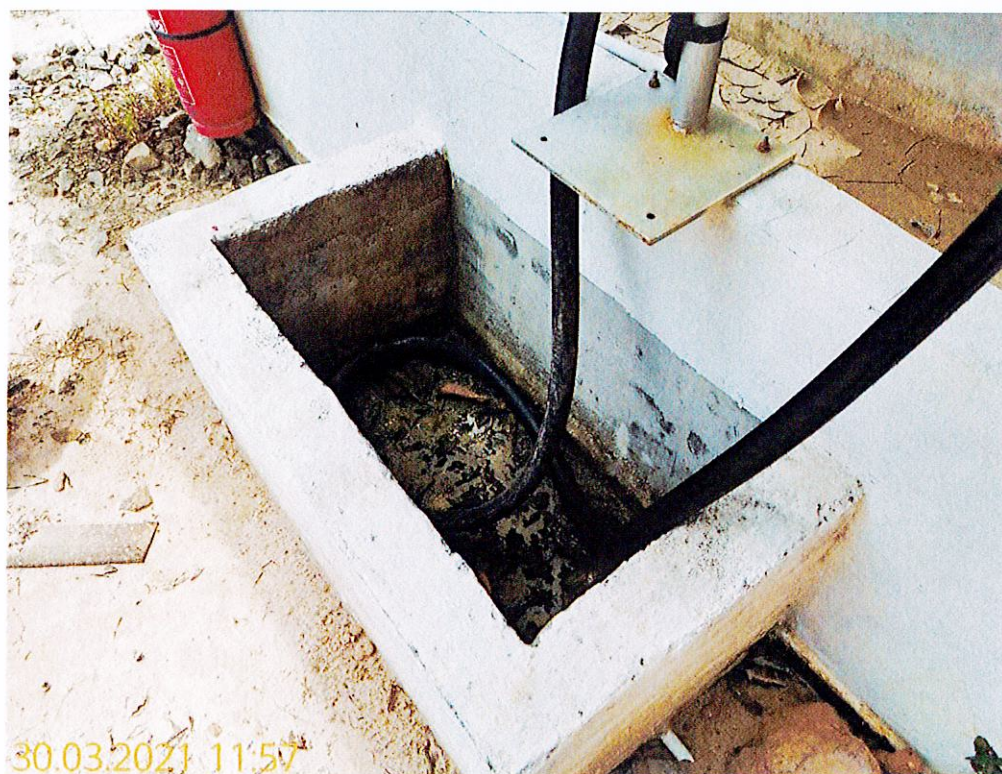
**Plate 19**

Nozzle storage area of the skid tank within the log pond area was equipped with concrete containment bund filled with sand to prevent oil from directly seep into the ground.

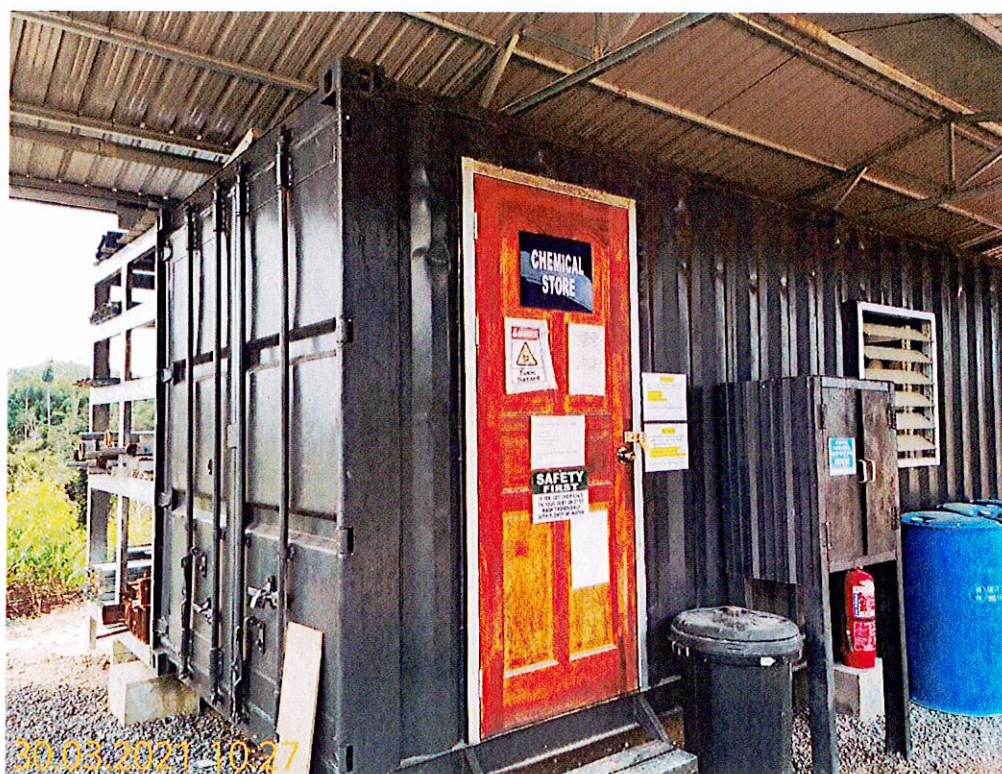
**Plate 20**

View showing the agrochemical storage area on-site.

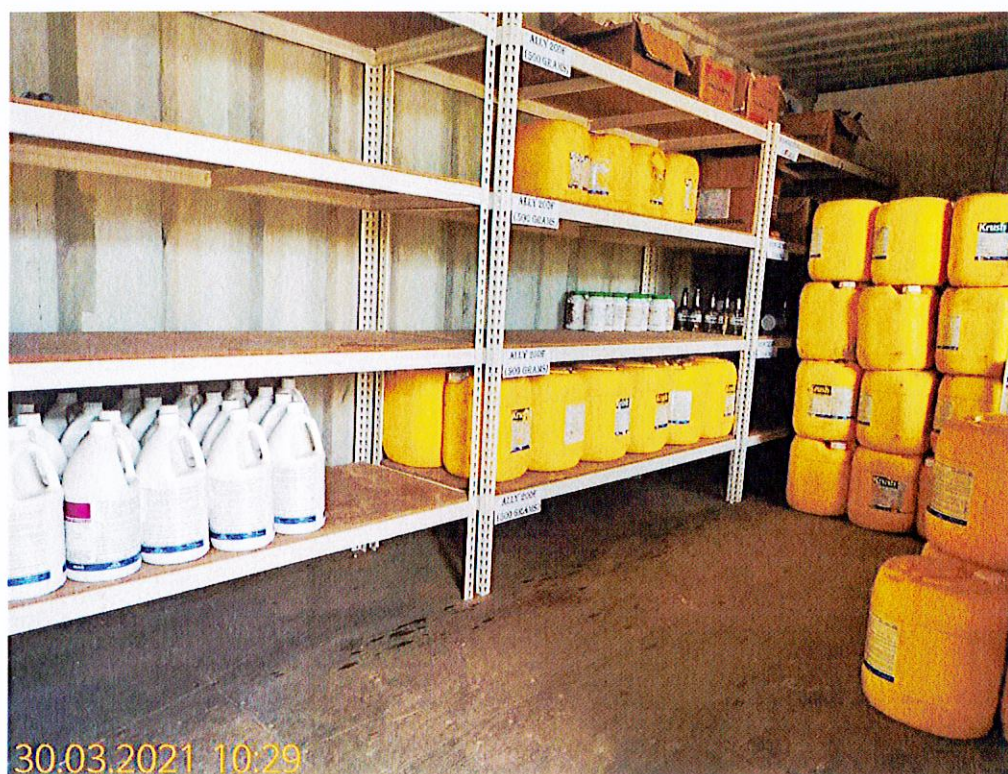
**Plate 21**

Agrochemical containers on-site was labelled and stacked properly.

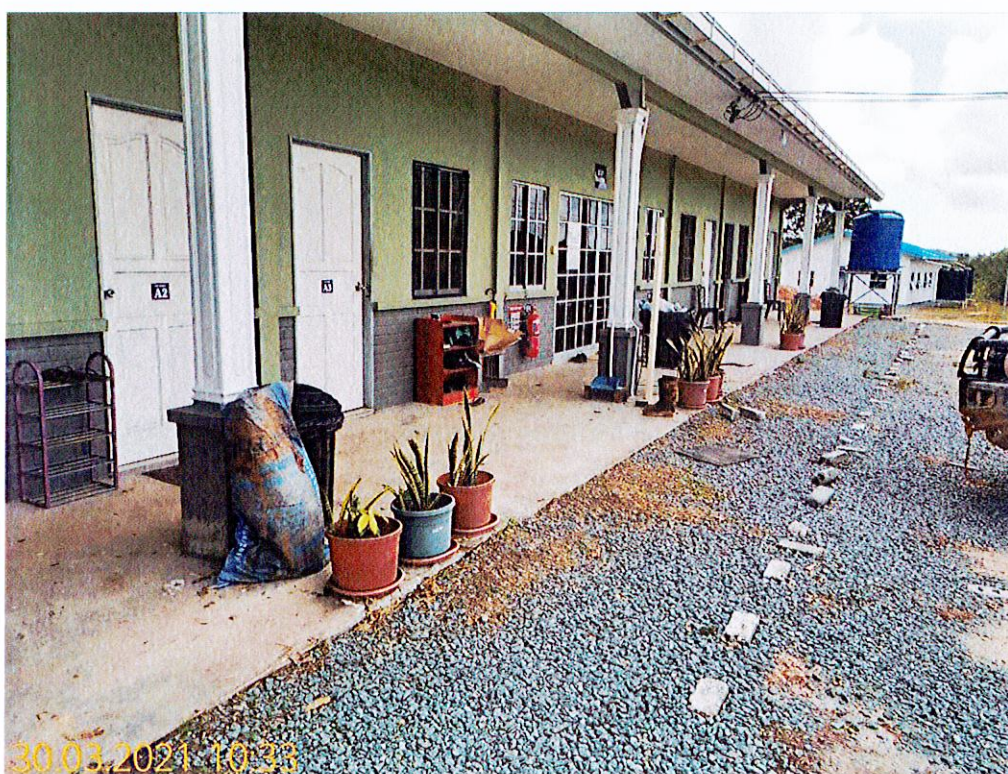
**Plate 22**

Garbage bin was provided to facilitate solid wastes collection.

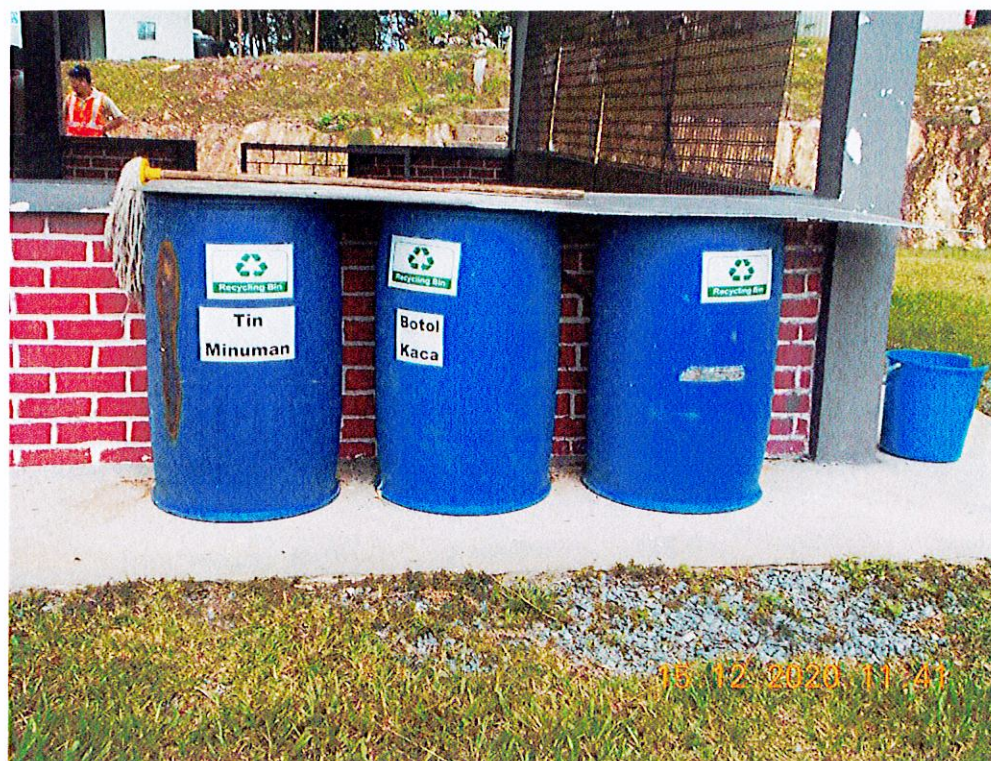
**Plate 23**

Recycle bins in place to facilitate solid waste segregation.

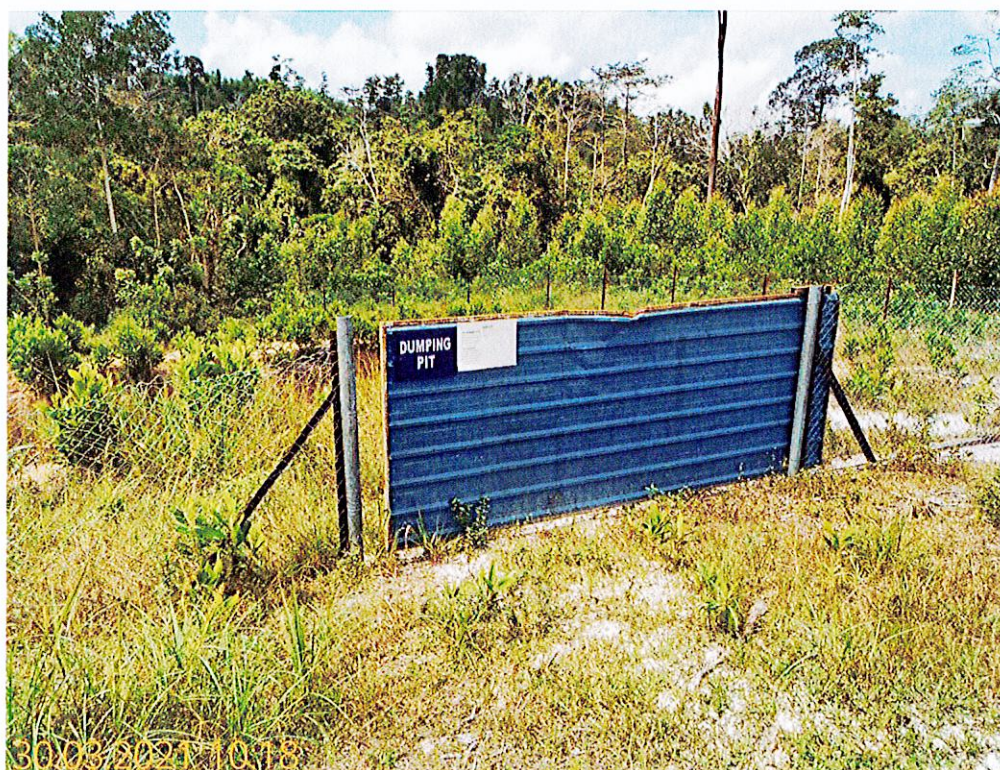
**Plate 24**

Dumping pit is available on-site.

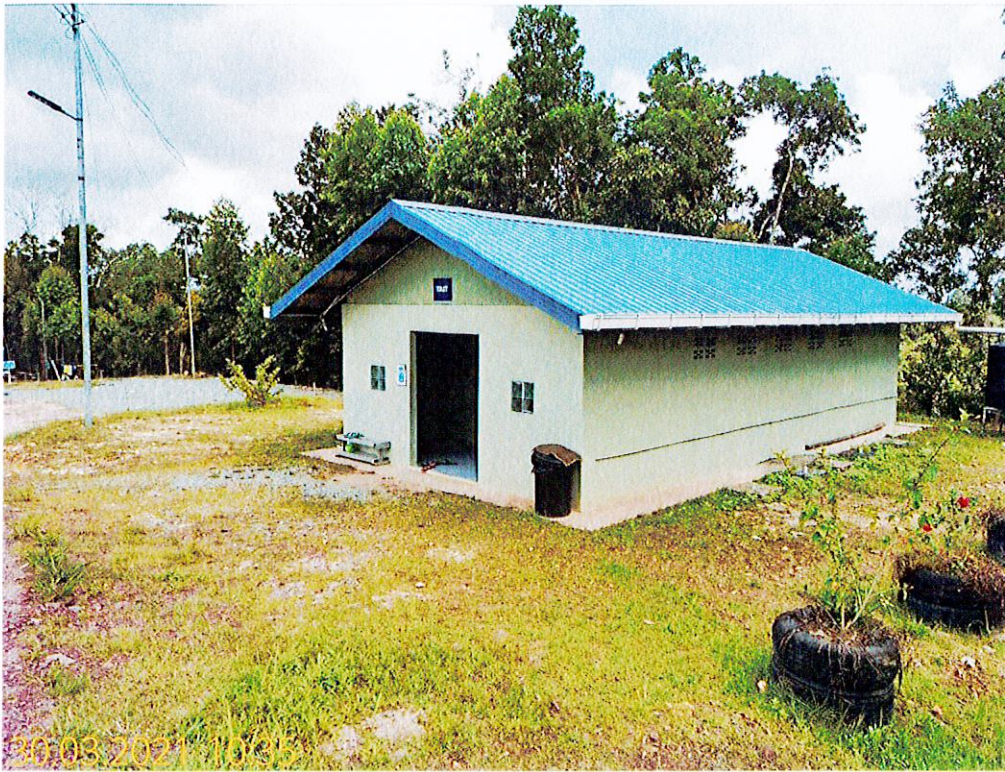
**Plate 25**

Toilet with septic tank was available at the project site to cater sewage waste.

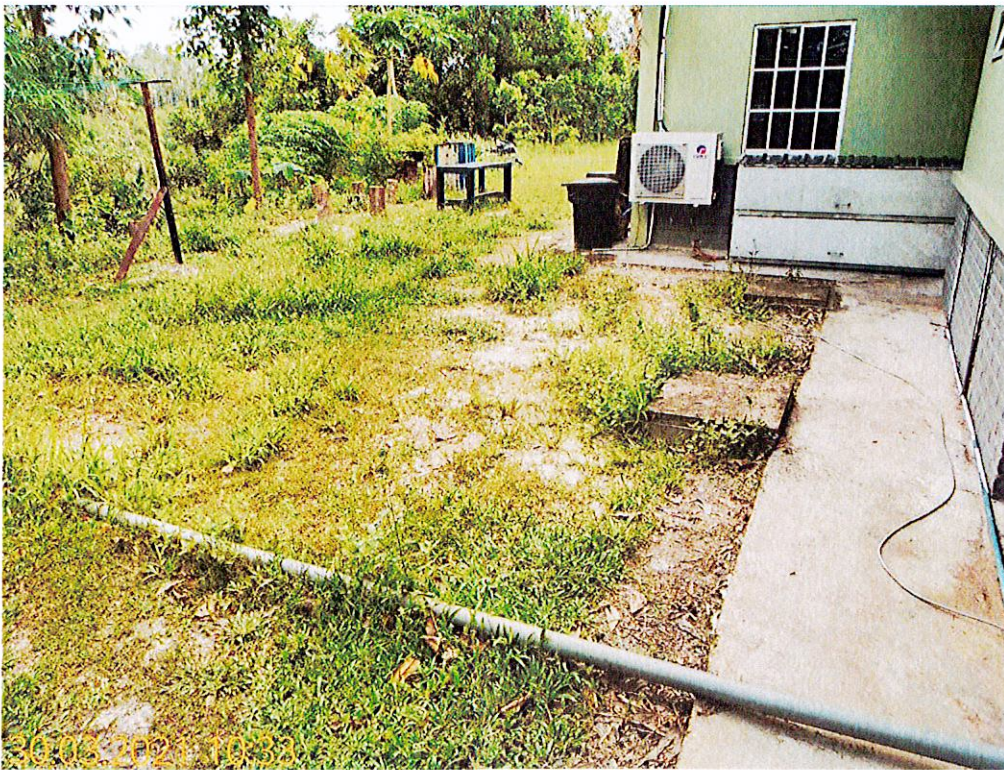
**Plate 26**

Toilet of the workers' quarters at the base camp is equipped with septic tank.

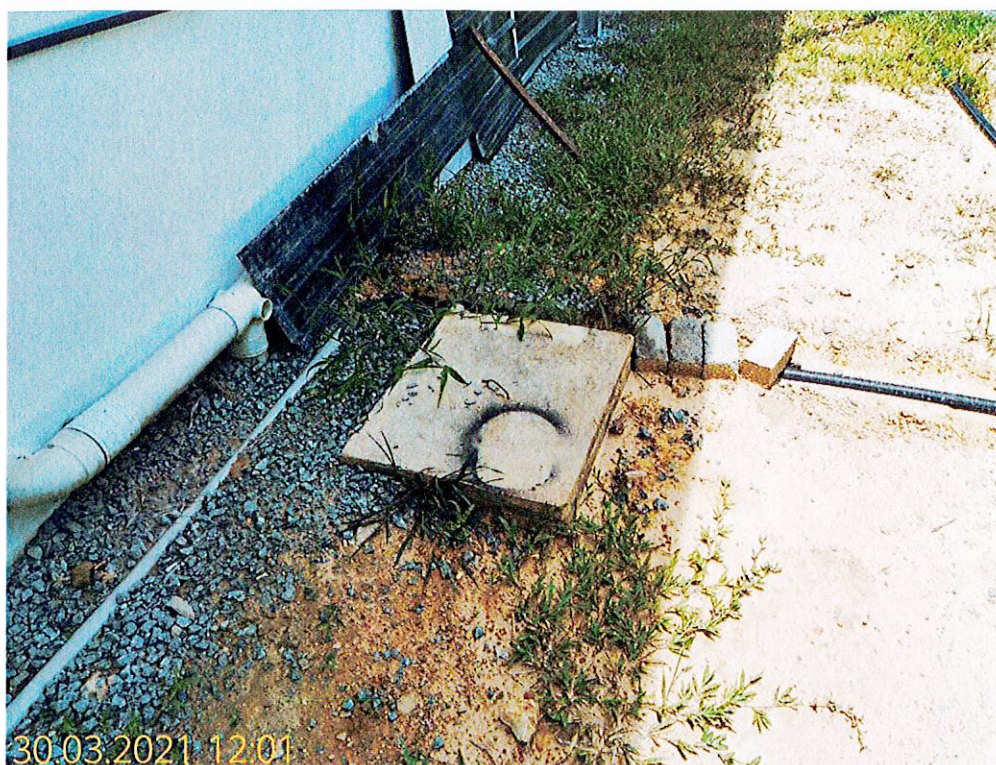
**Plate 27**

Toilet of the workers' quarters within the log pond area is equipped with septic tank.
