## ENVIRONMENTAL MONITORING AND COMPLIANCE AUDIT REPORT

### FOREST MANAGEMENT OF BENGKOKA AND TAMBALUGU FOREST RESERVES (6,467 HA), PITAS, SABAH

1<sup>st</sup> REPORT OF YEAR 2021

AEC Ref. No. : JPAS/PP/15/600-1/01/3/60(36)  
Report Reference : CK/MO411/1197-1/21  
Date of Report : 30<sup>th</sup> April 2021  
Report No. : 7

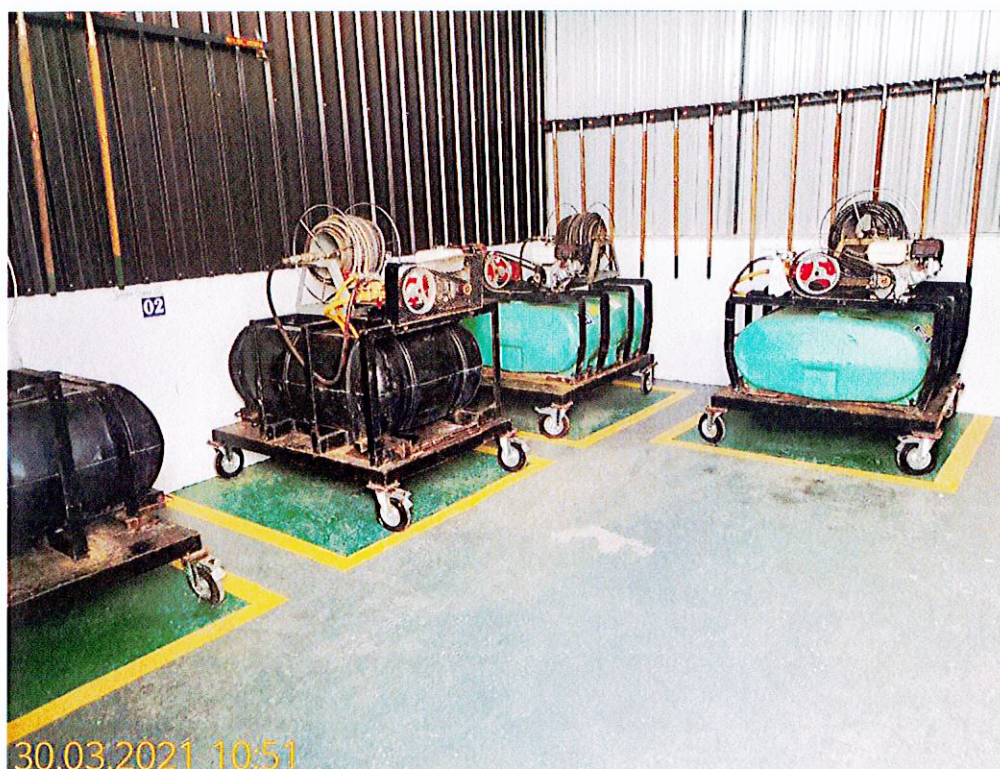
**Plate 28**

| AEC No. | Approved Environmental Conditions | Status | Observations / Comments | Photo No. | Corrective Action and Completion Date |
|---|---|---|---|---|---|
| i | Pembakaran terbuka adalah <b><u>tidak dibenarkan</u></b> . | Comply | <ul style="list-style-type: none"> <li>The Project Proponent had given assurance that there will be no open burning conducted during the Project development activities.</li> <li>Signboard pertaining to the prohibition of open burning in place, for notification purpose.</li> <li>Firefighting equipment provided on-site</li> </ul> | Plate 28 | - |

Portable fire prevention equipment provided to control fire outbreak (if any).
