## ENVIRONMENTAL MONITORING AND COMPLIANCE AUDIT REPORT

### FOREST MANAGEMENT OF BENGKOKA AND TAMBALUGU FOREST RESERVES (6,467 HA), PITAS, SABAH

1<sup>st</sup> REPORT OF YEAR 2020

AEC Ref. No. : JPAS/PP/15/600-1/01/3/60(36)  
Report Reference : CK/MO411/1197-1/20  
Date of Report : 17<sup>th</sup> August 2020  
Report No. : 5

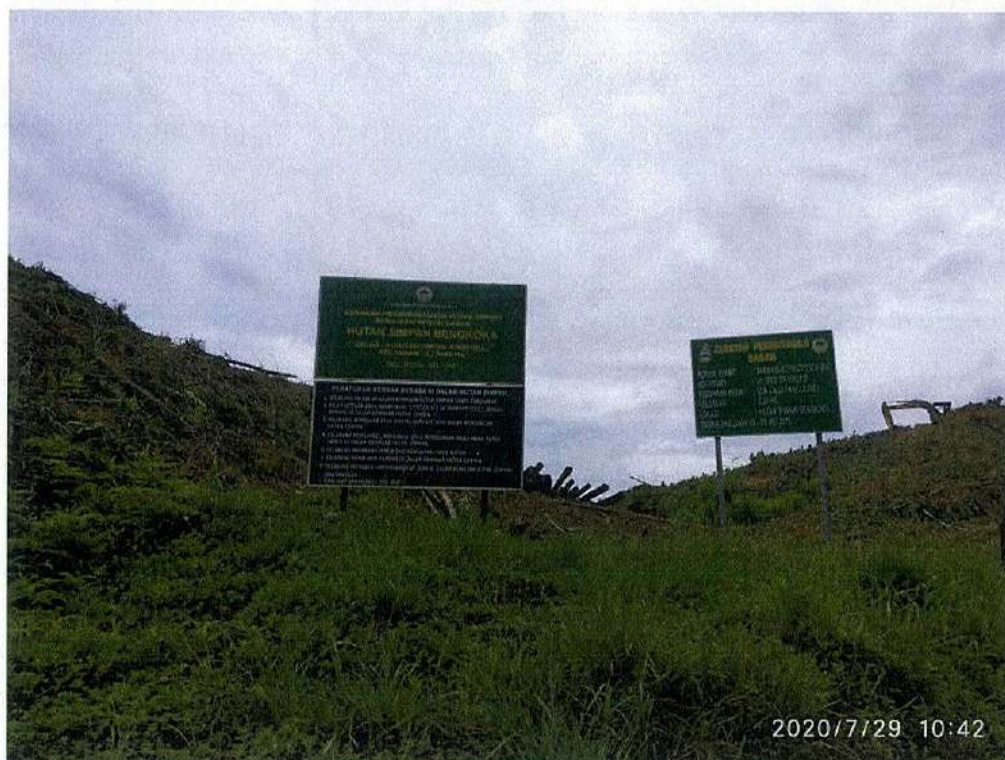
Plate 1

Signboard was erected to demarcate the Project site boundary.

| AEC No. | Approved Environmental Conditions | Status | Observations / Comments | Photo No. | Corrective Action & Date of Completion |
|---|---|---|---|---|---|
| ii | Sempadan kawasan projek yang telah diukur hendaklah ditanda di lapangan serta dipasang dengan papan tanda di lokasi-lokasi yang mudah dilihat sebelum aktiviti perladangan hutan dimulakan. | Comply | <ul style="list-style-type: none"> <li>Signboard, entrance gate and coloured pegs were erected to demarcate the Project boundary on-site.</li> <li>Signboard between coupes / block was erected for demarcation purposes.</li> </ul> | Plates<br>1 to 6 | - |

| iii | Semua tanda sempadan tapak projek hendaklah tidak ditimbus, dihalang, dirosakkan atau diganggu daripada kedudukan asal. | Comply | <ul style="list-style-type: none"> <li>Signboard and pegs were in good condition as observed during the site visit.</li> </ul> | Plates 1 to 6 | - |

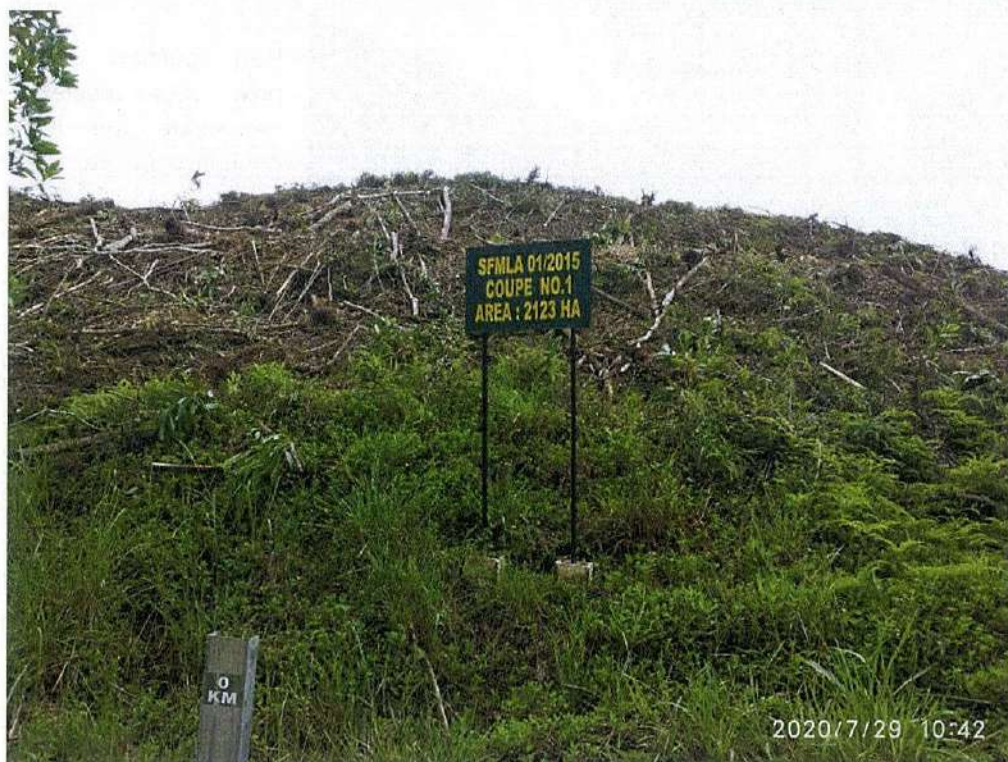
Plate 2

Signboard was erected to demarcate the project boundary between coupes / block on-site.

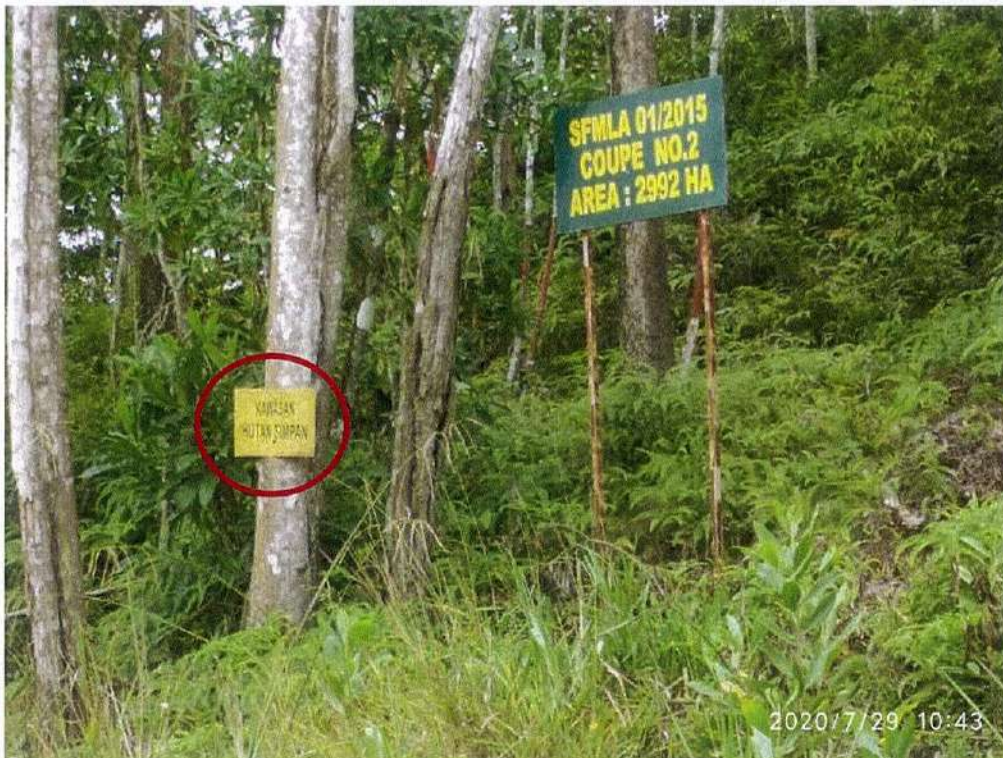
Signage (red circle) was provided to demarcate the Forest buffer zone on-site

| v | <b>Zon penampian</b> dengan kelebaran tidak kurang <b>50 meter</b> hendaklah disediakan di sempadan kawasan projek yang bersempadan dengan Hutan Simpan Bengkoka dan ditunjukkan pada "Figure 6.2.1" dalam Perjanjian Syarat-syarat Alam Sekitar ini. | Comply | <ul style="list-style-type: none"> <li>The Project Proponent had provided 50-meter width buffer zone adjacent to the Bengkoka Forest Reserves prior to Project development on-site.</li> </ul> | Plate 3 | - |
| vi | Sebarang aktiviti perladangan hutan <b><u>tidak dibenarkan</u></b> dalam kawasan zon penampian. | Comply | <ul style="list-style-type: none"> <li>The 50-meter width buffer zone was excluded from any Project development.</li> </ul> | Plate 3 | - |

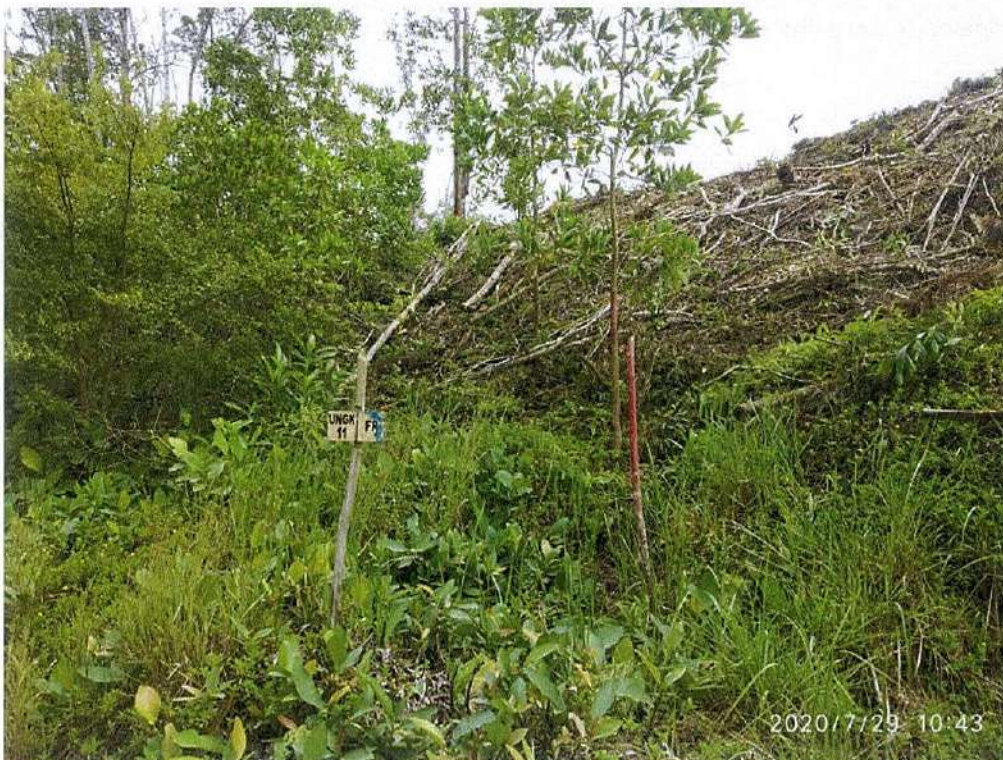
Plate 4

Red painted wooden pole was erected to demarcate the Project boundary on-site.

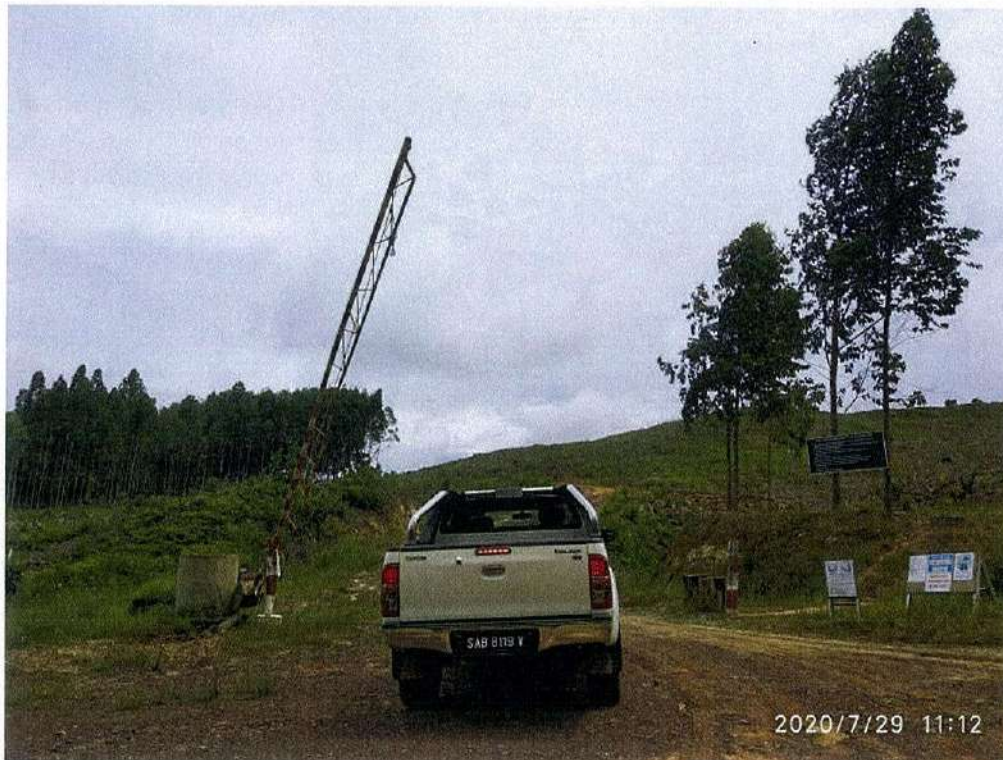
**Plate 5**

Signboard and entrance gate were erected to demarcate the Project boundary on-site.

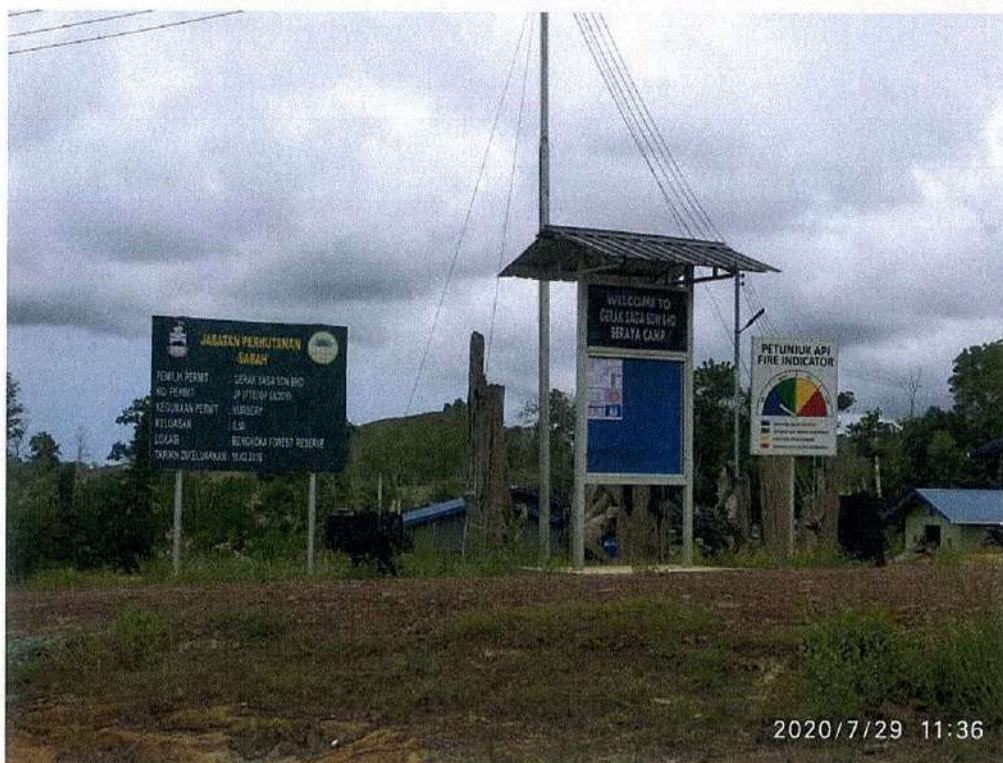
**Plate 6**

Signboard was erected at the Project base camp area.

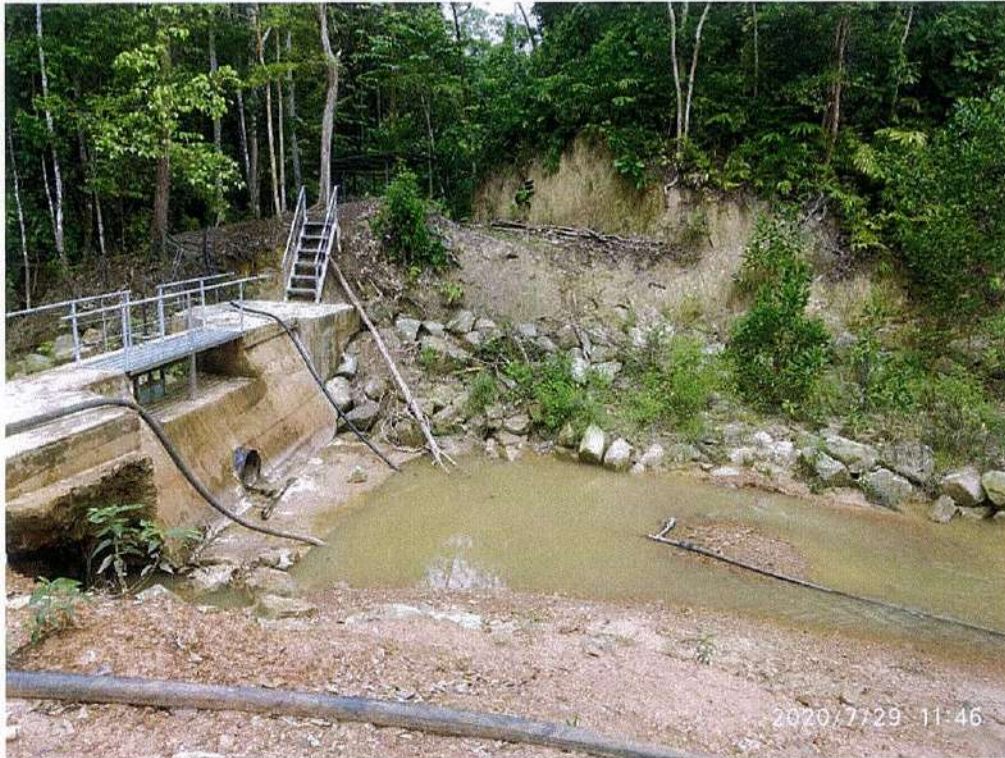
**Plate 7**

Overview of the water reservoir dam located within the Project site.

| iv | Aktiviti perladangan hutan adalah <b><u>tidak dibenarkan</u></b> di dalam kawasan tadahan air, takungan air dan "water intake point" sebagaimana dinyatakan dan masing-masing ditandakan sebagai "Water Catchment", "Water Reservoir" dan "Water Intake" dalam maklumat tambahan rujukan CK/EV403-4278/0199/17 bertarikh 13 April 2017 dan ditunjukkan pada "Figure 6.2.1" dalam Perjanjian Syarat-syarat Alam Sekitar ini. | Comply | <ul style="list-style-type: none"> <li>There is no development activity carried out within the water catchment areas, water reservoir and water intake as observed during the site visit.</li> </ul> | Plate 7 | - |

| viii | Sempadan kawasan tadahan air, takungan air dan "water intake point", zon penampungan dan kawasan berkecurunan 25 darjah atau lebih yang dilindungi hendaklah ditanda di lapangan dan dipasang dengan papan tanda di lokasi-lokasi yang mudah dilihat sebelum aktiviti perladangan hutan dimulakan. | Comply | <ul style="list-style-type: none"> <li>The water catchment areas, water reservoir area, water intake area and steep protection area (<math>\geq 25^\circ</math> slope area), was demarcated with a signboard and colored pegs as observed during the site visit.</li> </ul> | Plate 7 | - |

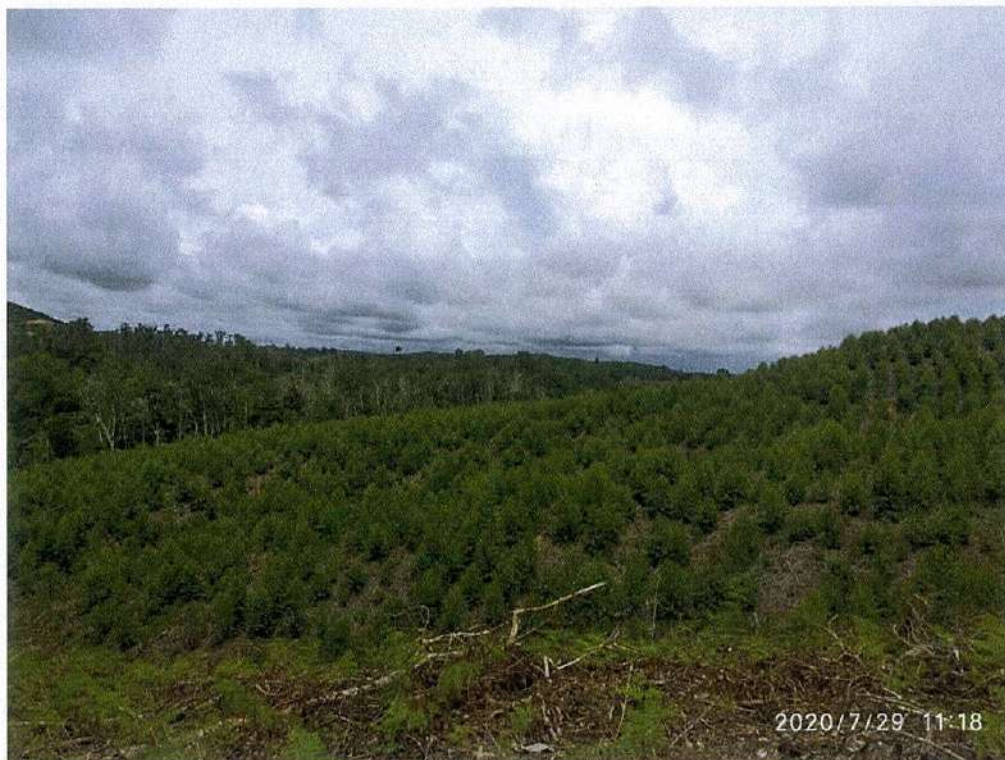
**Plate 8**

View towards the newly planted area within the Project site.

| i | Semua kawasan tanah dan cerun yang terdedah hendaklah distabilkan dan direhabilitasi dengan menanam spesies tumbuhan yang diluluskan oleh Jabatan Perhutanan Negeri Sabah. | Comply | <ul style="list-style-type: none"> <li>The Project Proponent assured that cover crops will be planted at the exposed area of the Project site to reduce the risk of soil erosion.</li> <li>Existing vegetation on the inactive and idle area on-site were retained and remained undisturbed.</li> </ul> | Plates 8 & 10 | - |

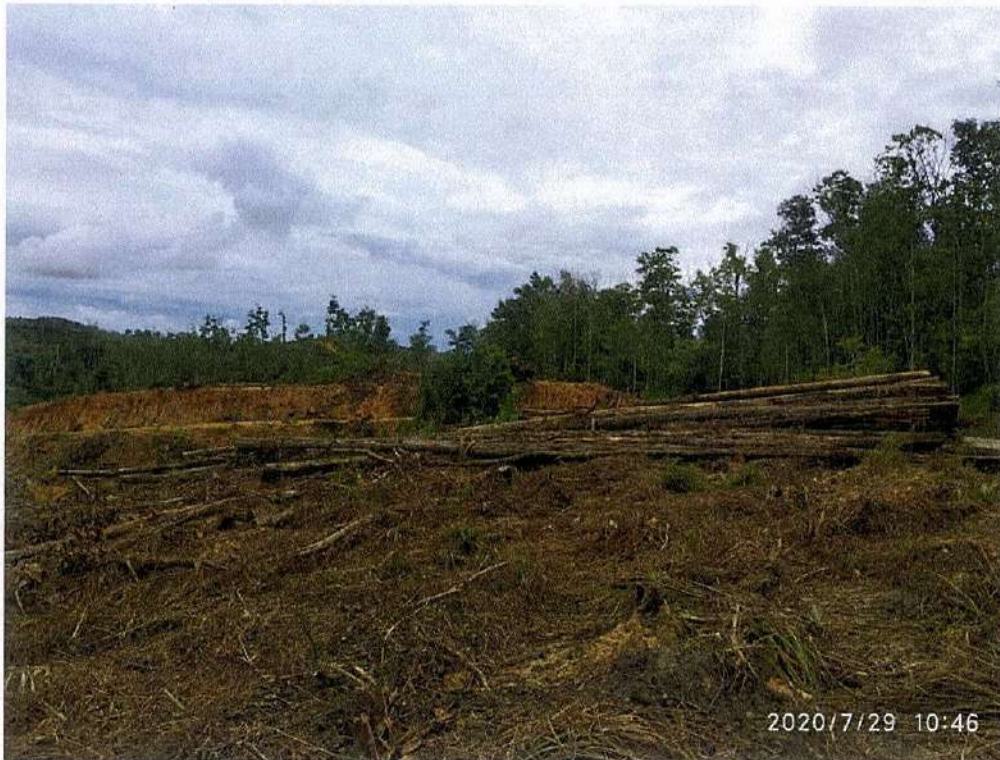
**Plate 9**

Biomass was left in-situ on exposed area of the Project site for natural decomposition, thus to reduce the risk of soil erosion on-site.

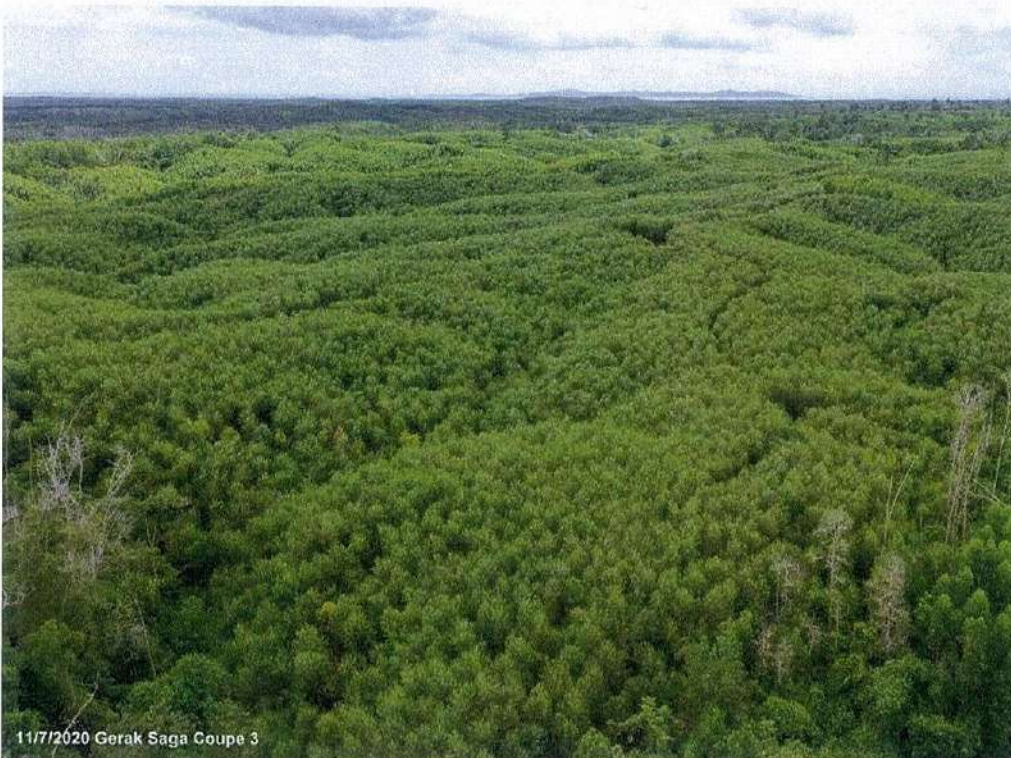
**Plate 10**

Overview of Project site area (Coupe 3).

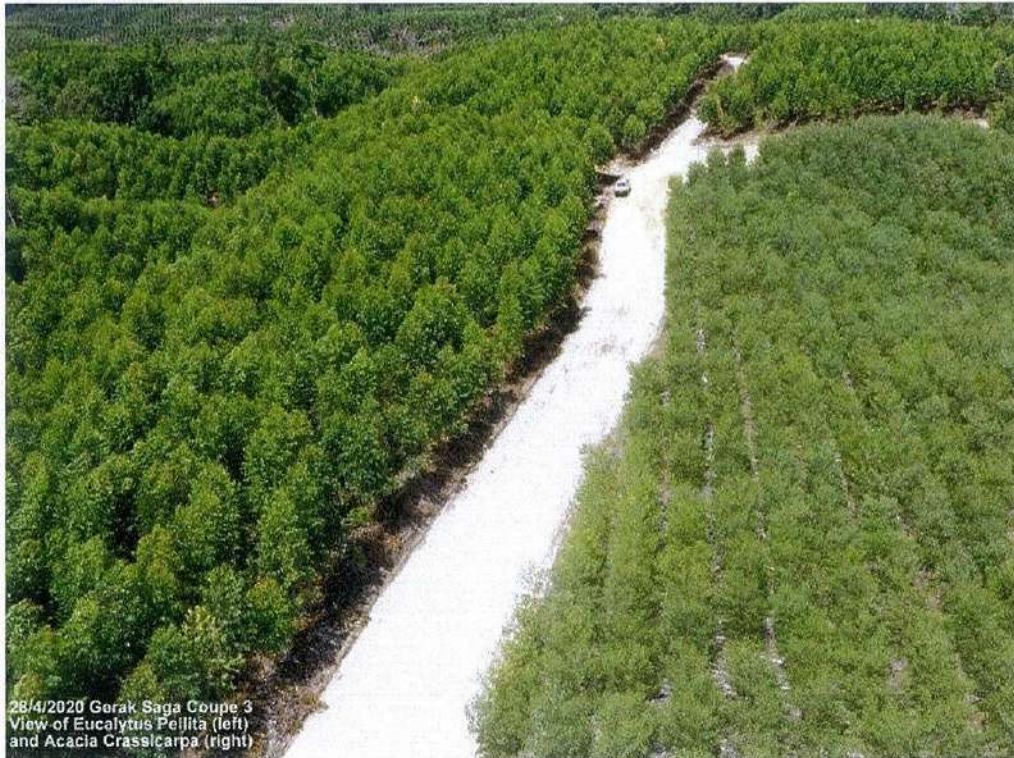
**Plate 11**

Overview of *Eucalytus Pellita* sp (left) and *Acacia Crassicaarpa* sp (right).

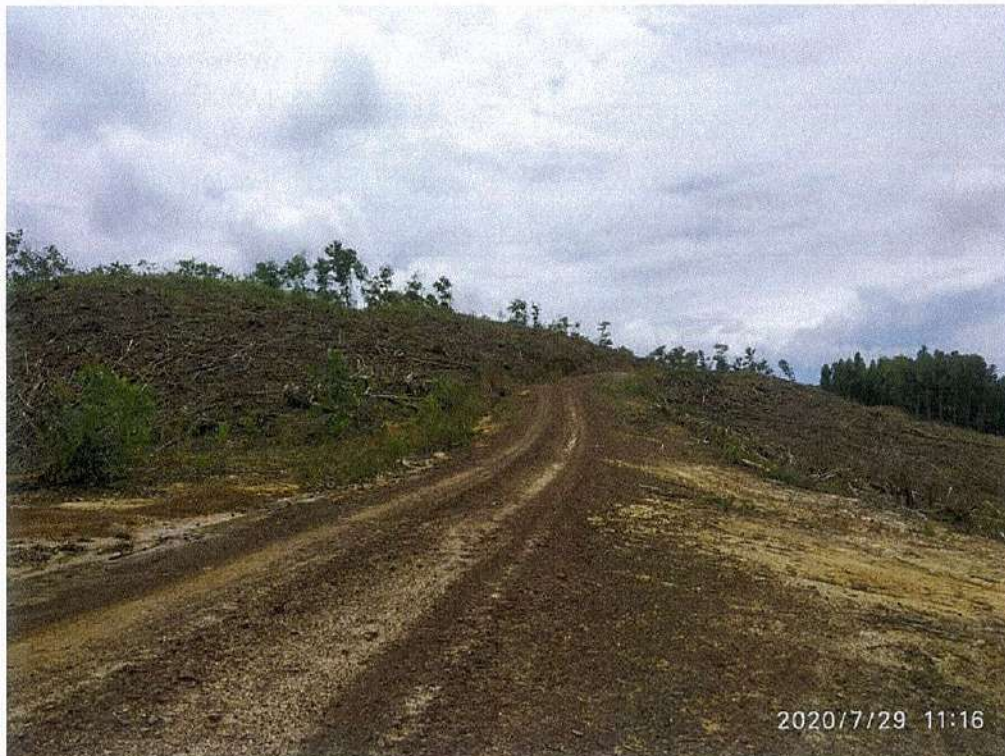
**Plate 12**

Overview of the road condition toward the project site.

| i | Jalan sedia ada hendaklah digunakan bagi mengurangkan gangguan terhadap tanah. | Comply | <ul style="list-style-type: none"> <li>The existing access road was fully utilized as observed during the site visit.</li> </ul> | Plate 11, 12 | - |
| ii | Sistem perparitan hendaklah disediakan bagi mengalirkan air keluar dari struktur jalan dan dilencongkan ke kawasan yang mempunyai tumbuhan. | Comply | <ul style="list-style-type: none"> <li>The existing access road on-site was equipped with earth drainages which was diverted towards the nearest vegetated area.</li> </ul> | Plate 12 | - |

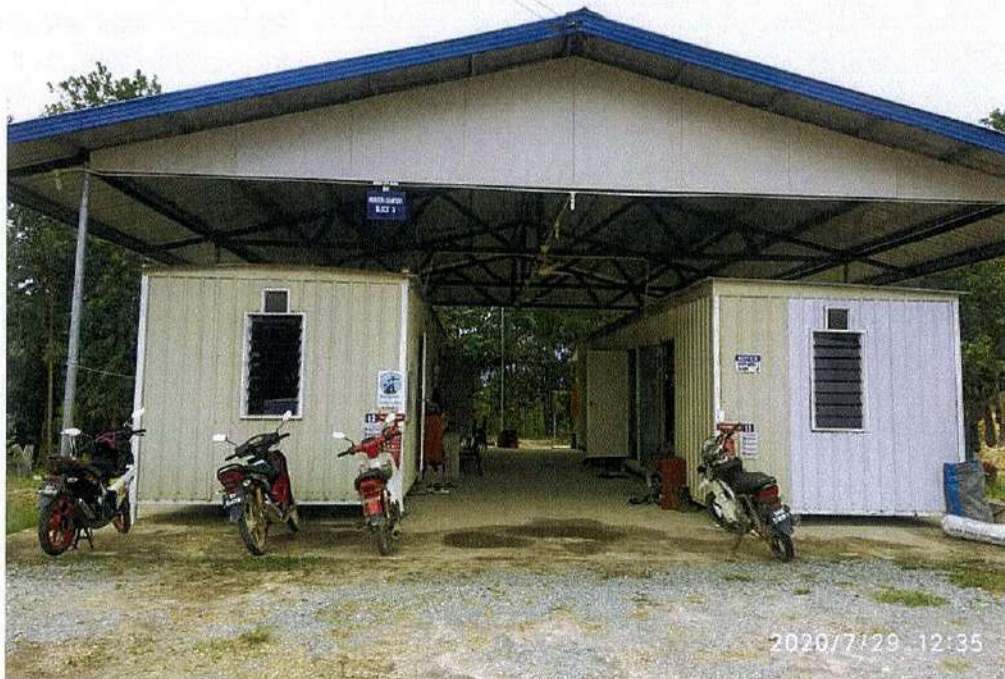
Plate 14

View towards the workers' quarters at the contractors' base camp.

The facility is located at more than 30 meters away from any nearest natural waterways.

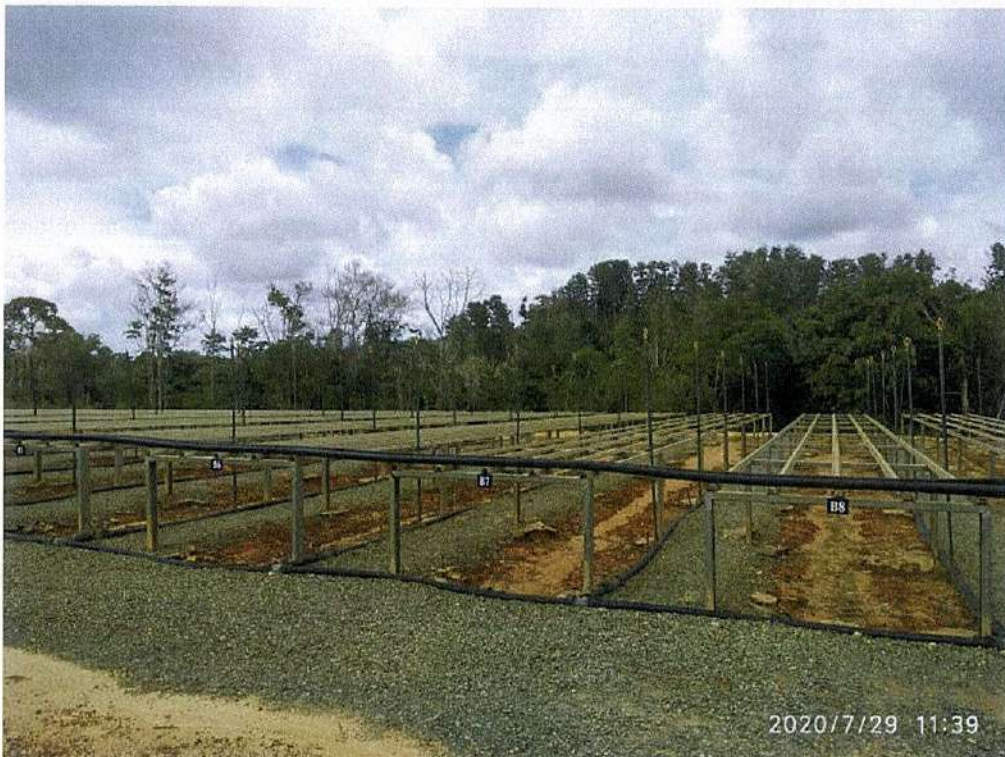
View towards the nursery on-site.

The facility is located at more than 50 m away from any nearest natural waterways.

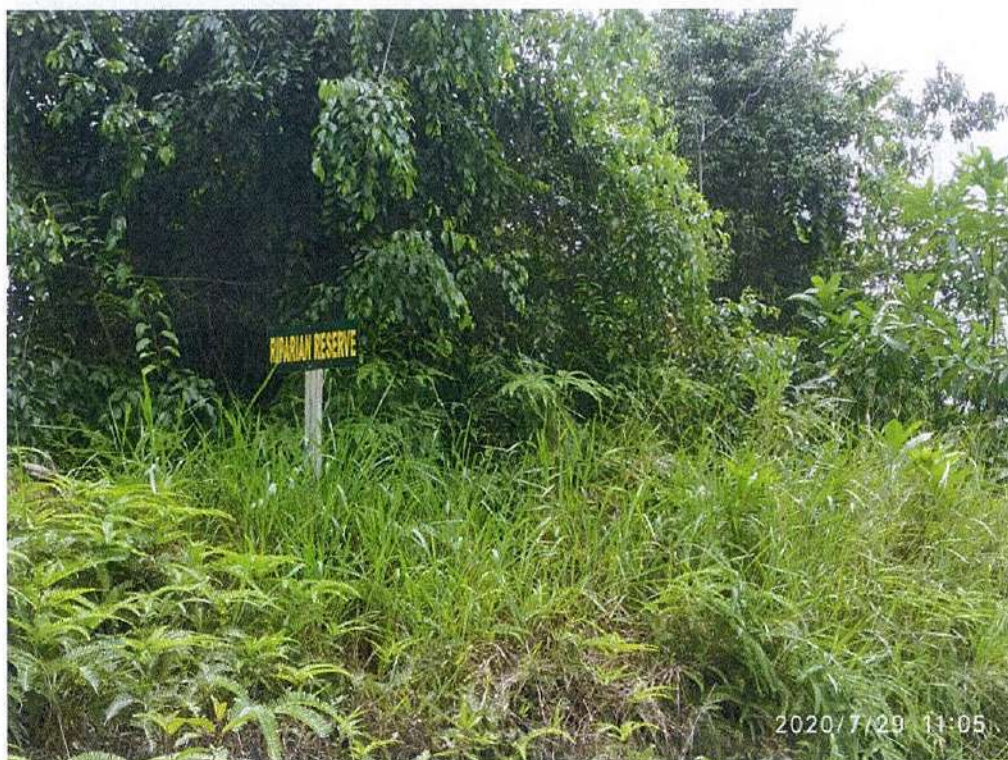
**Plate 15**

Signboard was erected to demarcate the Riparian Reserves on-site.

| i | Sebarang aktiviti pembersihan dan perladangan hutan adalah <b><u>tidak dibenarkan</u></b> dalam simpanan sungai sebagaimana ditunjukkan pada "Figure 6.2.1" dalam Perjanjian Syarat-syarat Alam Sekitar ini. | Comply | <ul style="list-style-type: none"> <li>There are no development activities carried out within the Riparian Reserve area as observed during the site visit.</li> </ul> | Plate 15 | - |

| ii | Sempadan simpanan sungai hendaklah ditanda di lapangan dengan cat merah serta dipasang dengan papan tanda di lokasi-lokasi yang mudah dilihat sebelum aktiviti pembersihan dan perladangan hutan dimulakan. | Comply | <ul style="list-style-type: none"> <li>Trees along the Riparian Reserves belt was painted with blue colour to demarcate the Riparian Reserves belt on-site.</li> <li>Signboard and coloured pegs were erected to demarcate the Riparian Reserves on-site.</li> </ul> | Plate 15 | - |
| iii | Sebarang pembinaan rumah pekerja, kem pekerja, bengkel, tandas atau struktur bangunan lain <b><u>tidak dibenarkan</u></b> dalam simpanan sungai. | Comply | <ul style="list-style-type: none"> <li>There were no structures constructed within the Riparian Reserves area.</li> </ul> | Plate 15 | - |
| v | Sebarang bahan tanah lebihan, sisa pepejal, sisa biomas, kumbahan, bahan minyak, kimia atau bahan-bahan toksik <b><u>tidak dibenarkan</u></b> dilupuskan dalam simpanan sungai. | Comply | <ul style="list-style-type: none"> <li>There were no signs of any overburden, biomass or any types of wastes (i.e. sewage, oil, chemical, toxic, etc) being disposed within the Riparian Reserves area as observed during the site visit.</li> </ul> | Plate 15 | - |

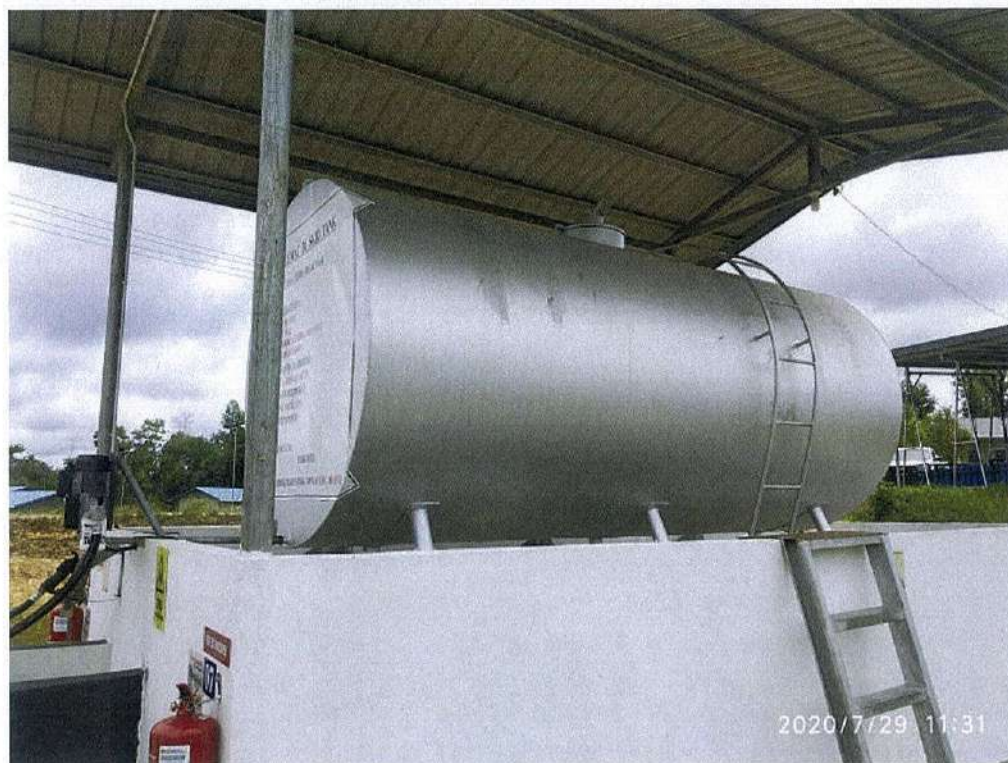
**Plate 16**

View towards the skid tank storage area situated at staff quarters area.

The facility was located at 50 meters away from any nearest natural waterways.

| 5.3 | <b>Bahan Minyak Dan Sisa Toksik</b> | | | | |
|---|---|---|---|---|---|
| ii | Bahan minyak dan sisa toksik hendaklah dikumpul dan disimpan dalam bekas yang kukuh dan tidak mudah bocor. Bekas-bekas penyimpanan tersebut hendaklah dilabel. | Comply | <ul style="list-style-type: none"> <li>Oily materials were stored in HDPE container.</li> <li>Diesel was stored inside metal skid tank.</li> </ul> | Plates<br>16 - 20 | - |
| iii | Kawasan penyimpanan bahan minyak dan sisa toksik tersebut hendaklah terlindung dari hujan dan terletak pada jarak mendatar tidak kurang <b>50 meter</b> dari tebing sungai atau alur air. | Comply | <ul style="list-style-type: none"> <li>Refer to the comments in <b>AEC 5.3 (i)</b>.</li> <li>The oil storage area and diesel skid tank on-site were located at more than 50 meters away from any nearest natural waterways.</li> <li>The oil storage area was equipped with concretized floor, bunded and sheltered from weather exposure.</li> <li>The diesel skid tank storage area on-site was equipped with concretized floor, bunded and shelter from weather exposure.</li> </ul> | Plates<br>16 - 20 | - |

| iv | Kawasan penyimpanan bahan minyak dan sisa toksik hendaklah disediakan dengan sistem saliran serta perangkap minyak. | Comply | <ul style="list-style-type: none"> <li>The diesel skid tank and oil storage area were equipped with oil trap.</li> <li>The nozzle storage area of the skid tank was equipped with perimeter concrete containment bund filled with sand to prevent oil from directly seep into the ground.</li> </ul> | Plates 16 - 20 | - |

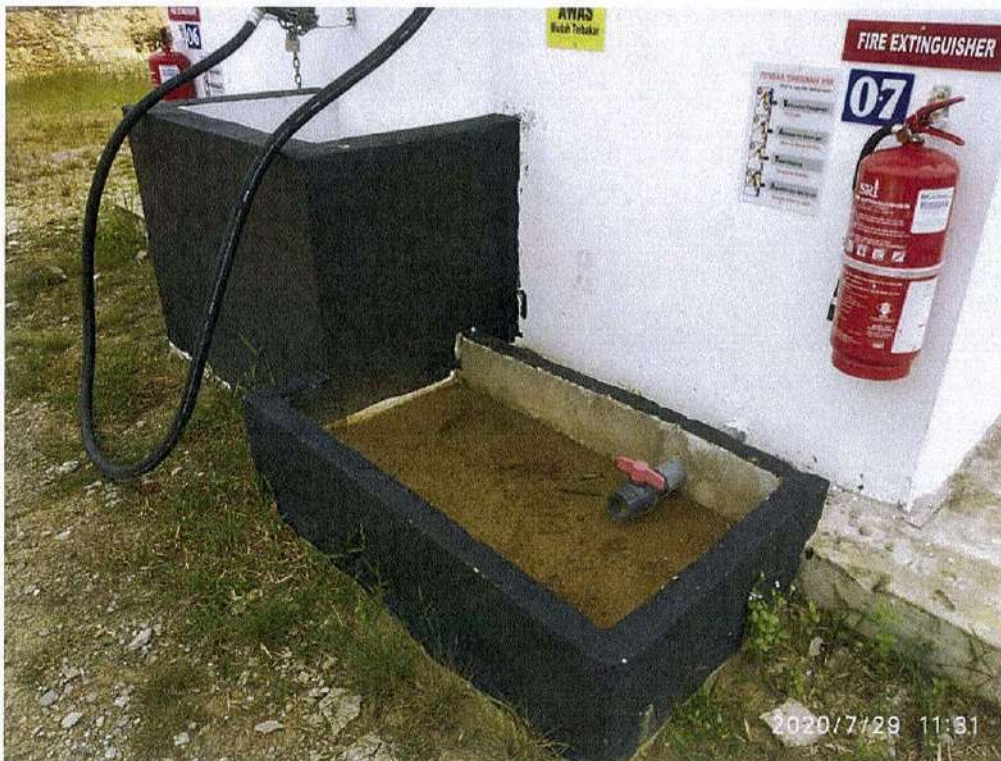
**Plate 17**

The diesel skid tank was equipped with perimeter concrete bund filled with sand to prevent oil from directly seep into the ground.

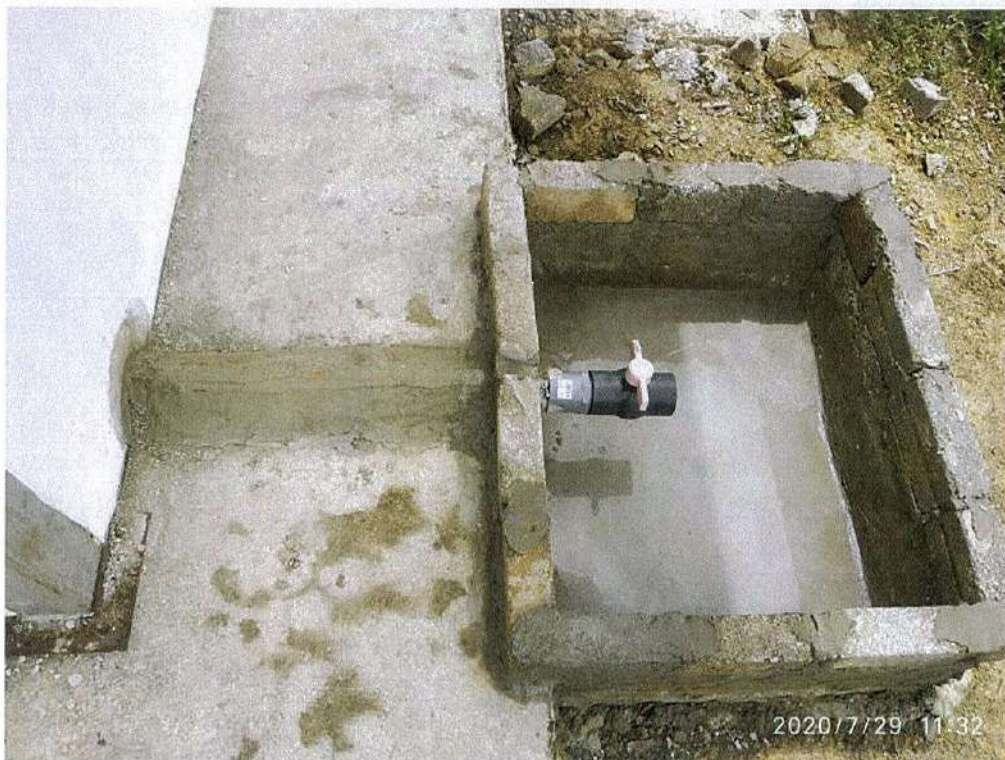
**Plate 18**

The diesel skid tank was equipped with oil trap to contain any oil spillage.

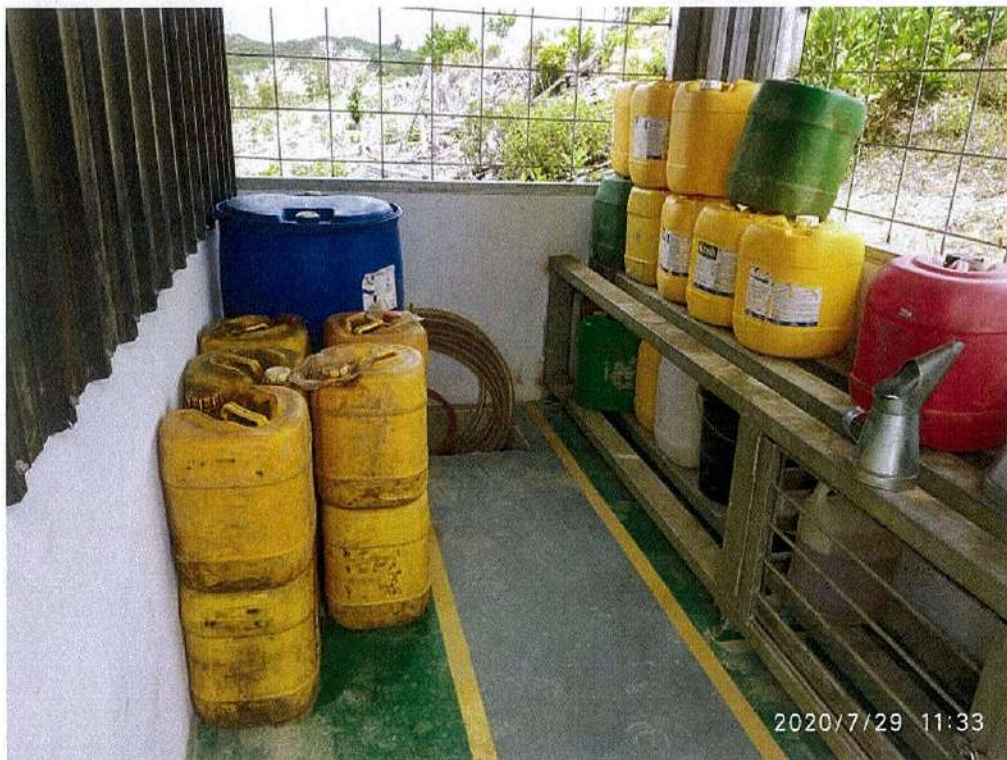
**Plate 19**

Close up view of the oil storage area situated at the site office.

The facility is located at more than 50 m away from any nearest natural waterways.

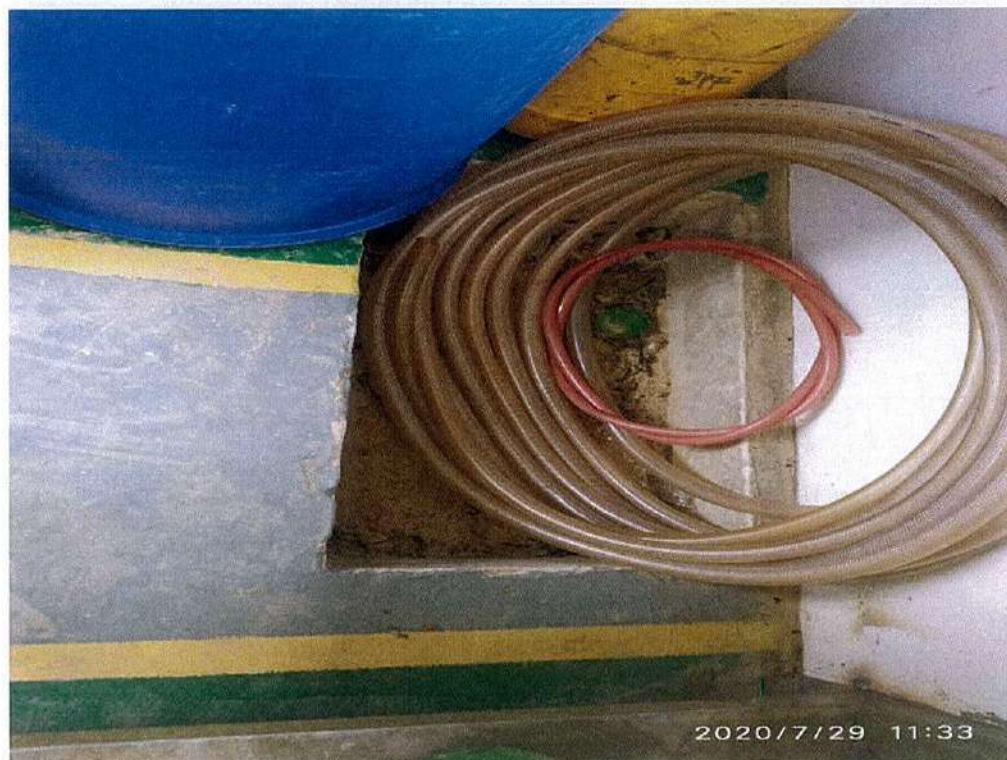
**Plate 20**

The oil storage area was equipped with oil trap.

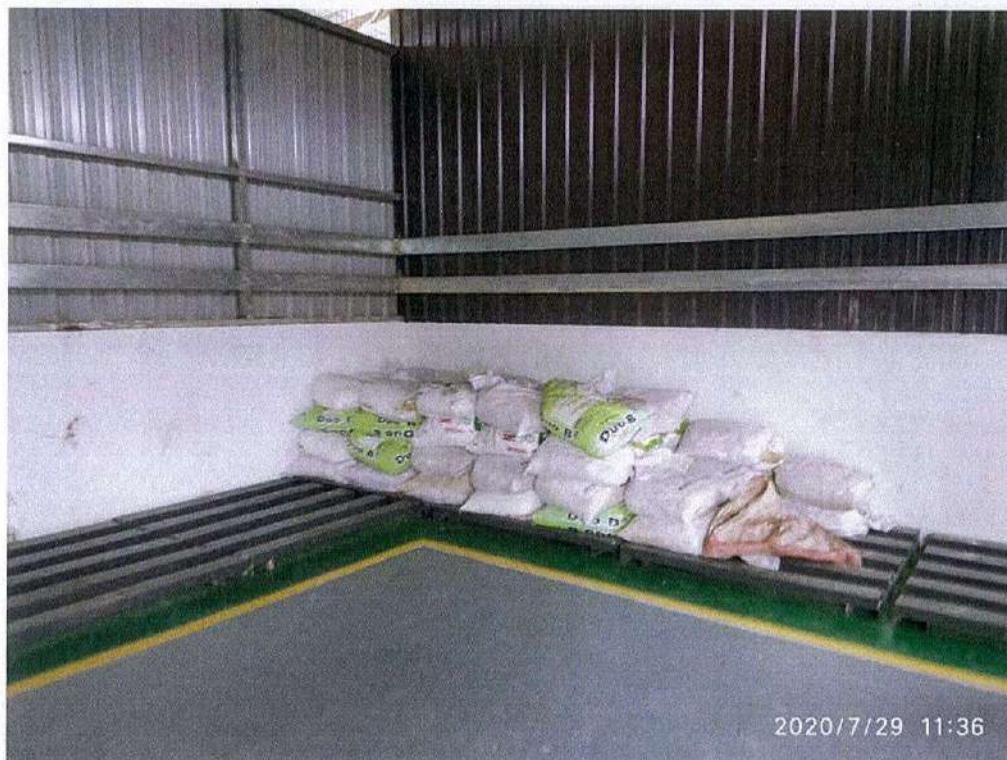
**Plate 21**

View towards the fertiliser storage area on-site.

The facility is located at more than 50 m away from any nearest natural waterways.

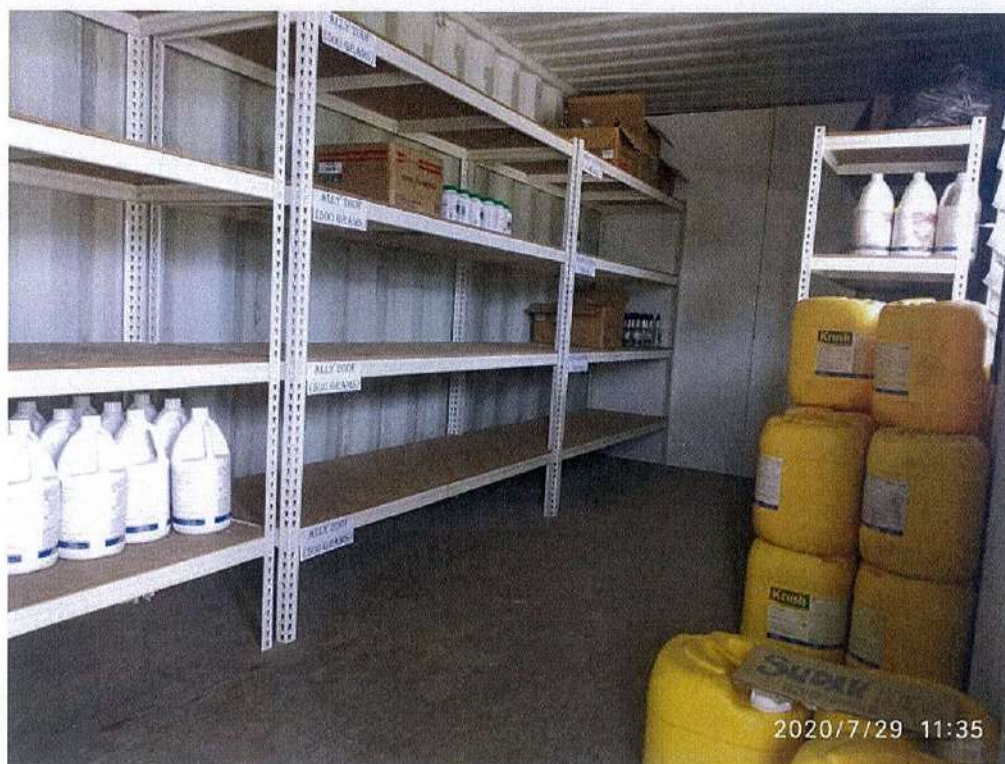
**Plate 22**

View towards the agrochemical storage area on-site.

| ii | <i>Kemudahan mengumpul dan mengutip sisa pepejal dan biomas hendaklah disediakan. Lokasi kawasan pengumpulan hendaklah terletak pada jarak mendatar tidak kurang <b>30 meter</b> dari tebing sungai atau alur air.</i> | <i>Comply</i> | <ul style="list-style-type: none"> <li>• Garbage bins was provided at the staffs' quarters area and workers' quarters at the contractor base camp to facilitate solid waste collection.</li> <li>• Dumping pit was provided on-site.</li> <li>• The facilities were located at more than 30 meters away from any nearest natural waterways.</li> </ul> | <i>Plates 22 &amp; 23</i> | - |

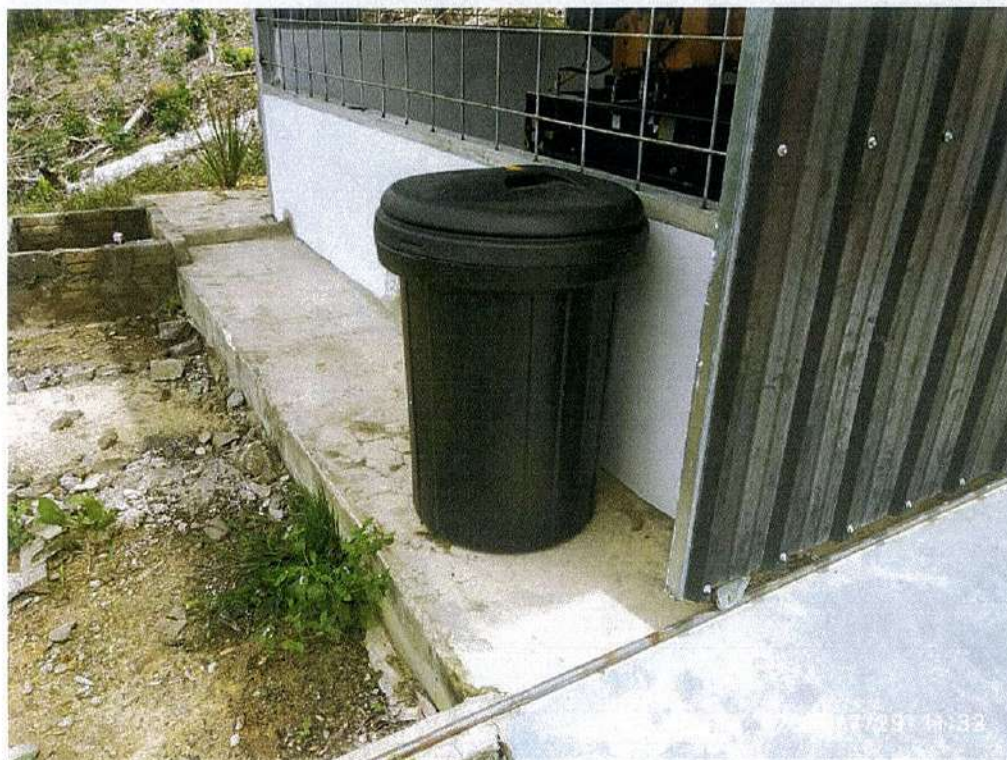
Plate 23

Garbage bin was provided to facilitate solid wastes collection.

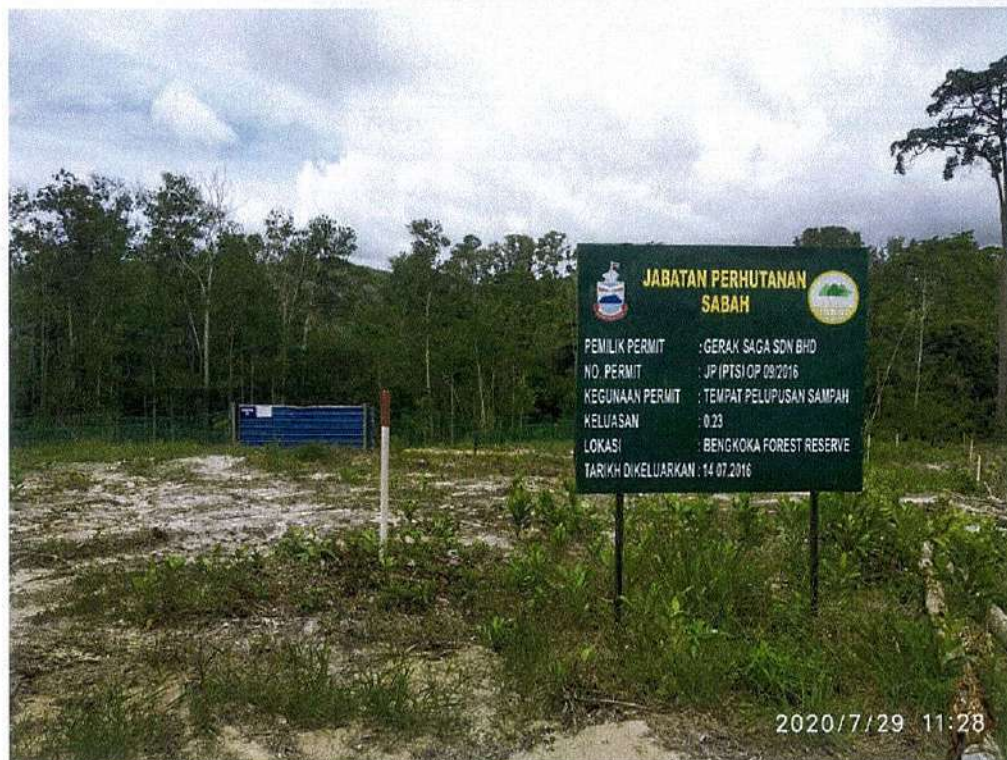
Plate 24

Landfill was provided on-site to facilitate solid waste collection on-site.

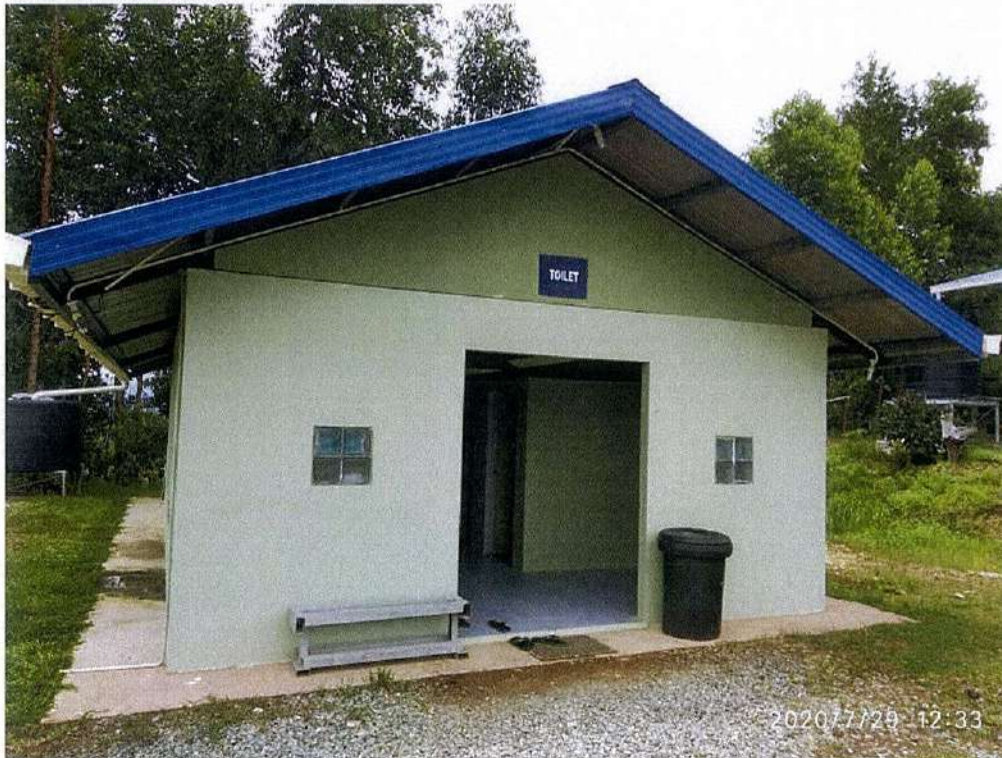
**Plate 25**

Toilet with septic tank was available at the project site to cater sewage waste.

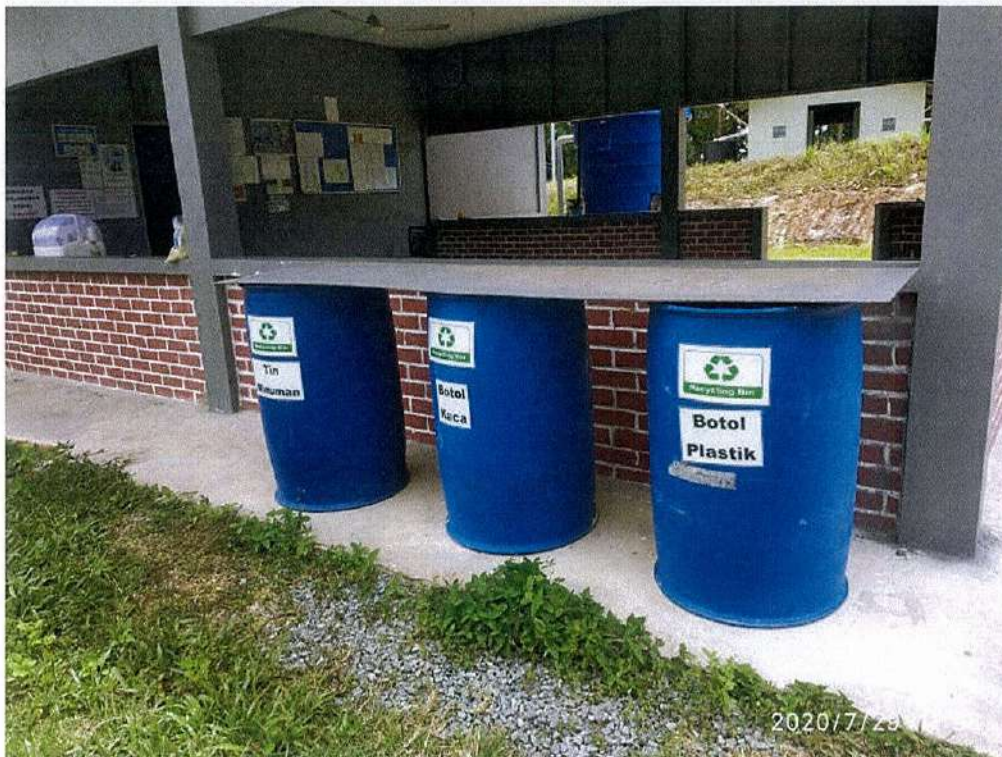
**Plate 26**

Recycled bins were provided at the canteen area for solid waste segregation.

| iii | <i>Semua sisa pepejal seperti botol, tin, plastik dan besi hendaklah dikumpul secara berasingan dan dikitar semula.</i> | <i>Comply</i> | <ul style="list-style-type: none"> <li>• Recycle bins were provided at the workers quarters area to facilitate solid waste segregation.</li> </ul> | <i>26</i> | - |
