## ENVIRONMENTAL MONITORING AND COMPLIANCE AUDIT REPORT

FOREST MANAGEMENT OF BENGKOKA AND TAMBALUGU  
FOREST RESERVES (6,467 HA), PITAS, SABAH

3<sup>rd</sup> REPORT OF YEAR 2021

Report Reference : CK/MO411/1197-3/21

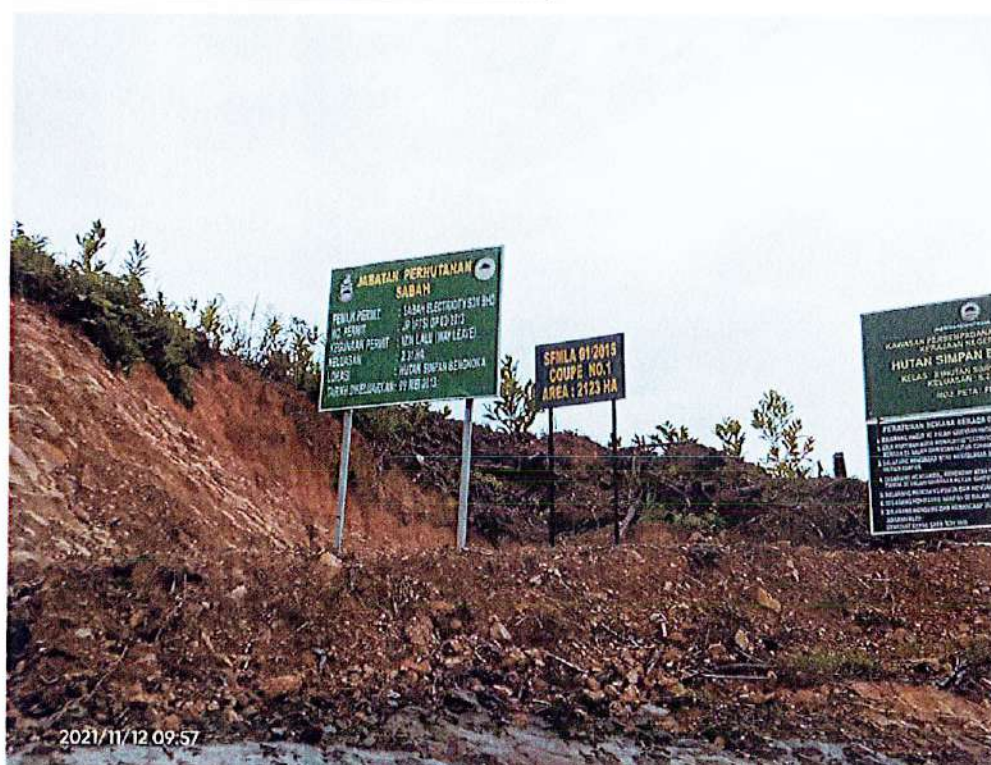
Plate 3

| AEC No. | Approved Environmental Conditions | Status | Observations / Comments | Photo No. | Corrective Action and Completion Date |
|---|---|---|---|---|---|
| iii | Semua tanda sempadan tapak projek hendaklah tidak ditimbus, dihalang, dirosakkan atau diganggu daripada kedudukan asal. | Comply | <ul style="list-style-type: none"> <li>Signboard and pegs are in good condition as sighted during the site visit.</li> </ul> | Plates 3 to 6 | - |

Signage in place demarcating Project boundary.

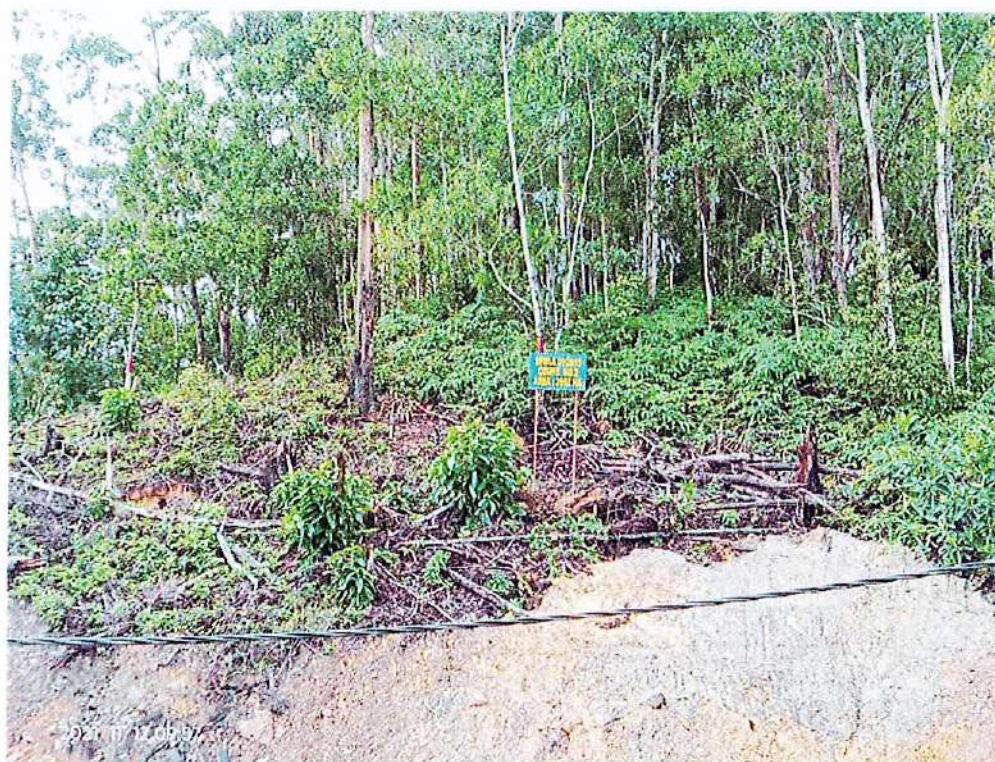
Plate 4

Signage in place demarcating Project coupes.

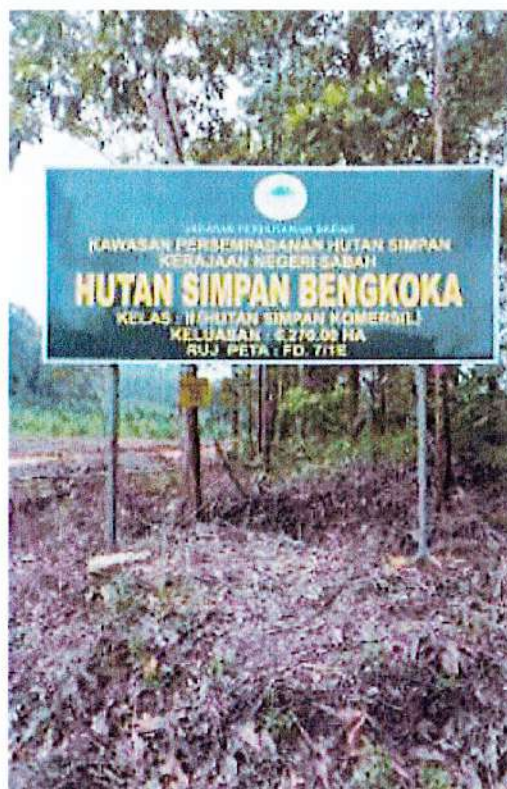
**Plate 5**

Signage in place demarcating boundary between the Project site and Kg. Sorupil.

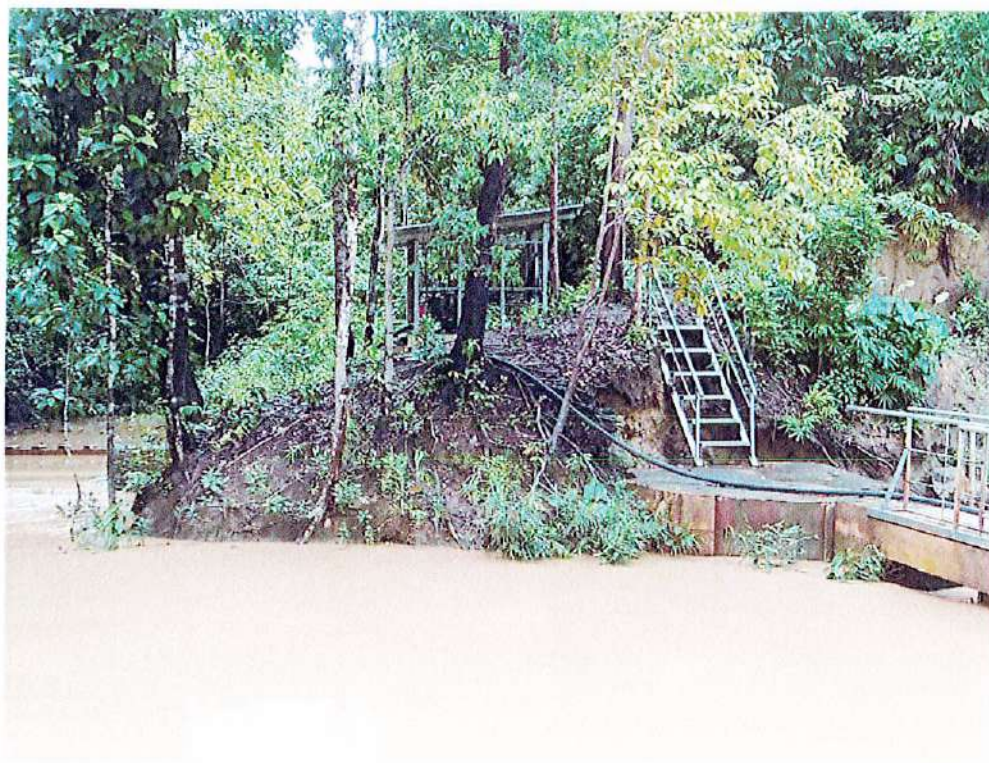
**Plate 7**

View of the water reservoir dam located within the Project site.

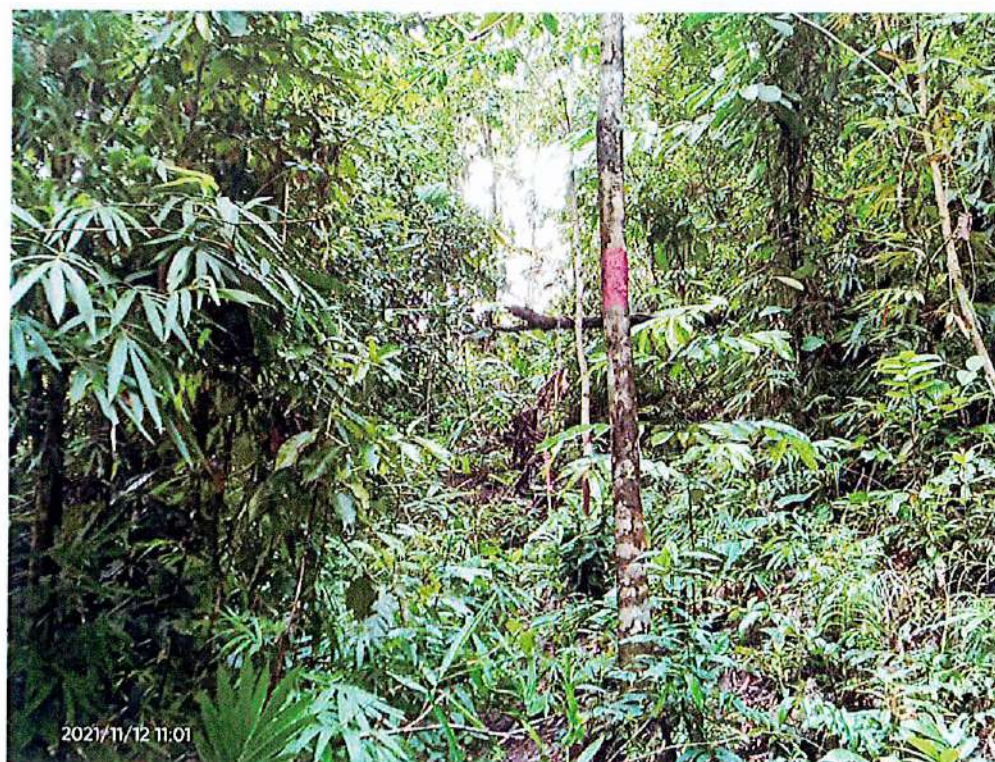
**Plate 8**

View showing enrichment planting conducted along the Riparian Reserve area near the water reservoir dam located within the Project site.

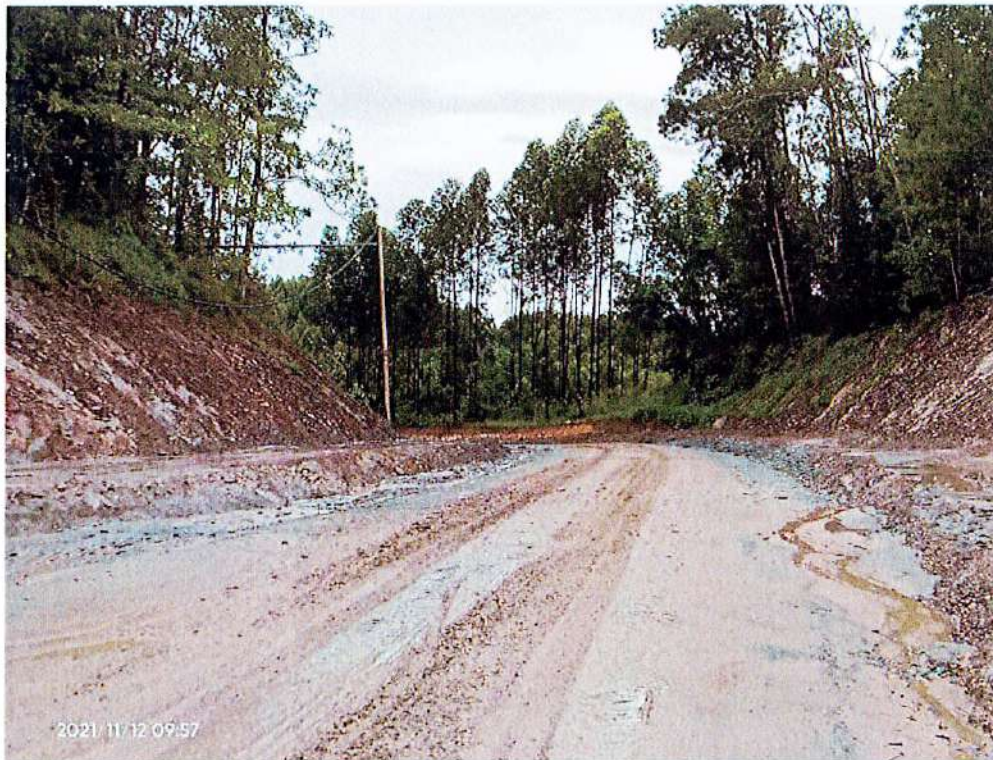
**Plate 10**

| AEC No. | Approved Environmental Conditions | Status | Observations / Comments | Photo No. | Corrective Action and Completion Date |
|---|---|---|---|---|---|
| i | Jalan sedia ada hendaklah digunakan bagi mengurangkan gangguan terhadap tanah. | Comply | <ul style="list-style-type: none"> <li>Existing access road was fully utilized as sighted during the site visit.</li> </ul> | Plate 10 | - |
| ii | Sistem perparitan hendaklah disediakan bagi mengalirkan air keluar dari struktur jalan dan dilencongkan ke kawasan yang mempunyai tumbuhan. | Comply | <ul style="list-style-type: none"> <li>Existing access road sighted equipped with earth drainage, channelling surface runoff towards the nearest vegetated area.</li> </ul> | Plate 10 | - |

View showing the internal existing access road.

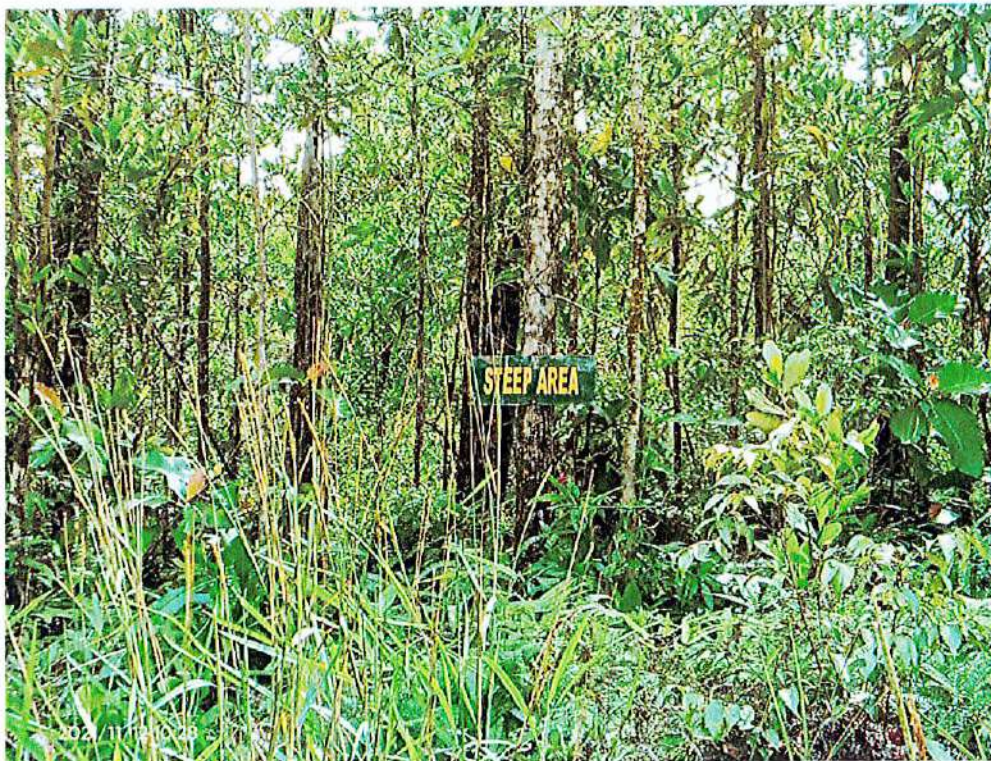
**Plate 14**

| AEC No. | Approved Environmental Conditions | Status | Observations / Comments | Photo No. | Corrective Action and Completion Date |
|---|---|---|---|---|---|
| i | Semua kawasan tanah dan cerun yang terdedah hendaklah distabilkan dan direhabilitasi dengan menanam spesis tumbuhan yang diluluskan oleh Jabatan Perhutanan Negeri Sabah. | Comply | <ul style="list-style-type: none"> <li>Cover crops planted at exposed Project areas to reduce the risk of soil erosion.</li> <li>Existing vegetation on inactive and idle Project areas were retained and remain undisturbed.</li> </ul> | Plate 14 | - |

The steep area within Coupe 2 (Block 39) demarcated using a sign board.

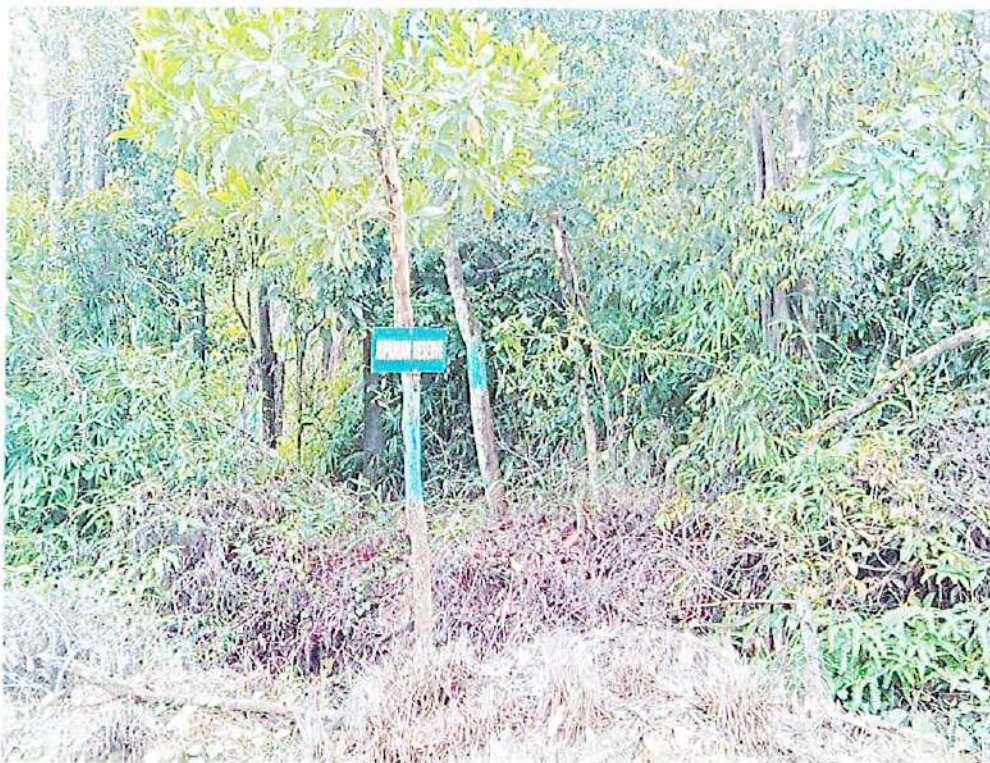
**Plate 15**

| AEC No. | Approved Environmental Conditions | Status | Observations / Comments | Photo No. | Corrective Action and Completion Date |
|---|---|---|---|---|---|
| i | Sebarang aktiviti pembersihan dan perladangan hutan adalah <b><u>tidak dibenarkan</u></b> dalam simpanan sungai sebagaimana ditunjukkan pada "Figure 6.2.1" dalam Perjanjian Syarat-syarat Alam Sekitar ini. | Comply | <ul style="list-style-type: none"> <li>Development within the riparian reserves was not sighted.</li> </ul> | Plate 15 | - |
| ii | Sempadan simpanan sungai hendaklah ditanda di lapangan dengan cat merah serta dipasang dengan papan tanda di lokasi-lokasi yang mudah dilihat sebelum aktiviti pembersihan dan perladangan hutan dimulakan. | Comply | <ul style="list-style-type: none"> <li>Tree trunks along the belt of the riparian reserves were painted in blue for demarcation purposes.</li> <li>Signboard sighted in place demarcating Project's riparian reserve.</li> </ul> | Plate 15 | - |

A signboard in place demarcating Project riparian reserves.

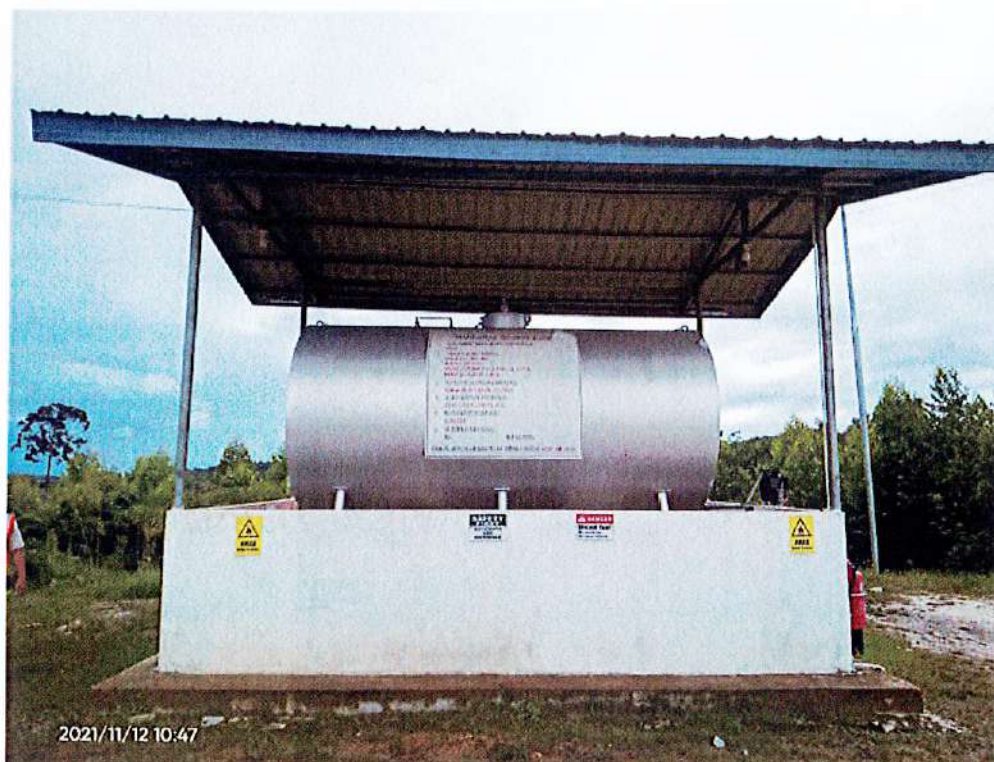
**Plate 16**

View showing the skid tank shed situated near the staff quarters.

This facility is equipped with concretized floor, bunded and sheltered from weather exposure.

The facility is located 50 meters away from nearest natural waterways.

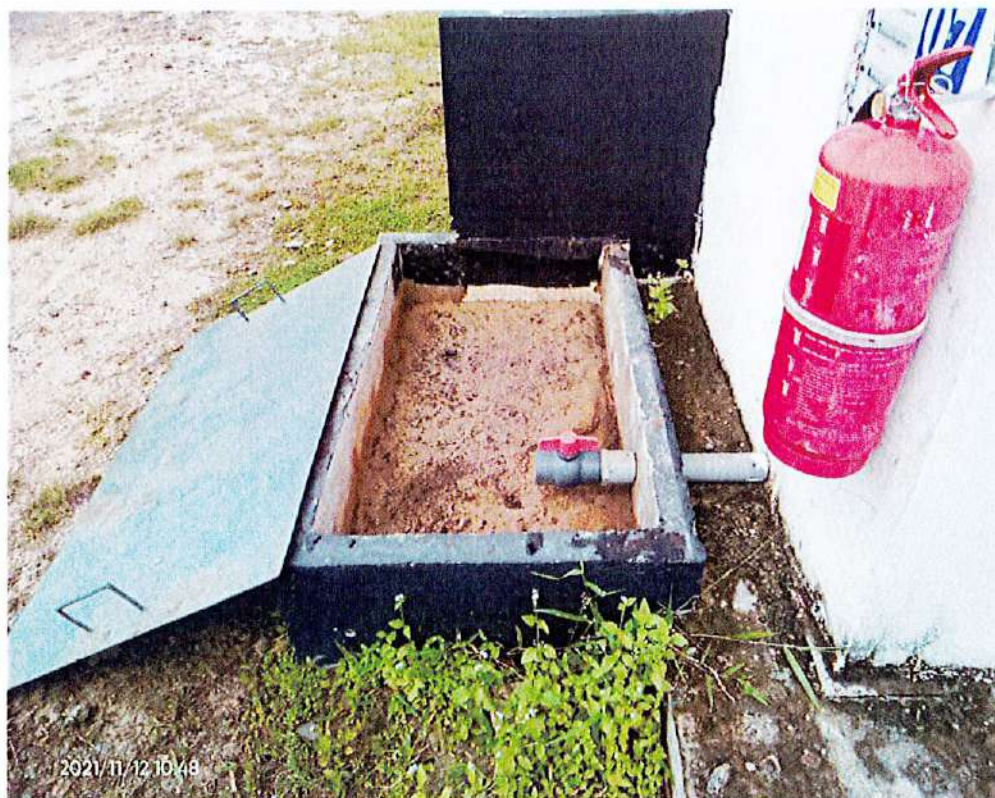
**Plate 18**

The diesel skid tank shed is equipped with an oil trap.

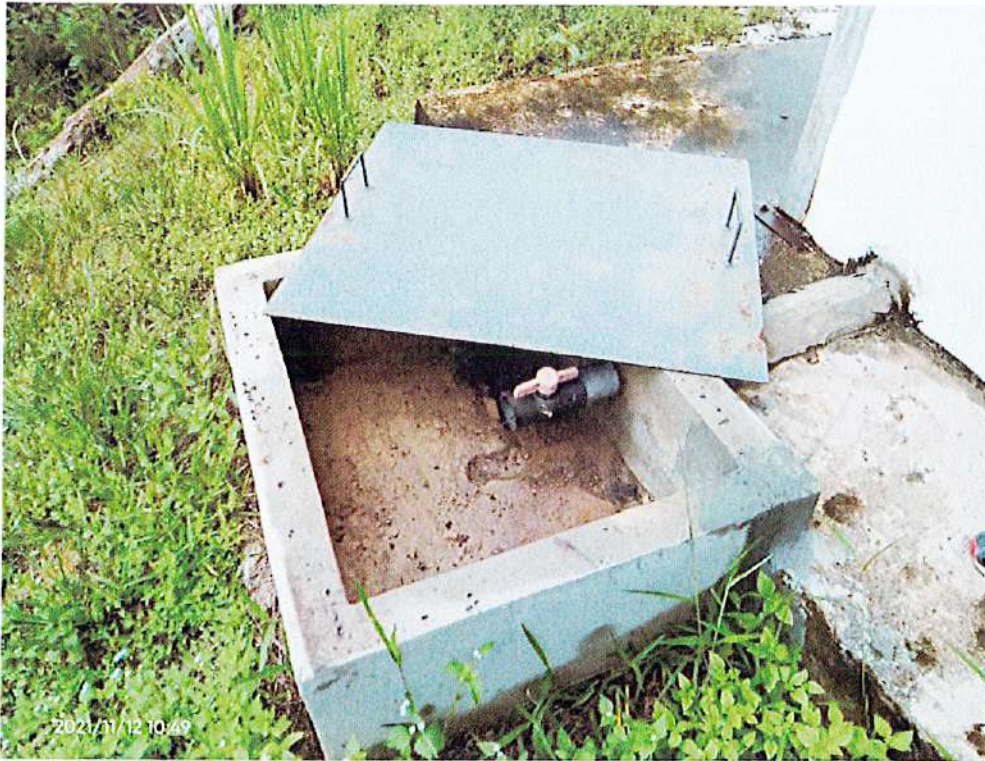
**Plate 19**

The lubricant and oil storage building sighted equipped with an oil trap.

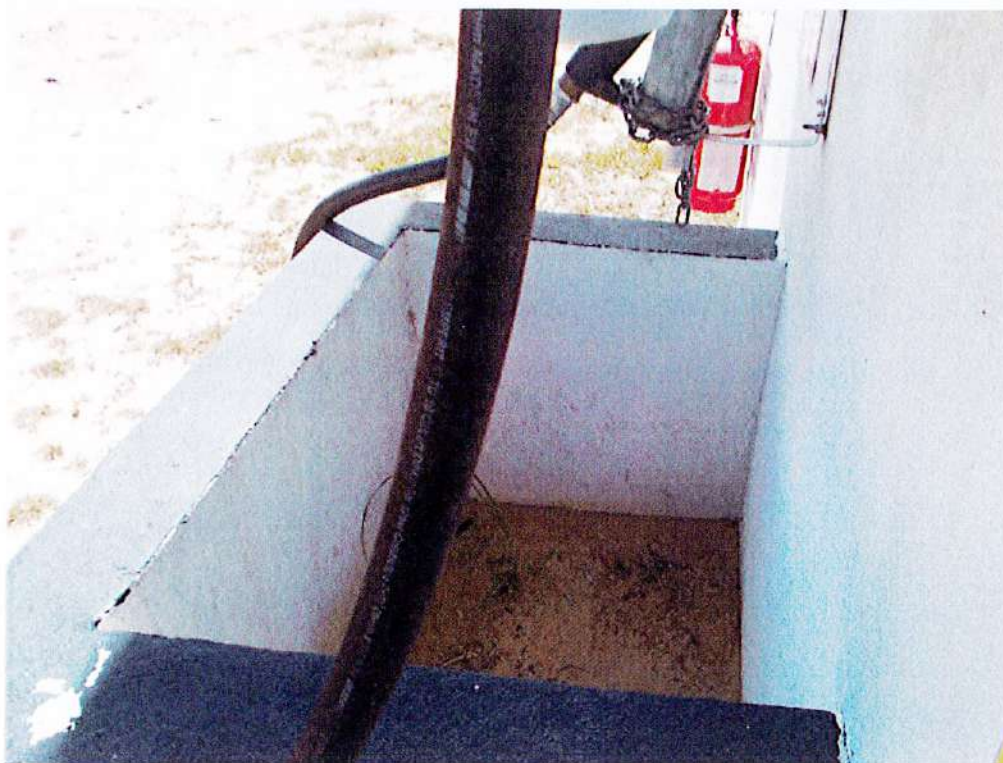
**Plate 20**

The fuel dispensing nozzle is affixed just above the containment chamber, filled with sand to prevent oil from seeping directly into the ground.

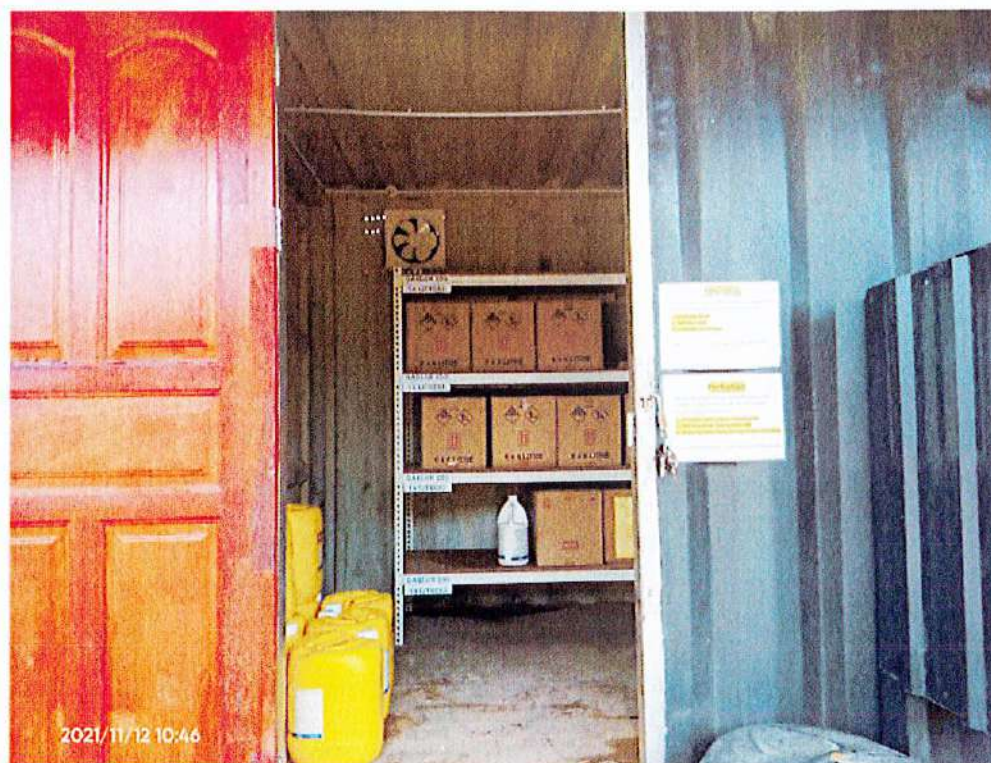
**Plate 21**

View showing the agrochemical storage store.

This facility is located more than 50m away from nearest natural waterways.

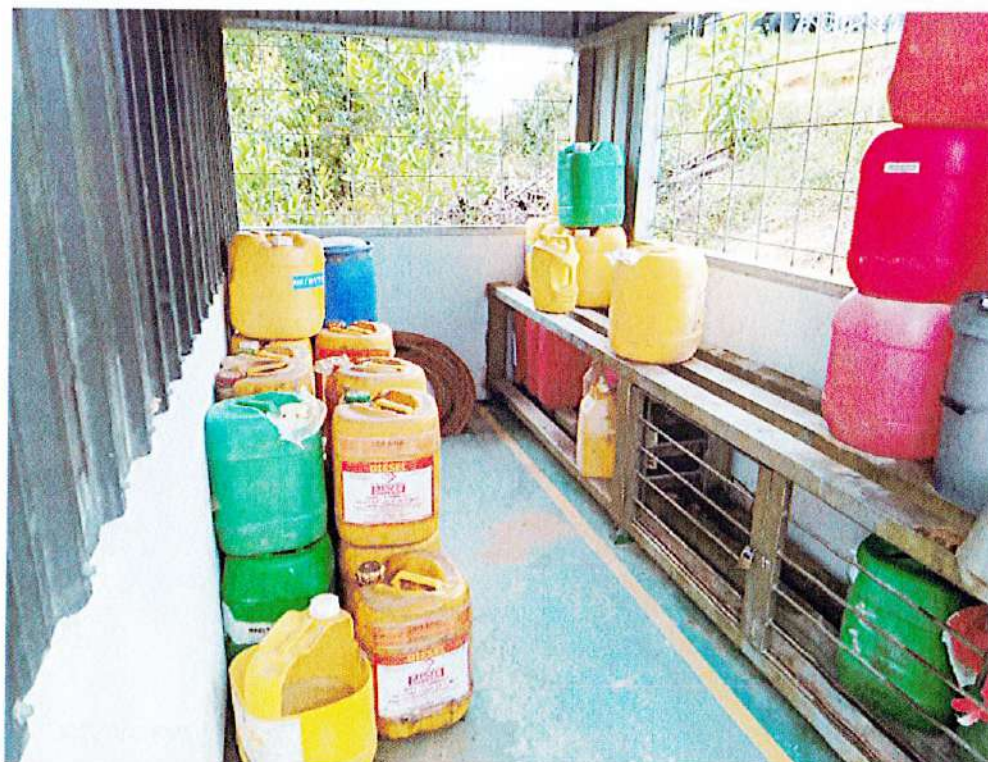
**Plate 23**

Close-up view of the lubricant and oil storage area situated at the site office.

This facility is equipped with concretized floor, bunded and sheltered from weather exposure and located more than 50 m away from any nearest natural waterways.

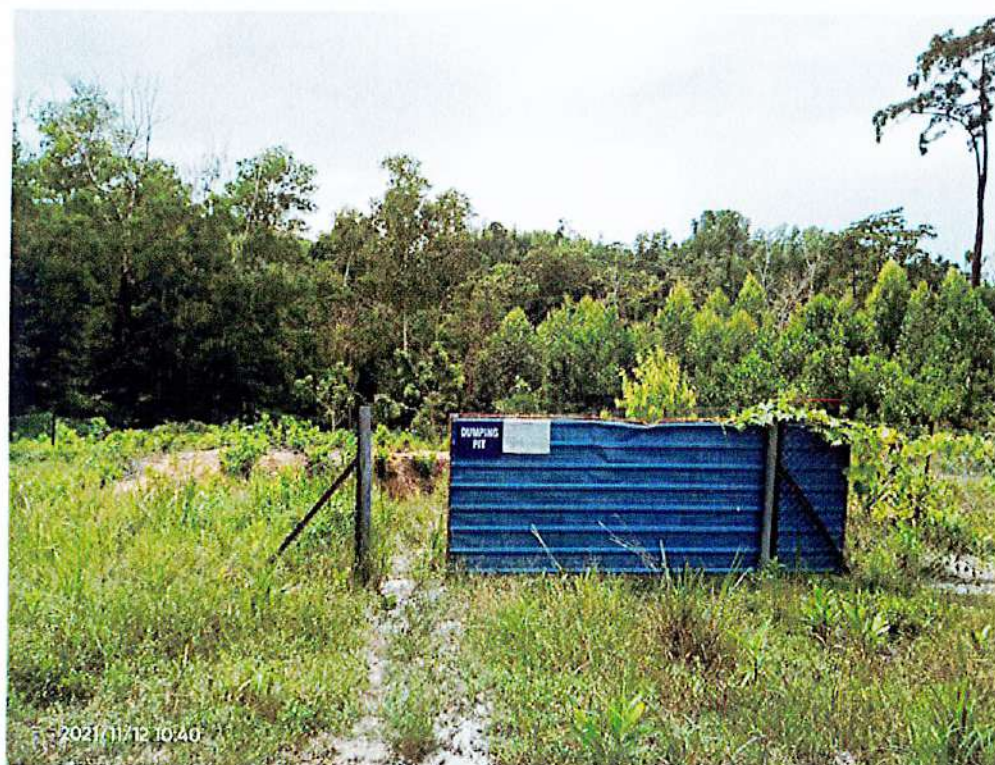
**Plate 28**

Dumping pit sighted onsite.

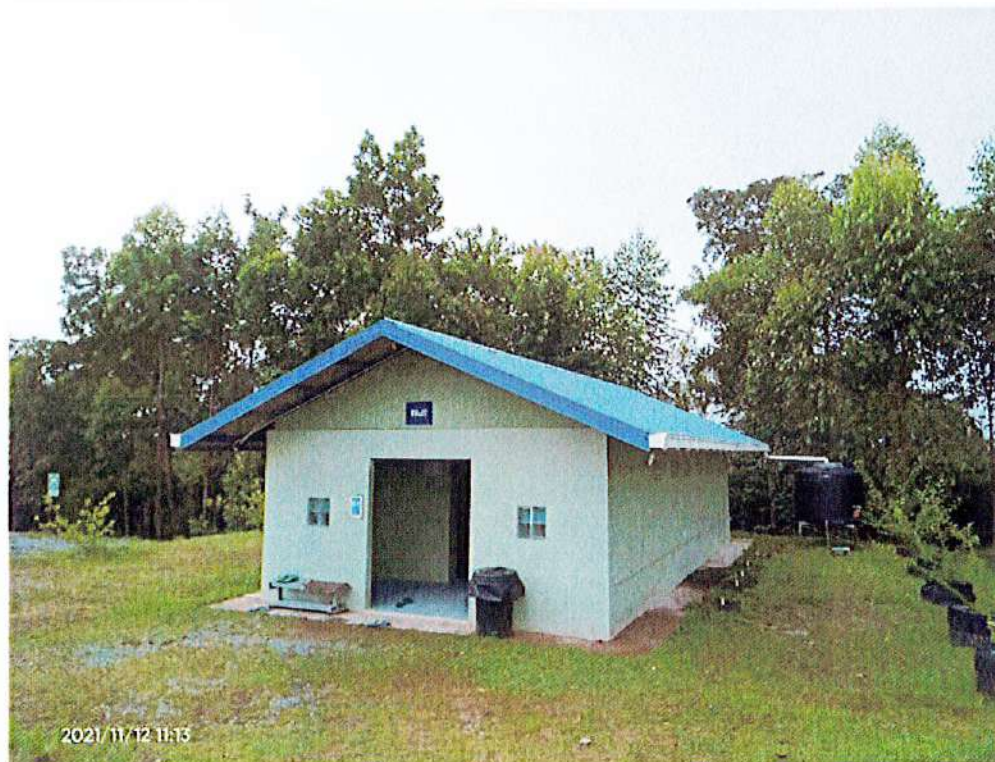
**Plate 29**

Toilet with septic tank in place at the Project site.

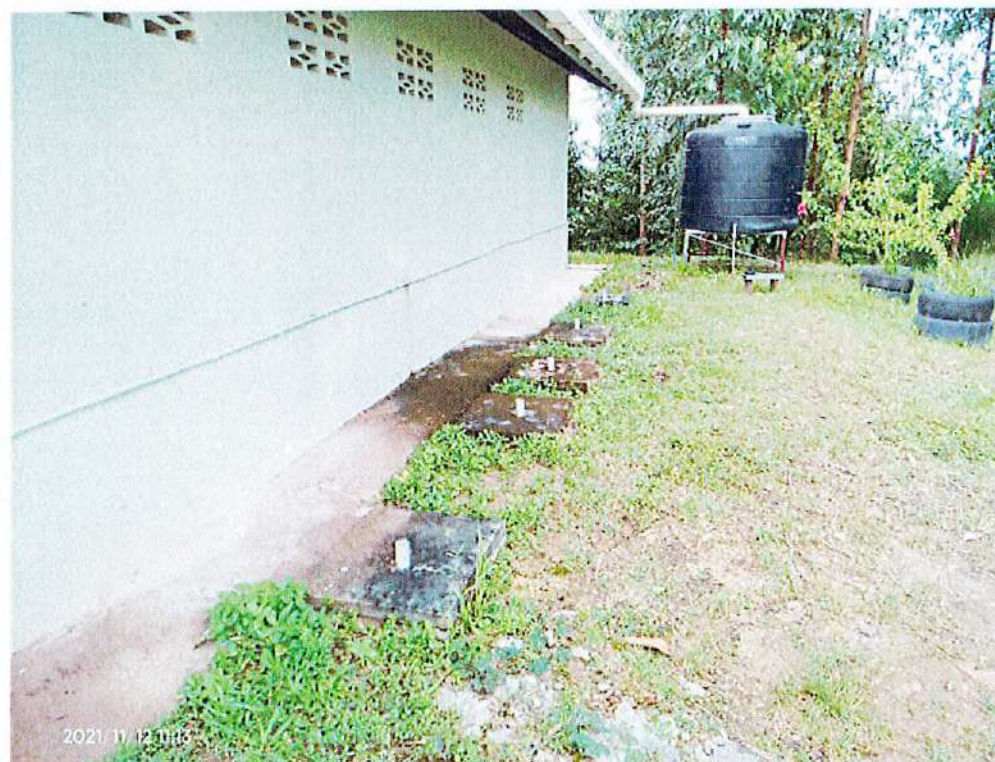
**Plate 30**

Toilet at the workers' quarters equipped with septic tank.

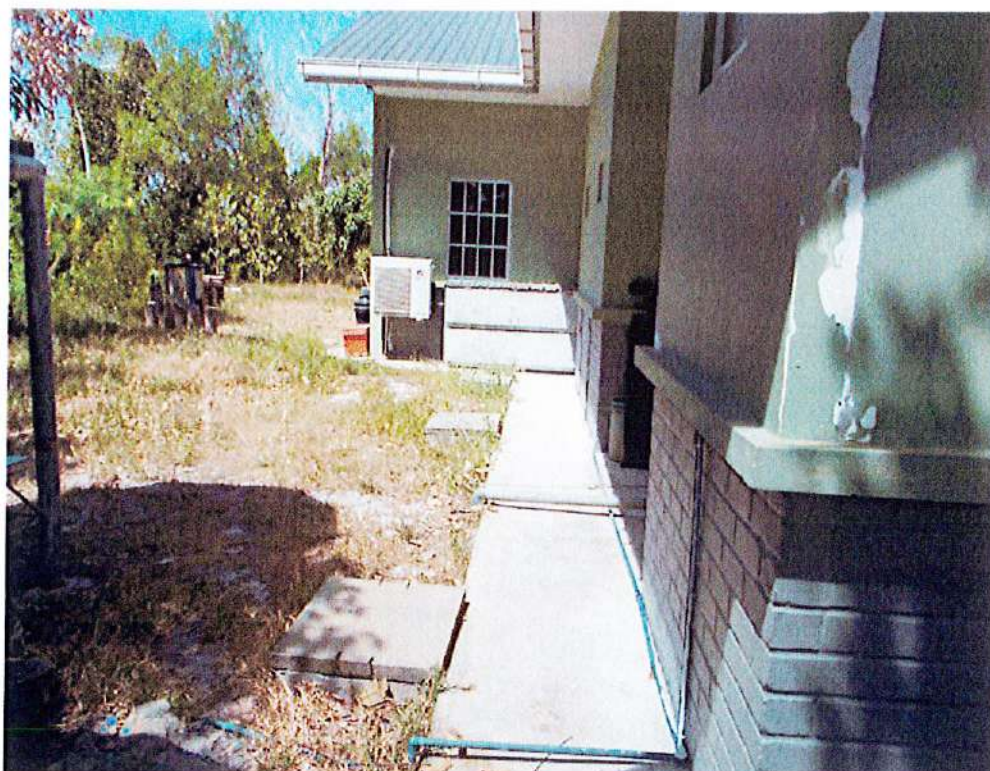
**Plate 31**

Staff toilet sited within the base camp equipped with septic tank.

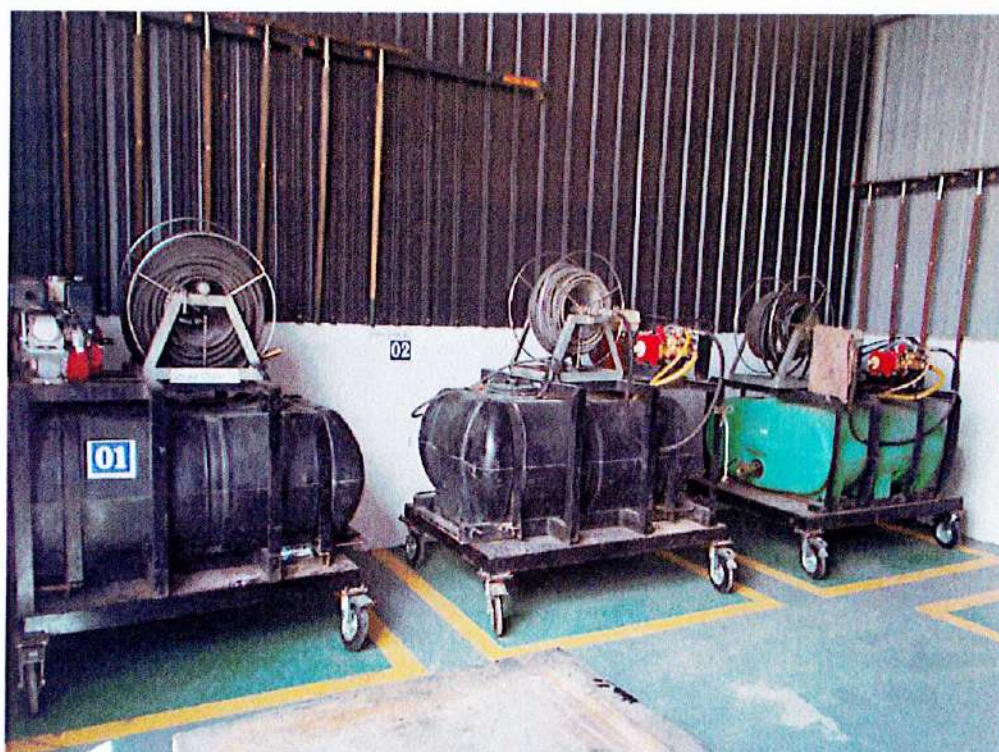
**Plate 32**

| AEC No. | Approved Environmental Conditions | Status | Observations / Comments | Photo No. | Corrective Action and Completion Date |
|---|---|---|---|---|---|
| i | Pembakaran terbuka adalah <b><u>tidak dibenarkan</u></b> . | Comply | <ul style="list-style-type: none"> <li>The Project Proponent had given assurance to adhere to zero open burning policy during Project development activities.</li> <li>Signboard pertaining to prohibition of open burning in place, for notification purposes.</li> <li>Firefighting equipment provided onsite</li> </ul> | Plate 32 | - |

Portable fire prevention equipment provided to mitigate fire outbreaks (if any).
