## ENVIRONMENTAL COMPLIANCE REPORT

**FOREST MANAGEMENT OF BENGKOKA AND  
TAMBALUGU FOREST RESERVES (6,467 HA), PITAS,  
SABAH.**

**2<sup>ND</sup> REPORT OF YEAR 2025**

AEC Ref. No. : JPAS/PP/15/600-1/01/3/60(46)  
Report Reference : CK/MO411/1197-2/25  
Date of Report : 4<sup>th</sup> July 2025

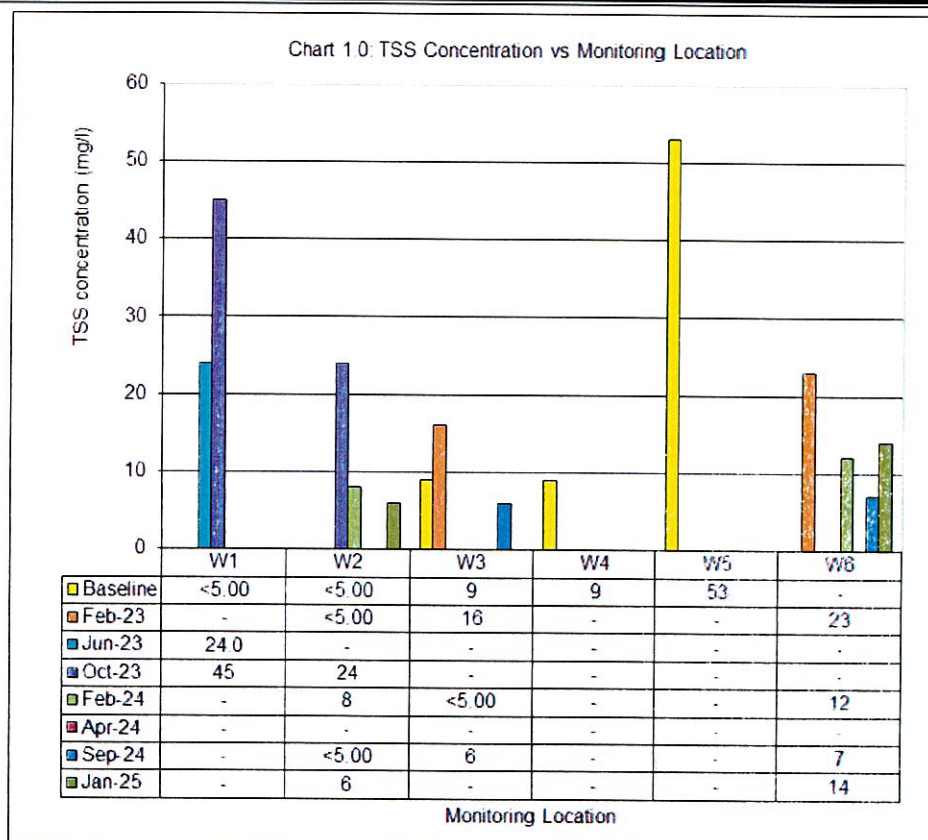
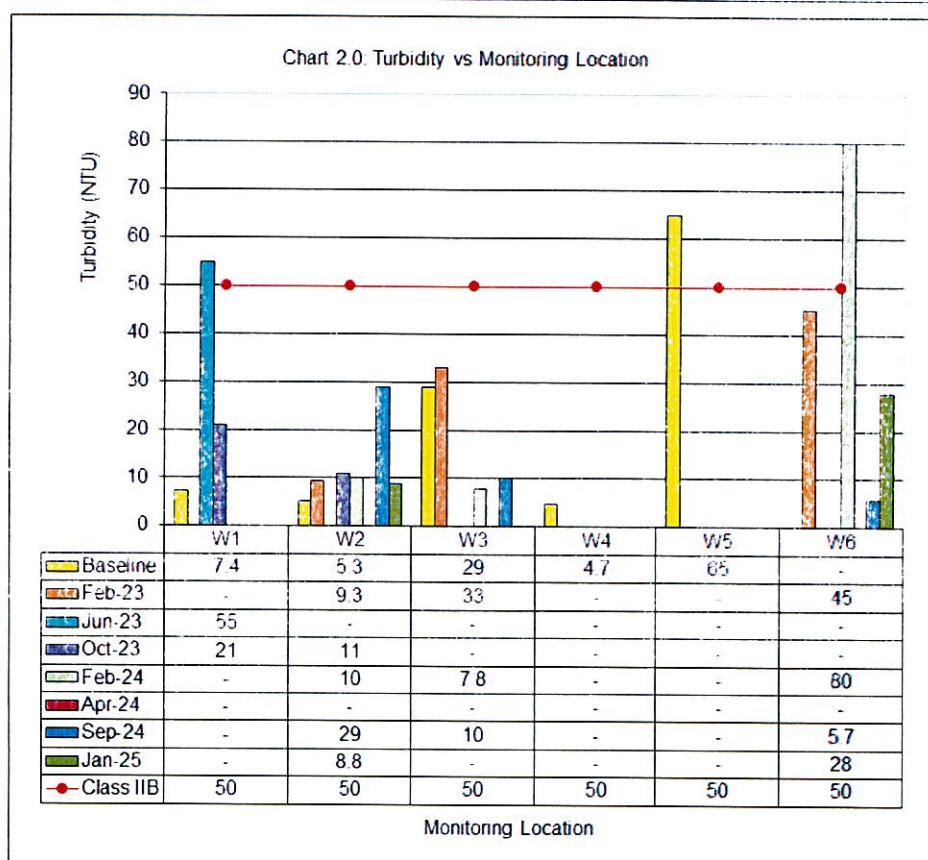
## HISTORICAL SURFACE WATER QUALITY GRAPHICAL REPRESENTATION

Surface water quality analysis shows measured parameters recorded levels below the recommended limits of **Class IIB**, exception for **TCC** in **W6**.

Total coliforms include bacteria that are found in the soil as well as in water that has been influenced by surface water. Hence, the exceedance in **TCC** at **W6** was likely attributed from runoff during recent rain event.

Note: \* Baseline data extracted from EIA for Forest Management of Bengkoka and Tambalugu Forest Reserves (6,467 Ha), Pitas, Sabah.  
 (-) denotes No Sample Available
