## ENVIRONMENTAL MONITORING AND COMPLIANCE AUDIT REPORT

### FOREST MANAGEMENT OF BENGKOKA AND TAMBALUGU FOREST RESERVES (6,467 HA), PITAS, SABAH

1<sup>st</sup> REPORT OF YEAR 2021

AEC Ref. No. : JPAS/PP/15/600-1/01/3/60(36)  
Report Reference : CK/MO411/1197-1/21  
Date of Report : 30<sup>th</sup> April 2021  
Report No. : 7

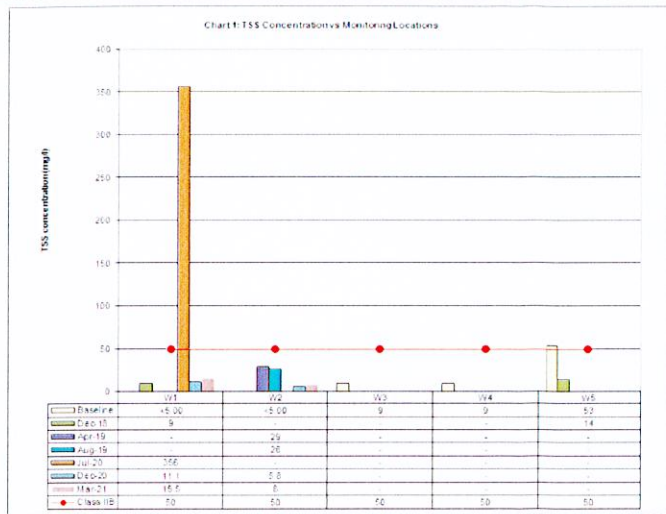
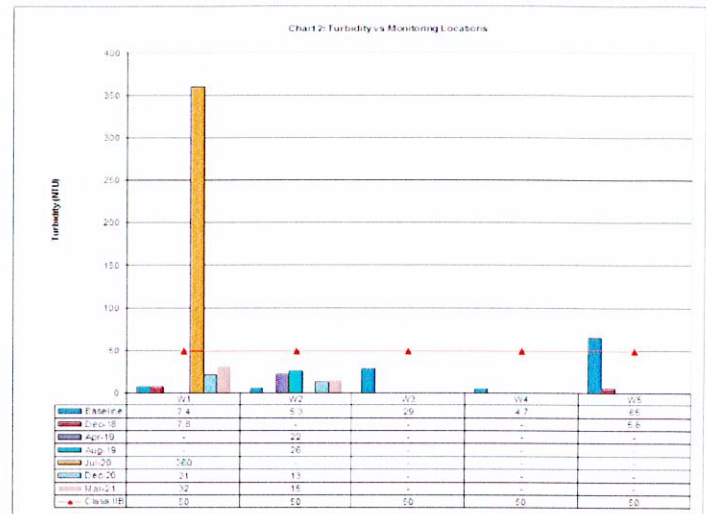
# HISTORICAL SURFACE WATER QUALITY GRAPHICAL REPRESENTATION

Note: \* Baseline data extracted from EIA for Forest Management of Bengkoka and Tambalugu Forest Reserves (6,467 Ha), Pitas, Sabah.

Surface water quality analysis show that all the parameters measured is **below** the recommended limit of **Class IIB** of **NWQSM**.

- Construction of sedimentation pond or drainage system within existing waterway or river reserve is strictly prohibited.
- Vegetation clearing shall be carried out in stages and confined to areas that are essential for Project development. Existing vegetation shall be retained to reduce runoff velocity and act as a natural barrier to minimize soil erosion.
- Re-vegetation or planting of cover crops shall be carried out in tandem with the field establishment works. This is to avoid prolonged and unnecessary exposure of bare ground elements such as rainfall, wind and surface runoffs.
- Usage of agro-chemical is minimized and strictly adhered to the rules and regulations as stipulated under the Pesticides Act 1974. Disposal of agro-chemicals such as pesticide and herbicide into existing stream or any waterway is strictly prohibited.
