## ENVIRONMENTAL MONITORING AND COMPLIANCE AUDIT REPORT

FOREST MANAGEMENT OF BENGKOKA AND TAMBALUGU  
FOREST RESERVES (6,467 HA), PITAS, SABAH

1<sup>st</sup> REPORT OF YEAR 2022

AEC Ref. No. : JPAS/PP/15/600-1/01/3/60(46)  
Report Reference : CK/MO411/1197-1/22  
Date of Report : 19<sup>th</sup> April 2022

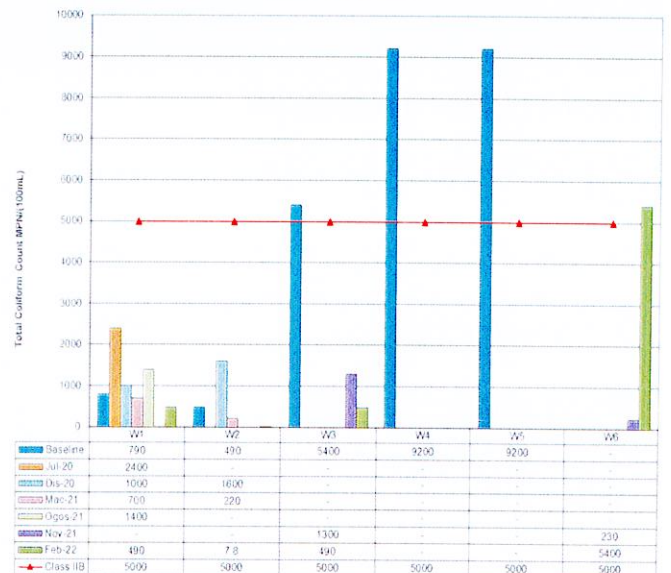
Chart 4.0: Total Coliform Count vs Monitoring Locations

TCC is the measure of all the coliform bacteria in the water body, which may determine the presence of human or animal waste in the water. The slight increase of the TCC in

the river water quality might be attributed by faecal matter (of wildlife) washed into the river due to the rain. These were mostly beyond the Project Proponent's control.

- Construction of sedimentation pond or drainage system within existing waterway or river reserve is strictly prohibited.
- Vegetation clearing shall be carried out in stages and confined to areas that are essential for Project development. Existing vegetation shall be retained to reduce runoff velocity and act as a natural barrier to minimize soil erosion.
- Re-vegetation or planting of cover crops shall be carried out in tandem with the field establishment works. This is to avoid prolonged and unnecessary exposure of bare ground elements such as rainfall, wind, and surface runoffs.
- Usage of agro-chemical is minimized and strictly adhered to the rules and regulations as stipulated under the Pesticides Act 1974. Disposal of agrochemicals such as pesticides and herbicides into existing streams or any waterway is strictly prohibited.
