ENVIRONMENTAL MONITORING AND COMPLIANCE AUDIT REPORT

FOREST MANAGEMENT OF BENGKOKA AND TAMBALUGU
FOREST RESERVES (6,467 HA), PITAS, SABAH

2nd REPORT OF YEAR 2021

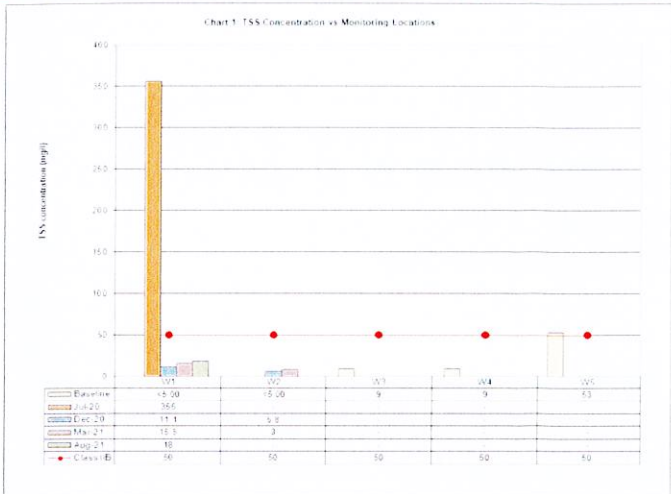
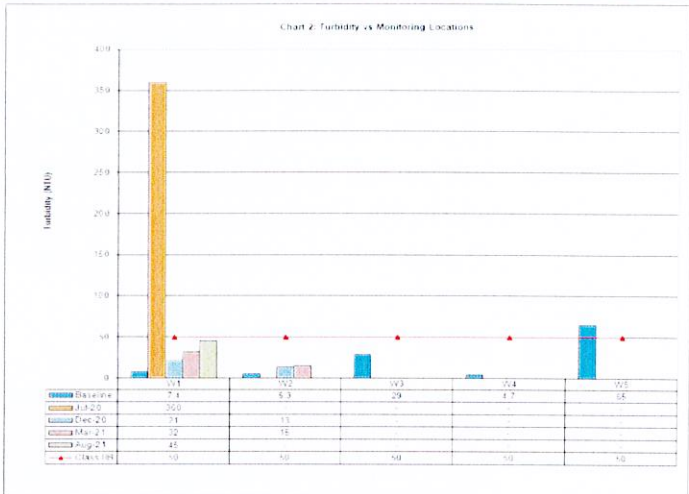
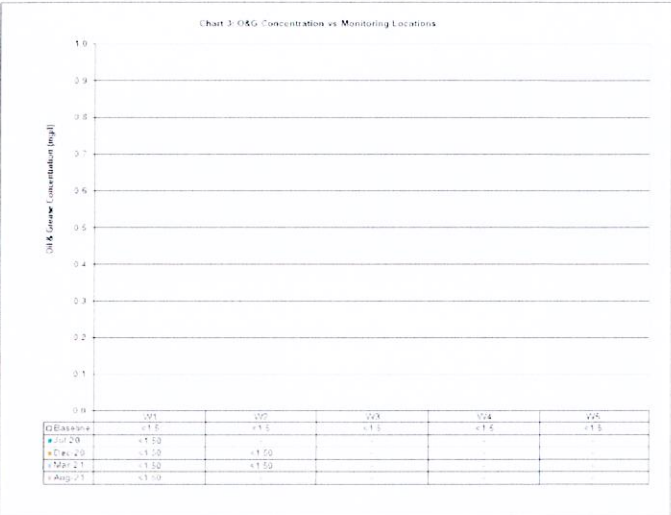
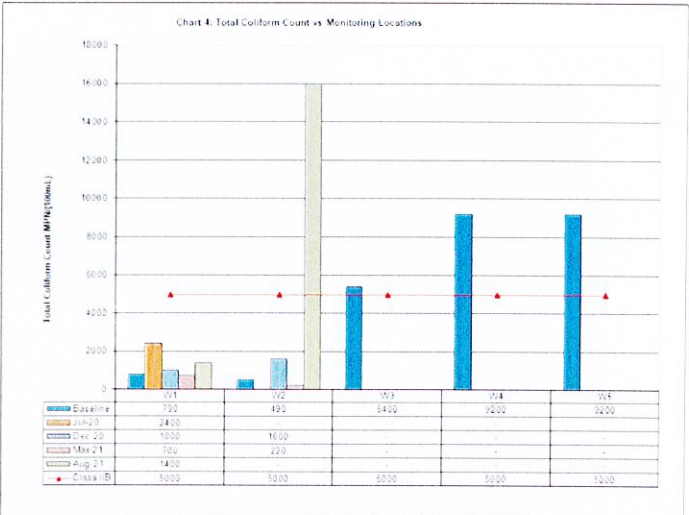
HISTORICAL SURFACE WATER QUALITY GRAPHICAL REPRESENTATION

Note: * Baseline data extracted from EIA for Forest Management of Bengkoka and Tambalugu Forest Reserves (6,467 Ha), Pitas, Sabah.

Surface water quality analysis show that all the parameters measured is below the recommended limit of **Class IIB**.
