ENVIRONMENTAL COMPLIANCE REPORT

**FOREST MANAGEMENT OF BENGKOKA AND TAMBALUGU
FOREST RESERVES (6,467 HA), PITAS, SABAH**

2nd REPORT OF YEAR 2022

Date of Report : 30th September 2022

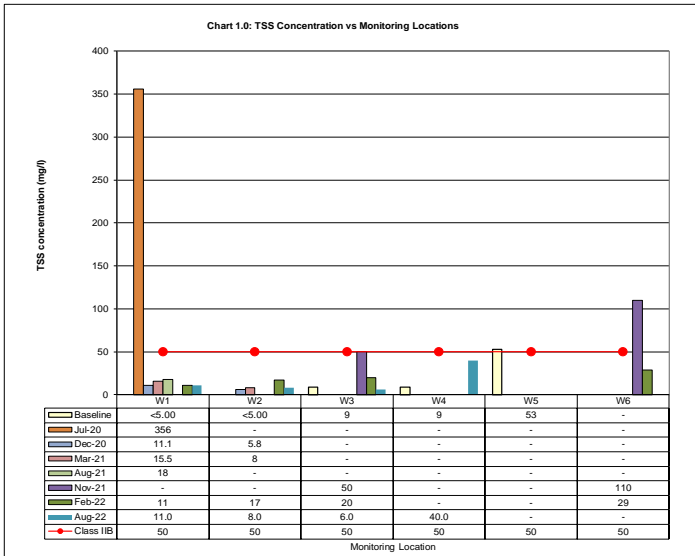
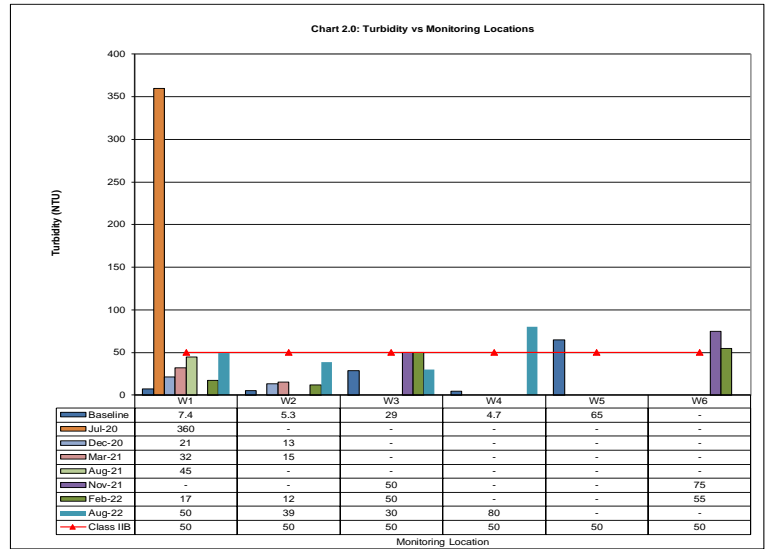
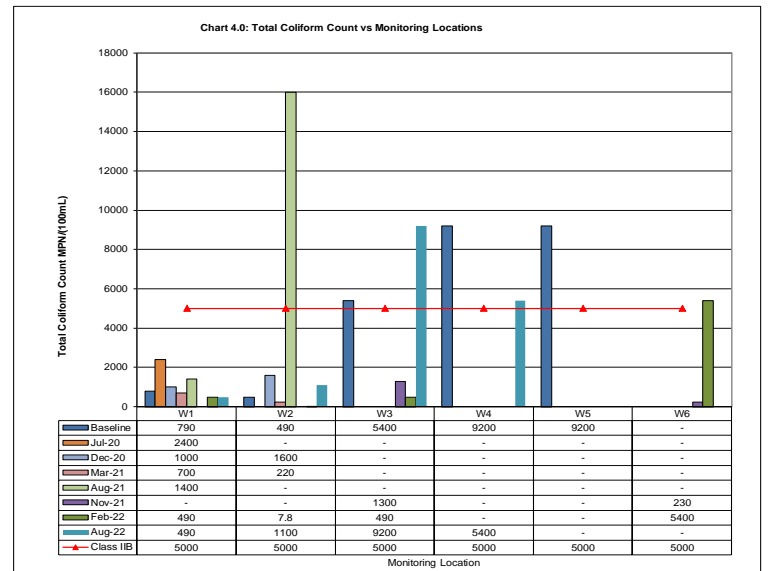
HISTORICAL SURFACE WATER QUALITY GRAPHICAL REPRESENTATION

Surface water quality analysis shows all measured parameters below the recommended limits of **Class IIB, except** for Turbidity (W4) and TCC (**W3 & W4**).

Turbidity is a measure of the level of cloudiness or opaqueness of water. The slight increase in turbidity level of the river water could be contributed by increased erosion of soil from riverbanks during recent rain event. The released of dirt/soil can settle out across the water body, giving a cloudy appearance, hence leading to high turbidity level.

TCC is the measure of all coliform bacteria in the water body, which may indicate the presence of human or animal waste in the water. The exceedance in TCC level in river water quality might be attributed by faecal matter (of wildlife) washed into the river from runoff during rain event, beyond the Project Proponent's control.

Note: * Baseline data extracted from EIA for Forest Management of Bengkoka and Tambalugu Forest Reserves (6,467 Ha), Pitas, Sabah.

- Construction of sedimentation pond or drainage system within existing waterway or river reserve is strictly prohibited.
- Vegetation clearing shall be carried out in stages and confined to areas that are essential for Project development. Existing vegetation shall be retained to reduce runoff velocity and act as a natural barrier to minimize soil erosion.
- Re-vegetation or planting of cover crops shall be carried out in tandem with the field establishment works. This is to avoid prolonged and unnecessary exposure of bare ground elements such as rainfall, wind, and surface runoffs.
- Usage of agro-chemical is minimized and strictly adhered to the rules and regulations as stipulated under the Pesticides Act 1974. Disposal of agrochemicals such as pesticides and herbicides into existing streams or any waterway is strictly prohibited.
