ENVIRONMENTAL COMPLIANCE REPORT

**FOREST MANAGEMENT OF BENGKOKA AND TAMBALUGU
FOREST RESERVES (6,467 HA), PITAS, SABAH**

1st REPORT OF YEAR 2023

AEC Ref. No. : JPAS/PP/15/600-1/01/3/60(46)
Report Reference : CK/MO411/1197-1/23
Date of Report : 3rd May 2023

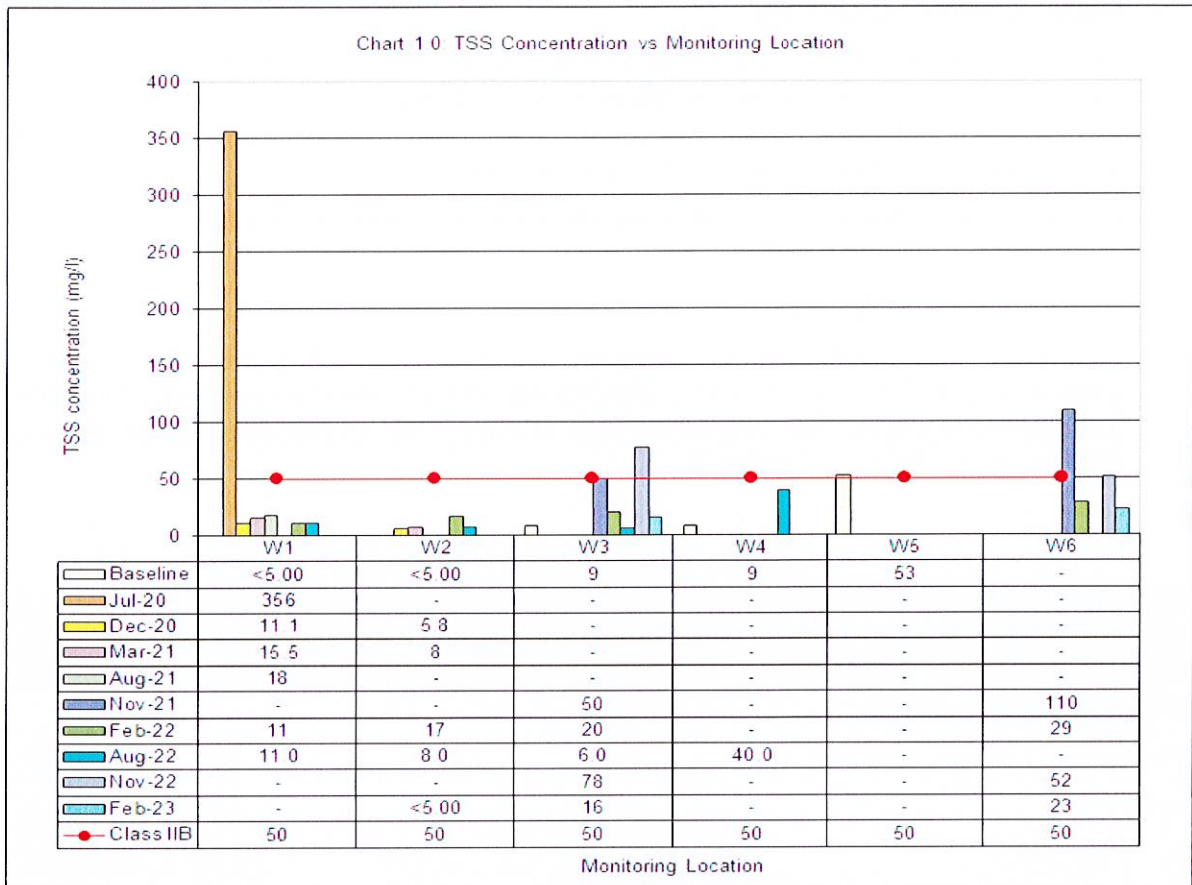
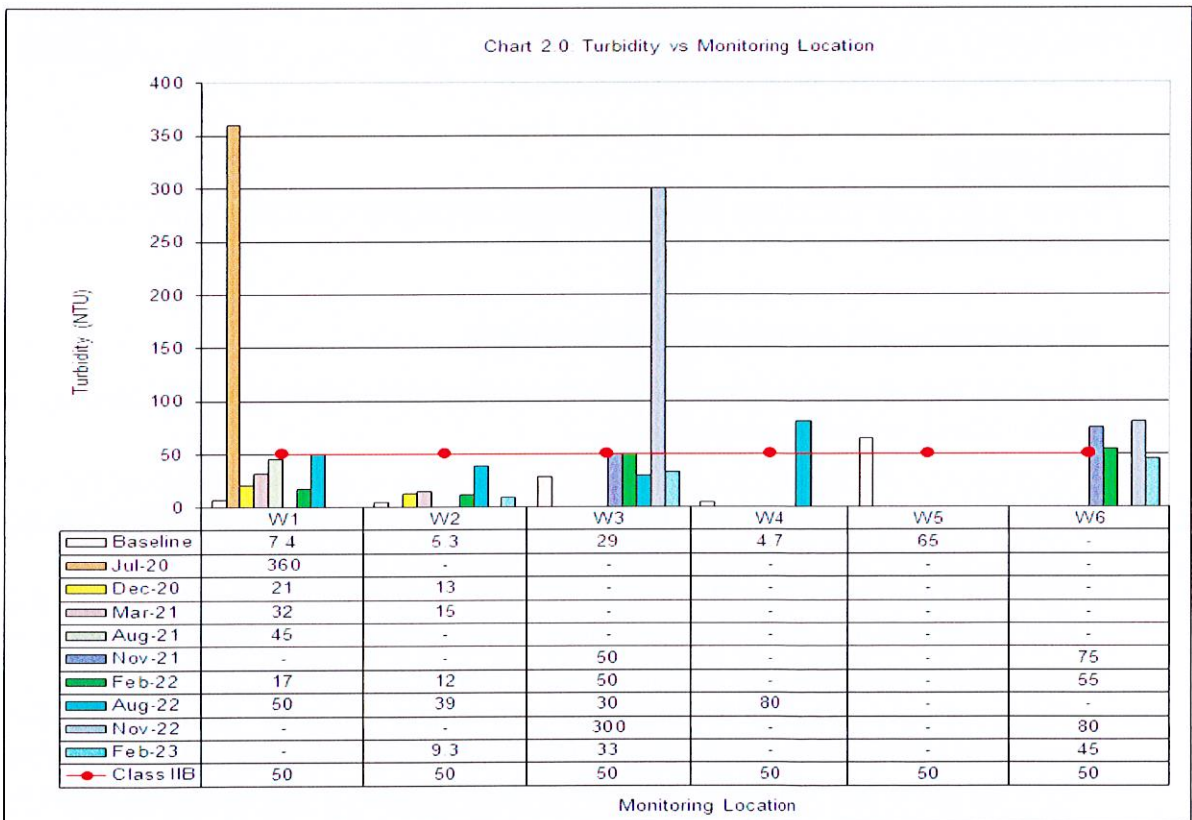
HISTORICAL SURFACE WATER QUALITY GRAPHICAL REPRESENTATION

Note: * Baseline data extracted from EIA for Forest Management of Bengkoka and Tambalugu Forest Reserves (6,467 Ha), Pitas, Sabah.

Surface water quality analysis shows measured parameters below the recommended limits of **Class IIB**.

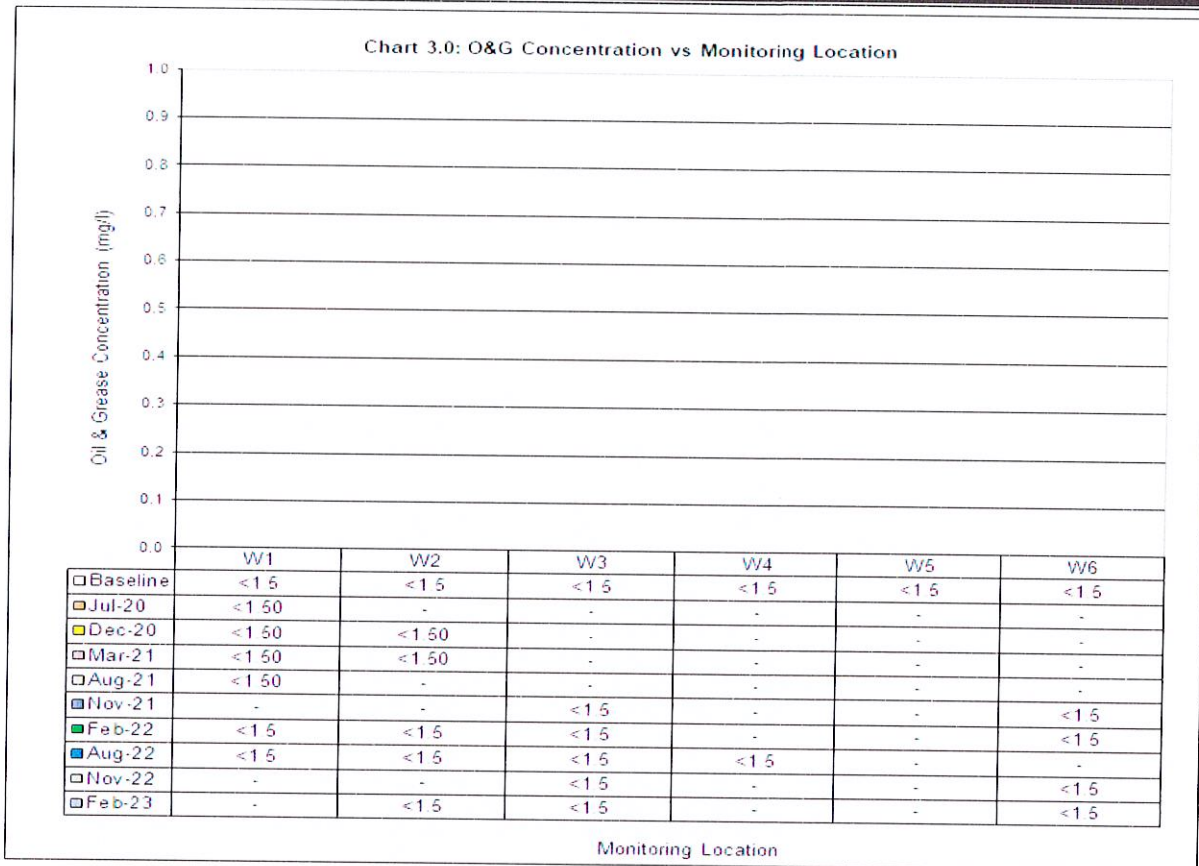
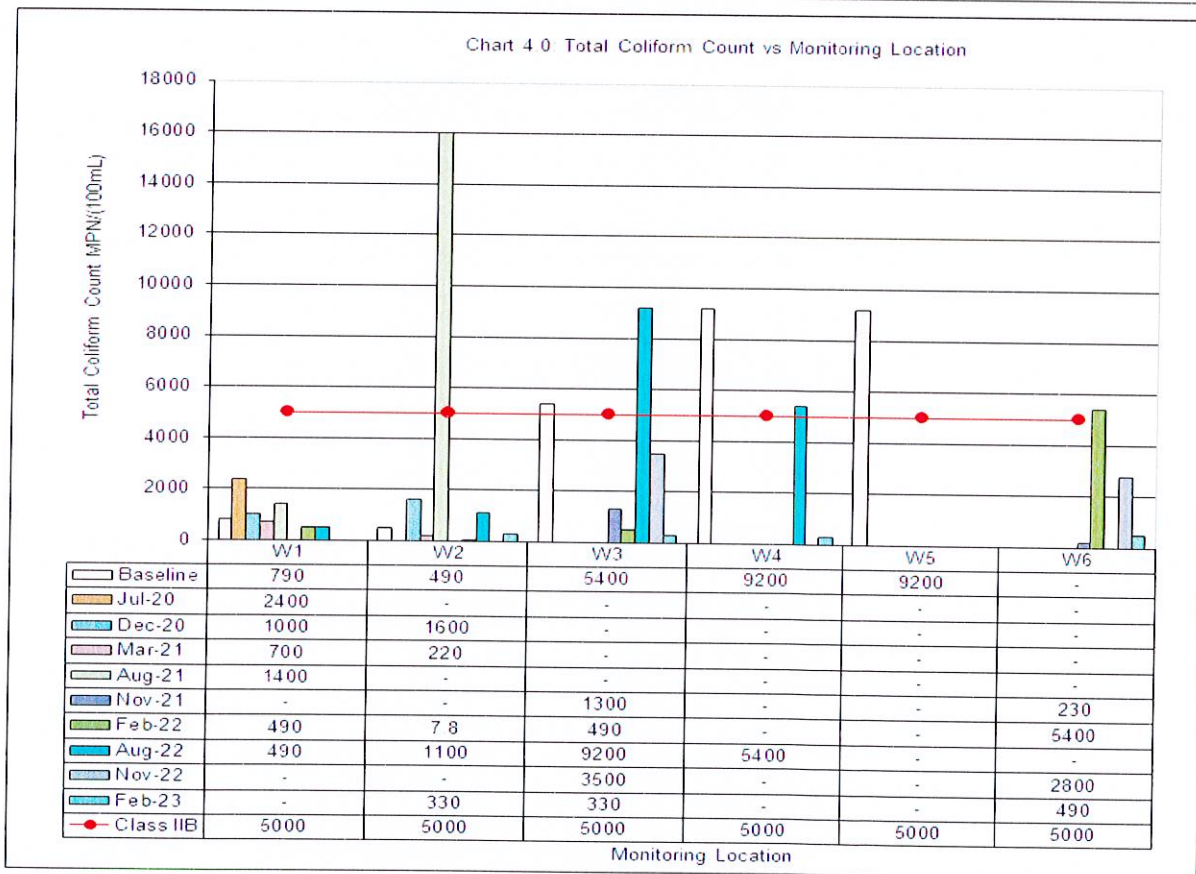
HISTORICAL SURFACE WATER QUALITY GRAPHICAL REPRESENTATION

Note: * Baseline data extracted from EIA for Forest Management of Bengkoka and Tambalugu Forest Reserves (6,467 Ha), Pitas, Sabah.
