## ENVIRONMENTAL MONITORING AND COMPLIANCE AUDIT REPORT

### FOREST MANAGEMENT OF BENGKOKA AND TAMBALUGU FOREST RESERVES (6,467 HA), PITAS, SABAH

1<sup>st</sup> REPORT OF YEAR 2021

AEC Ref. No. : JPAS/PP/15/600-1/01/3/60(36)  
Report Reference : CK/MO411/1197-1/21  
Date of Report : 30<sup>th</sup> April 2021  
Report No. : 7

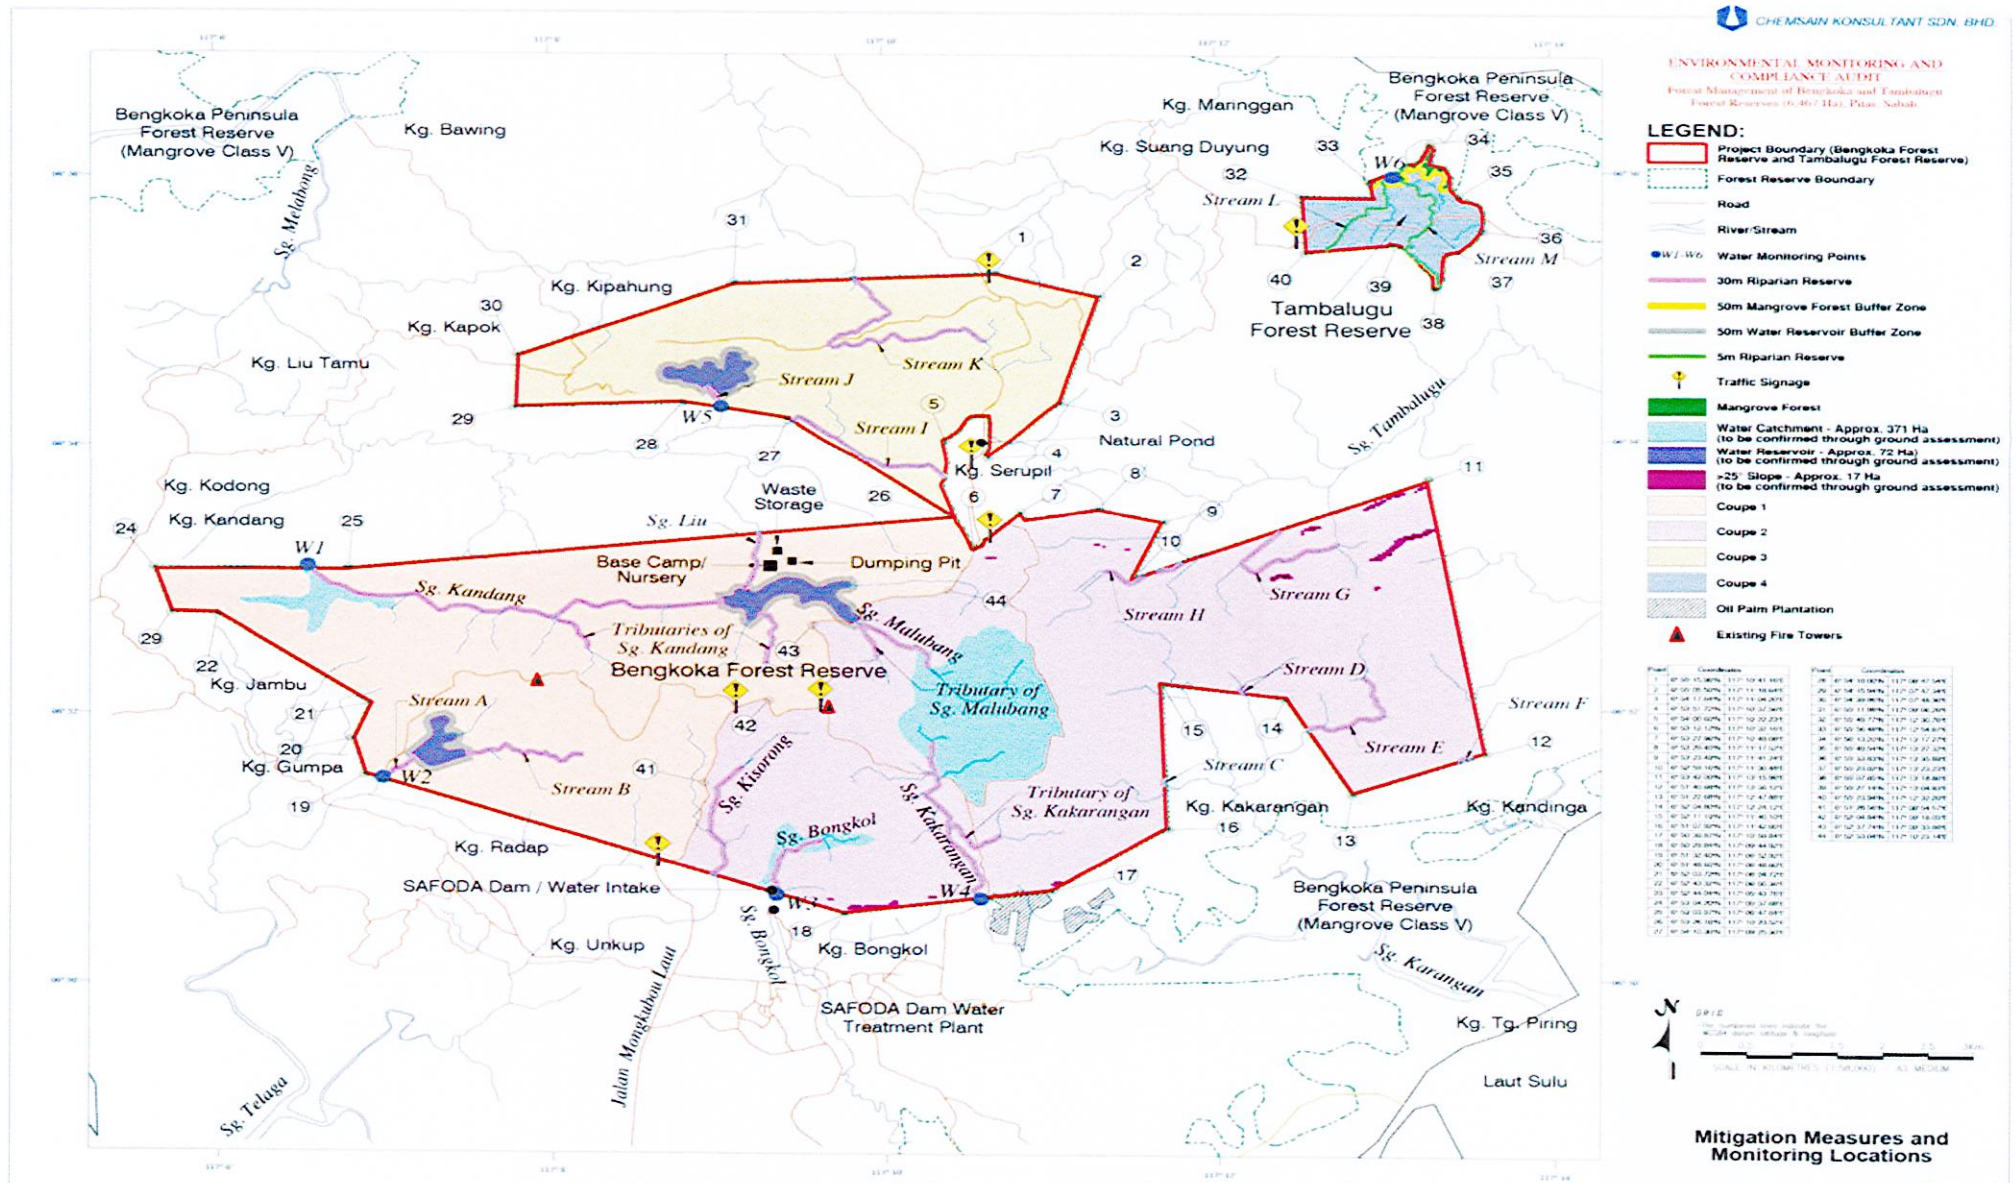
Figure 1.0: Mitigation Measures and Monitoring Locations

Designated monitoring and sampling location are shown in **Figure 1.0** with details tabulated in **Table 2.0**.

Water sampling was carried out on the 30<sup>th</sup> March 2020 at five (5) monitoring locations, **W1, W2, W3, W4** and **W5** as shown in **Figure 1.0**. However, no sampling was carried out at locations **W3, W4, W5** as the Project has not progressed into these locations yet. The weather was fine and sunny throughout the sampling exercises.
