## ENVIRONMENTAL COMPLIANCE REPORT

**FOREST MANAGEMENT OF BENGKOKA AND TAMBALUGU  
FOREST RESERVES (6,467 HA), PITAS, SABAH**

**3<sup>RD</sup> REPORT OF YEAR 2023**

AEC Ref. No. : JPAS/PP/15/600-1/01/3/60(46)  
Report Reference : CK/MO411/1197-3/23  
Date of Report : 14<sup>th</sup> December 2023

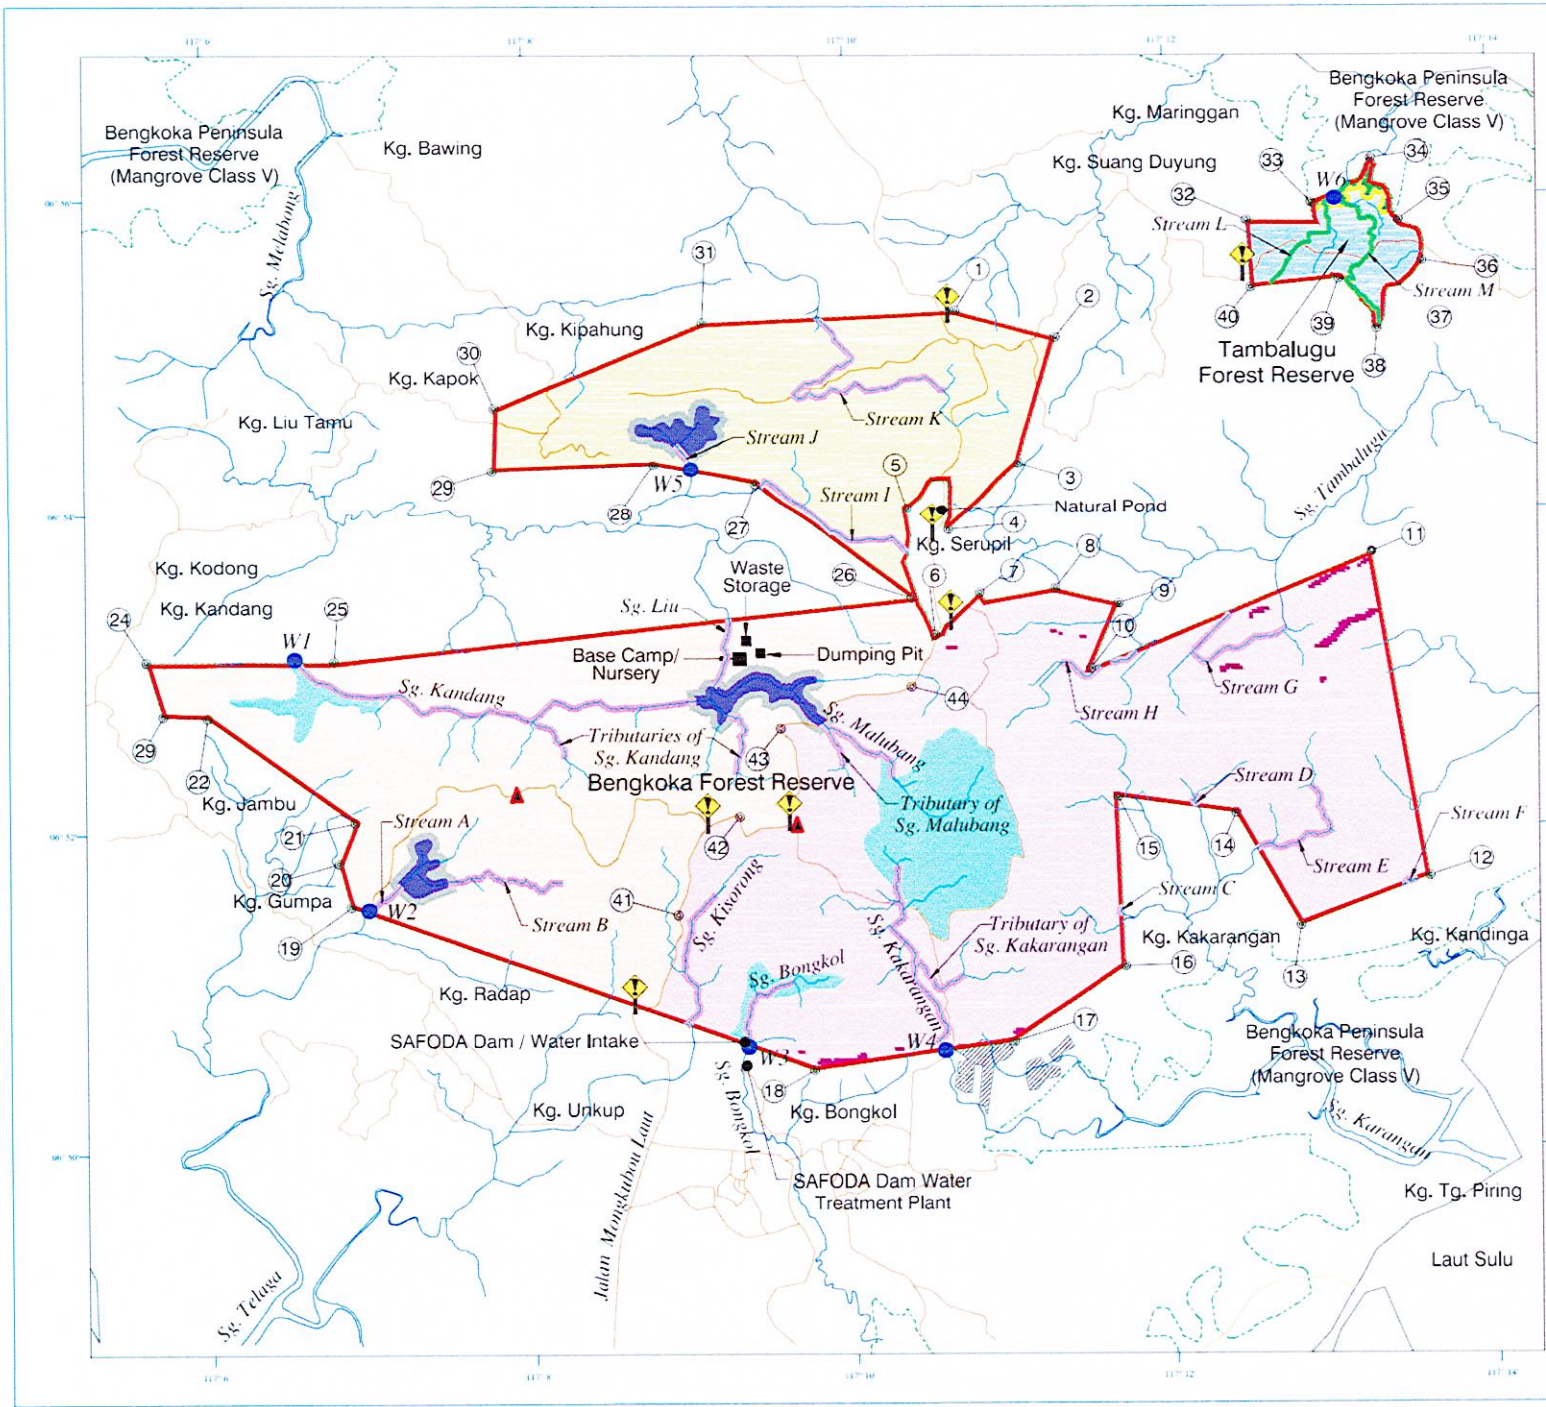
Figure: 1.0

Designated sampling locations are shown in **Figure 1.0** with details tabulated in **Table 2.0**.

**Mitigation Measures and Monitoring Locations**
